Arboricultural Impact Assessment (AIA) report for Mono Constructions regarding 56 Beane St, Gosford, NSW

By David Shrimpton
Koala Arbor Consulting Arborists
e:david@koalaarbor.com

26/02/2020

PRELIMINARY ARBORICULTURAL REPORT

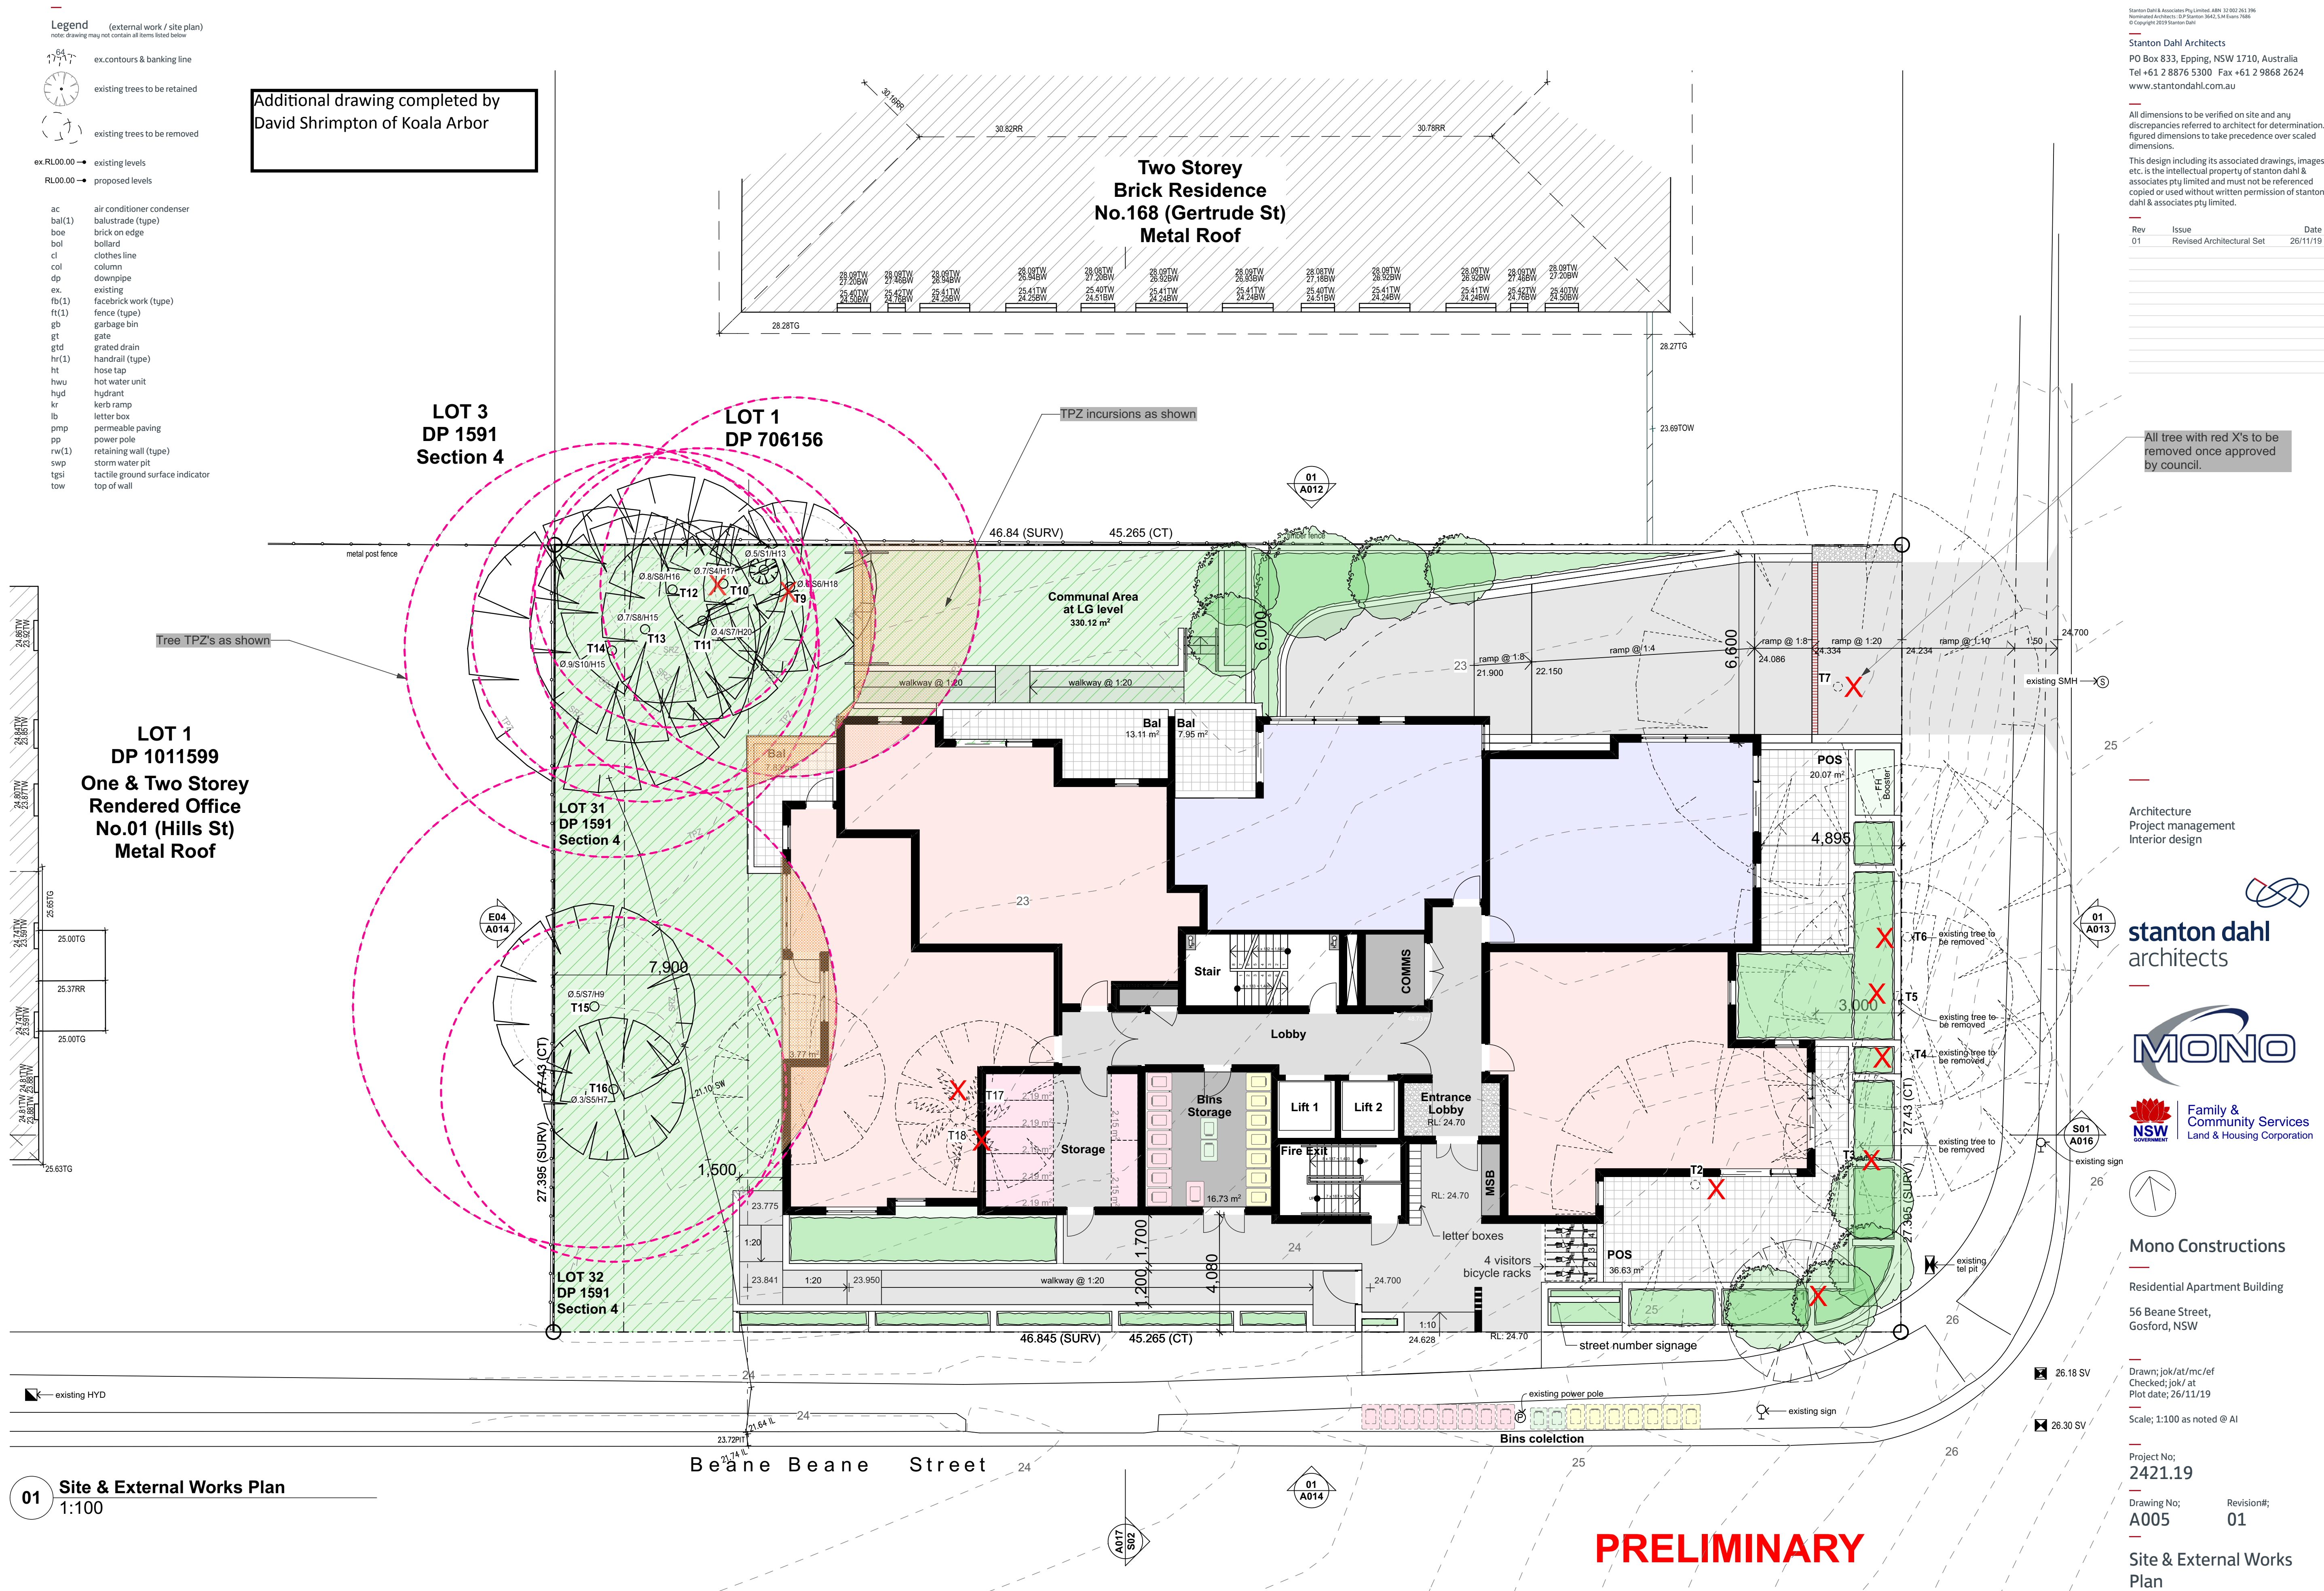
8. TPZ's and Incursion's Map

Any yet to be finalised plumbing or electrical work that overlaps with the TPZ as shown on page 9 "TPZ's and Incursions Map" will need to be considered and or avoided. It is noted an existing storm water pipe is located in the stand of trees to be retained. It's

current location terminates without further notation on the survey and plans provided. Consideration should be given to any works that intend to renew this pipe (if needed) as the structural root zone of several trees could be impacted by works to this area.

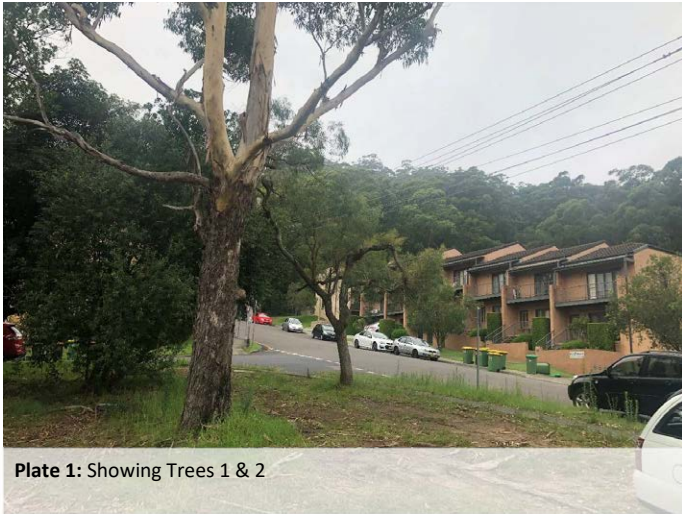
Plate 1: Showing Trees 1 & 2

- 2.2.7 Tree 1 is small in size, and if removed, replacement planting using healthy, advanced-size specimens could replace the loss of amenity within a short timeframe.

2.2.8 Tree 2

With council permission, the trees marked for removal (1, 2, 3, 4, 5, 6, 7, 8, 9, 10, 17, 18

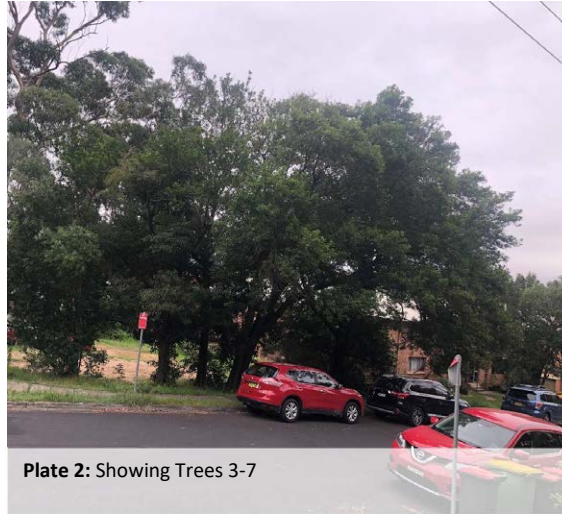
Plate 2: Showing Trees 3-7

- 2.2.3 Tree 3 *Olea europaea* subsp. *cuspidata* (African Olive) is subject to a *General Biosecurity Duty* and a *Regional Recommended Measure* by the Department of Primary Industries.⁴ *This species must not be traded, carried, grown or released into the environment.*

Tree 4 was identified as *Pittosporum undulatum* (Sweet Pittosporum) and is located adjacent to the Gertrude Street frontage. The tree has a short (5-15 years) estimated ULE, is of low Landscape Significance and has been allocated a Retention Value of *Consider for Removal*. The tree is a heavily suppressed specimen and contains a number of wounds with advanced stages of decay.

2.2.12 Tree 4 is small in size, and if removed, replacement planting using healthy, advanced-size specimens could replace the loss of amenity within a short timeframe.

2.2.14 Tree 5 is small in size, and if removed, replacement planting using healthy, advanced-size specimens could replace the loss of amenity within a short timeframe.

Tree 6 has been identified as *Glochidion ferdinandi* (Cheese Tree) and is located adjacent to the Gertrude Street frontage. The tree has a short (5-15 years) estimated ULE, is of moderate Landscape Significance and has been allocated a Retention Value of *Consider for Retention*. Included bark has developed between the junctions of co-dominant, first-order branches on Tree 6. The inclusion is likely to become a significant structural defect in the medium term as the branches increase in weight and diameter. Major inclusions have an increased risk of branch failure, particularly during severe weather events.

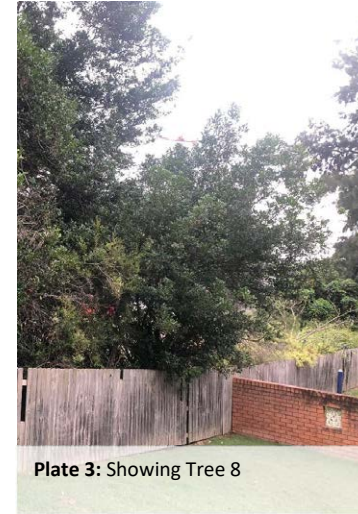
Plate 3: Showing Tree 8

2.2.18 Tree 8 is small in size, and if removed, replacement planting using healthy, advanced-size specimens could replace the loss of amenity within a short timeframe.

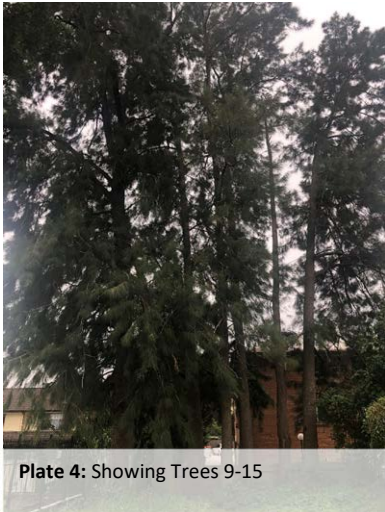
Plate 4: Showing Trees 9-15

2.2.20 Trees 9 and 11-15 should be managed as a group. The removal of individual trees from groups of trees which have been closely planted can open up the remaining canopy and alter the wind-loading forces, potentially increasing the risk of branch failures.

Six trees (11, 12, 13, 14, 15 and 16) should be retained and protected during the construction period as per *AS4970-2009 Protection of Trees on Development Sites*. This should include a sign on the trees of the project arborist details as well as at the front of the property.

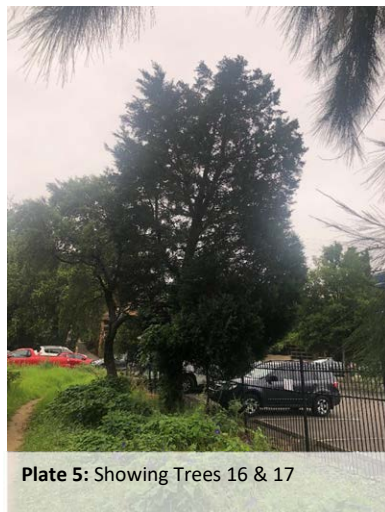
Plate 5: Showing Trees 16 & 17

2.2.22 Trees 16, 17 and 19 are small in size, and if removed, replacement planting using healthy, advanced-size specimens could replace the loss of amenity within a short timeframe.

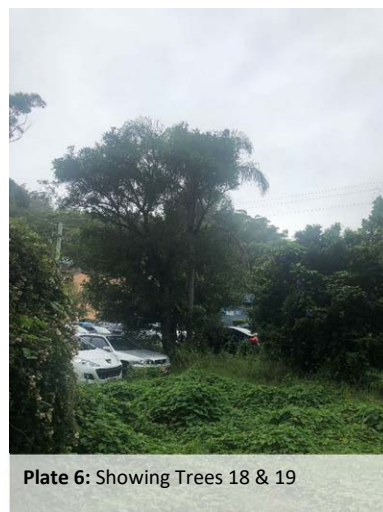
Plate 6: Showing Trees 18 & 19

- 2.2.4 Tree 19 *Syagrus romanzoffiana* (Cocos Palm) is listed as an *Undesirable Species in the Central Coast Council LGA* and consent is not required for its removal.⁵

2.2.24 Tree 18 is small in size, and if removed, replacement planting using healthy, advanced-size specimens could replace the loss of amenity within a short timeframe.
