# DETAILED SITE INVESTIGATION 56-58 BEANE STREET GOSFORD PREPARED FOR ROOT PARTNERSHIPS PTY LTD CES DOCUMENT REFERENCE: CES181201-RPS-AB

**Date:** 17 January 2019

# **EXECUTIVE SUMMARY**

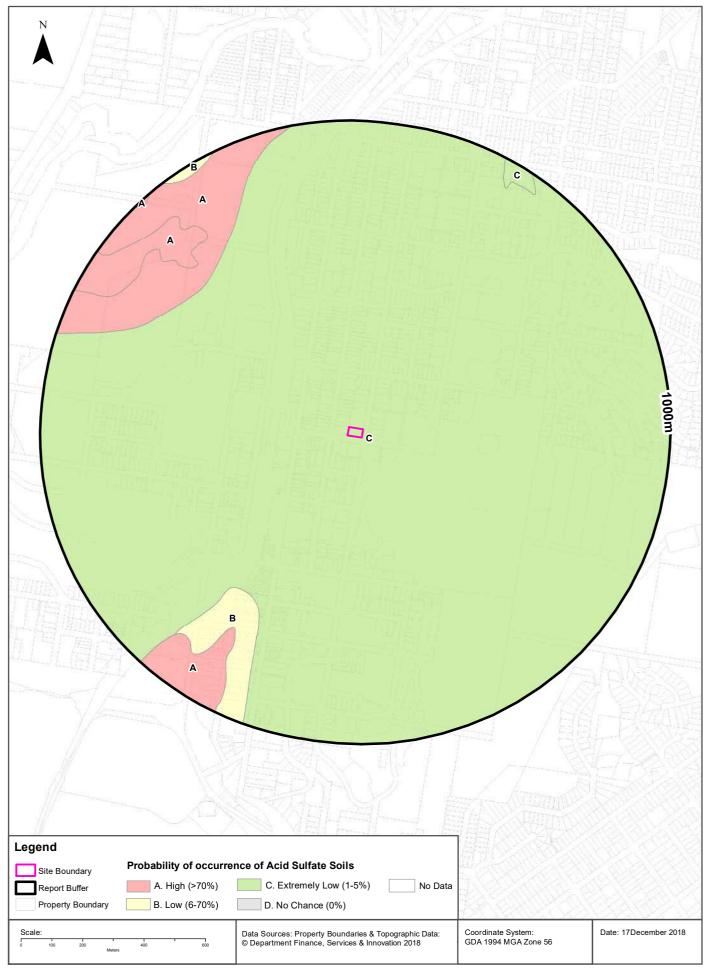
## **Atlas of Australian Acid Sulfate Soils**

In many cases where a high risk is indicated, less than 100% of the area will have a high hazard or risk.

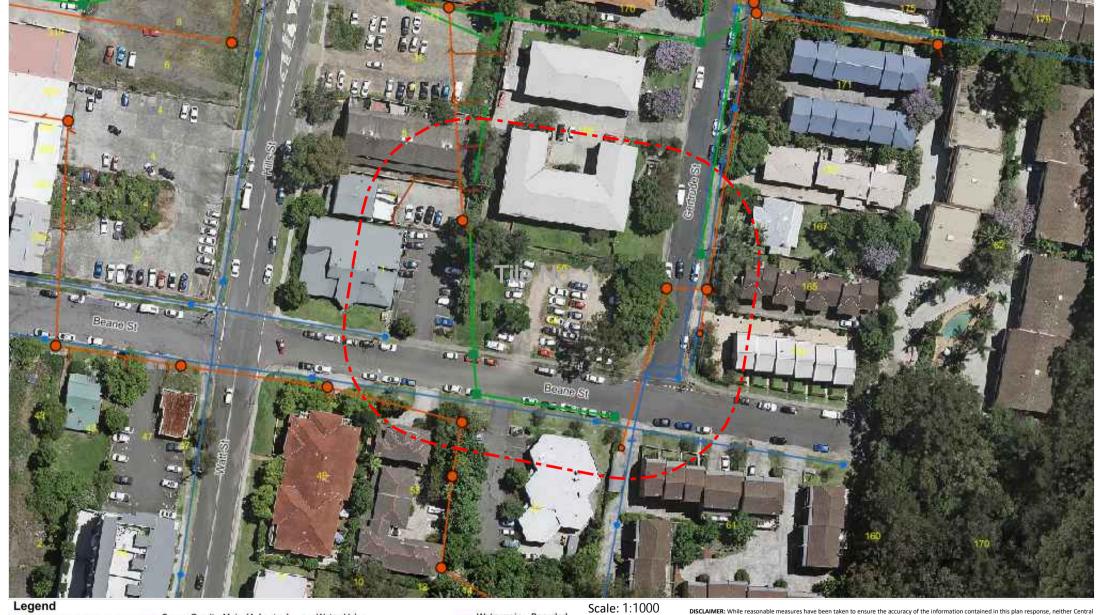
- Sewer Maintenance Hole
- Sewer Dead End .
- Sewer Lamphole ٠
- ---- Sewer Service Connection

- Water Hydrant — Sewer Gravity Main
- Plans generated [13/12/2018] by Pelicancorp TicketAccess Software | www.pelicancorp.com

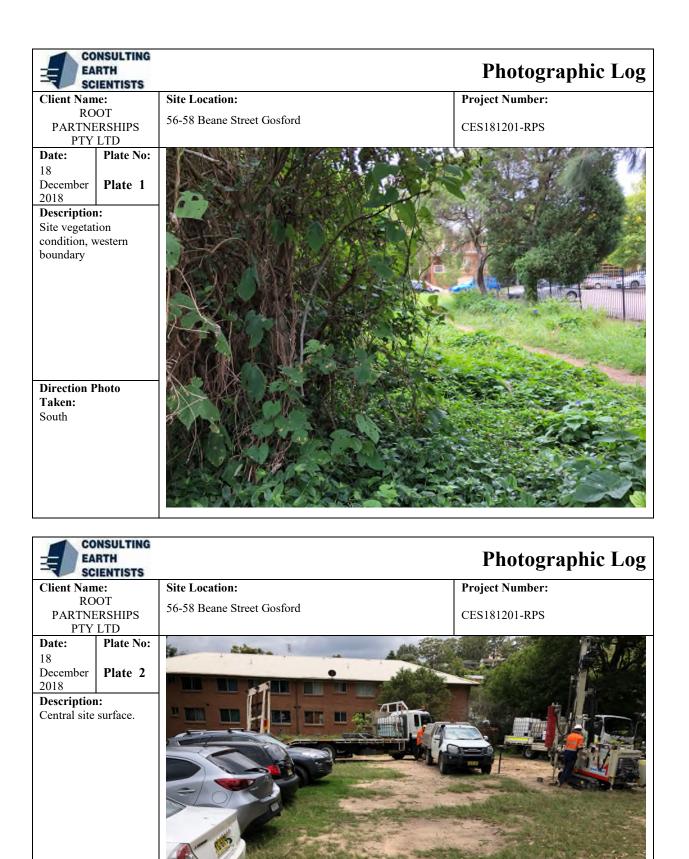
**Direction Photo Taken:** North
