LANDCOM

North Tuncurry (NSW) Residential Land Development Soil Contamination Investigation

301020-02358 – 00-EN-REP-0001

28 April 2010

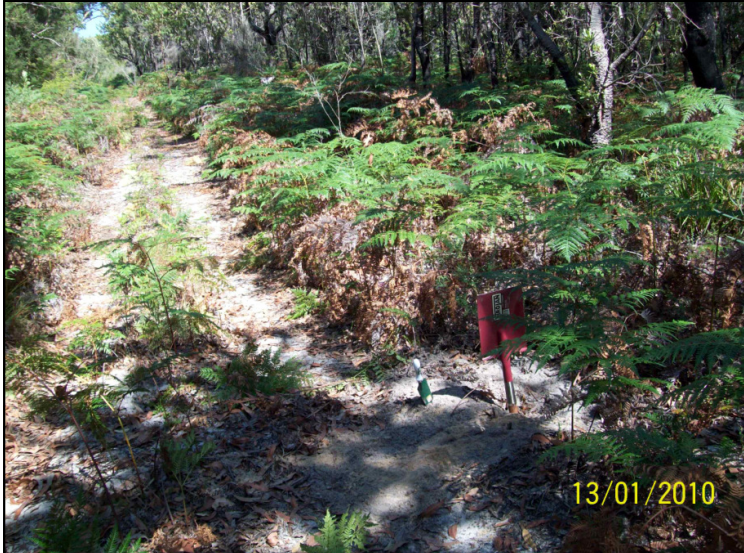
Photograph 1

Looking to the east of the site.
Typical view of dense vegetation
observed across the site.

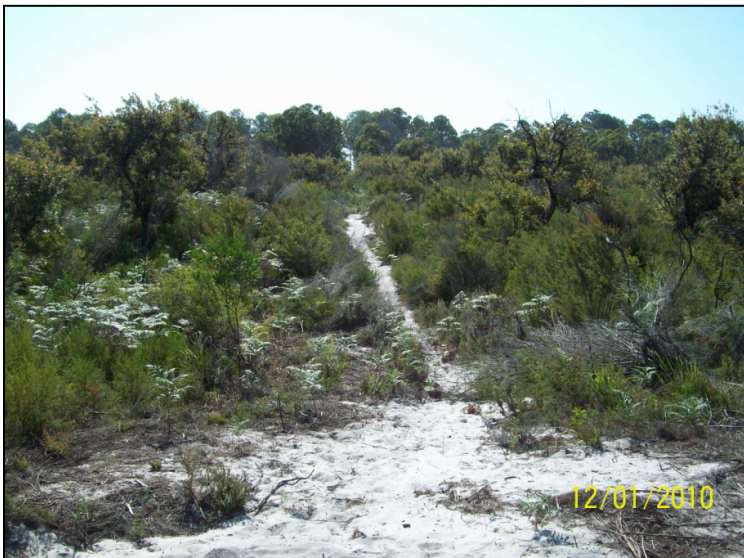
Photograph 2

Looking west towards BH15.
Access to borehole location
BH15 had to be undertaken by
foot due to dense vegetation
and narrow pathway for vehicle
access.

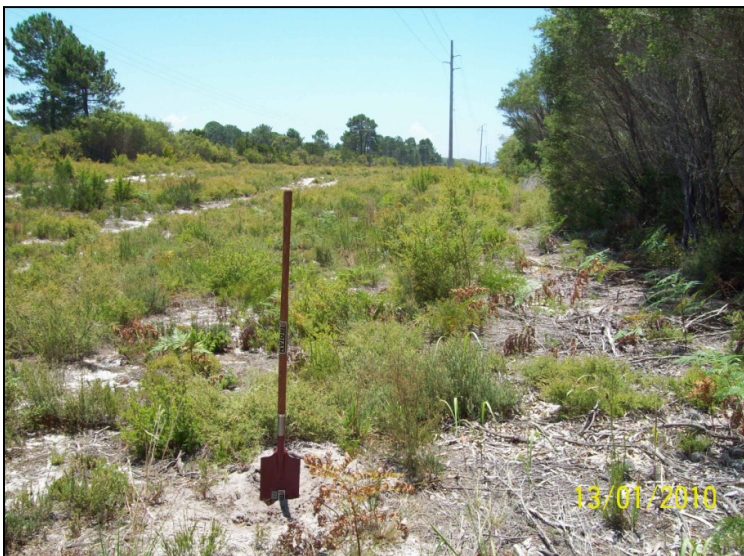
Photograph 3

Looking north towards BH9.
Electricity easement parallel to
The Lakes Way adjacent to the
western boundary of the site.

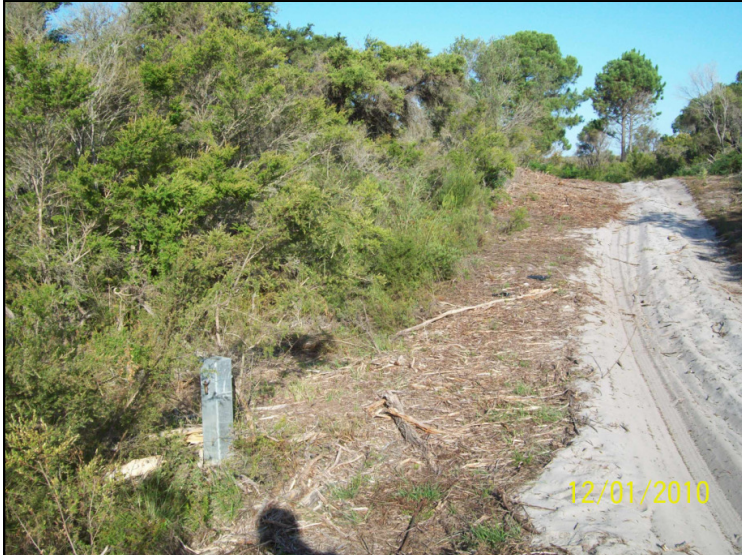
Photograph 4

Looking east towards existing (stand pipe – locked) piezometer located adjacent to the west of borehole location BH14.

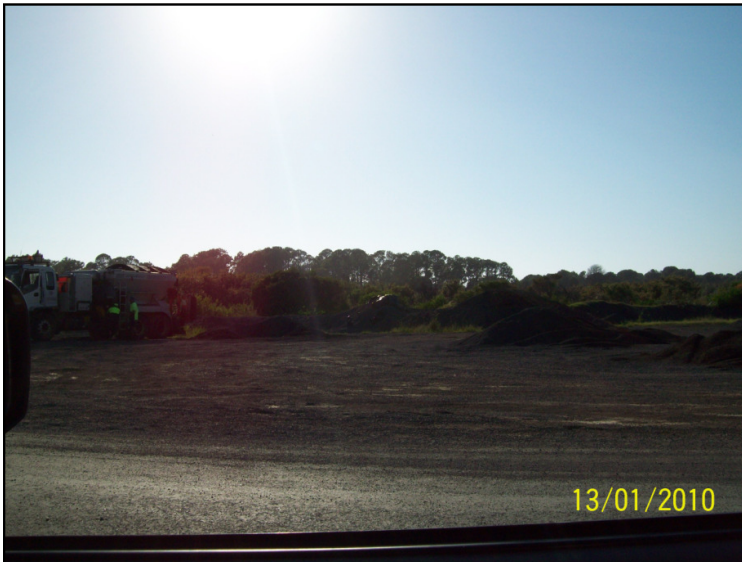
Photograph 5

Potential issues with regard to aesthetics are likely to include the near-surface soil staining as a result of engine oil discharge which were observed present within the crushed rock area at the junction of the road way leading to the golf course, and illegally dumped waste materials including: domestic waste, construction and demolition waste, pieces of scrap metal and abandoned cars observed across the site. ACMs were not observed during the field work undertaken by WorleyParsons.

Looking east towards 'crushed rock' area located adjacent to the start of the golf course access road. Note vehicle maintenance work undertaken by Council workers within the area.

Based on the findings and observations during this SCI, WorleyParsons recommends that a combination of remediation works and management procedures be implemented at the site during development. Remediation works would initially involve the removal of illegally dumped waste materials (e.g., domestic waste, construction and demolition waste, pieces of scrap metal and abandoned cars) observed across the site, and the removal of the near surface impacted soil within the ‘crushed rock’ surface area located adjacent to the beginning of golf course access road. Remediation of localised hydrocarbon impacted soil may involve either treatment (on or off site) or off-site disposal. A suitable environmental consultant should be present during the removal of the soil, for

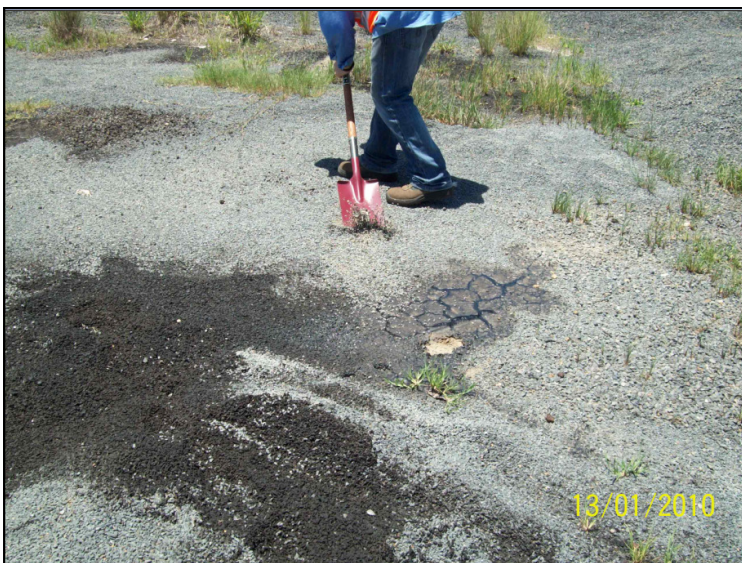
Photograph 6

- Potential issues with regard to aesthetics include: the near surface soil staining observed to be present within the ‘crushed rock’ area adjacent to the golf course access way, the obvious illegally dumped waste materials across the site (near surface) and the potential for other waste and ACMs as outlined in Section 6.2.

Surface condition of where vehicle maintenance work was carried out at the 'crushed rock' area located adjacent to the beginning of the golf course access road.
