REVISED HISTORIC HERITAGE ASSESSMENT

SNOWY MOUNTAINS SPECIAL ACTIVATION PRECINCT

SNOWY MONARO REGIONAL COUNCIL LGA

JUNE 2022

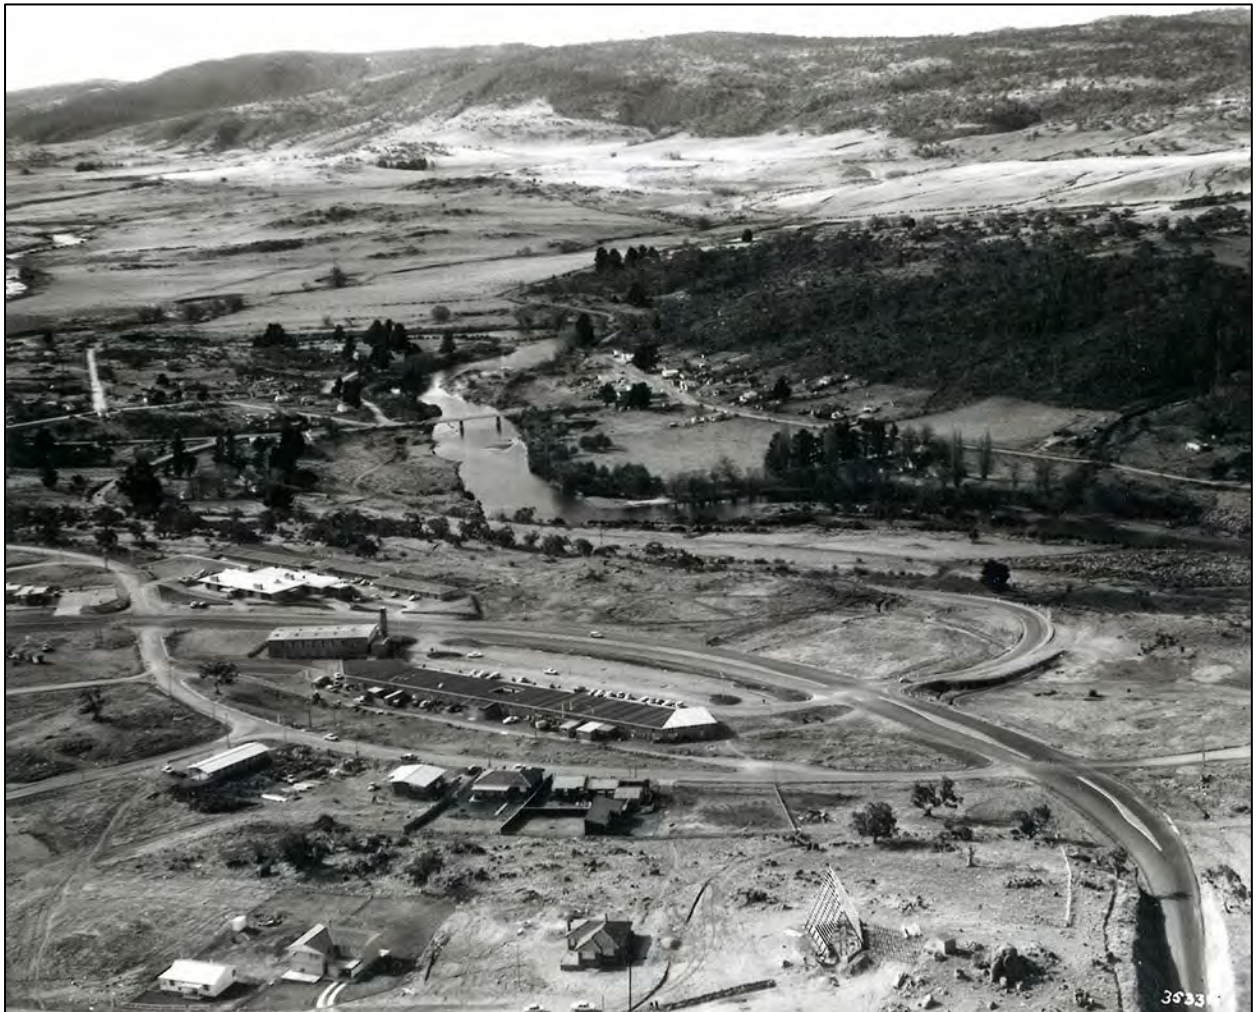
Figure 2-2: A 1965 view of new Jindabyne (foreground) being built with old Jindabyne in the mid-distance (source: snowymountains.com.au).

The Memorial Hall is a landmark building at Jindabyne and one of the first buildings constructed in new Jindabyne (in **Figure 2-2** the Memorial Hall with its distractive clock tower is shown to the left of the yet-to-be-built shopping centre, although the current upper car park is already in place).

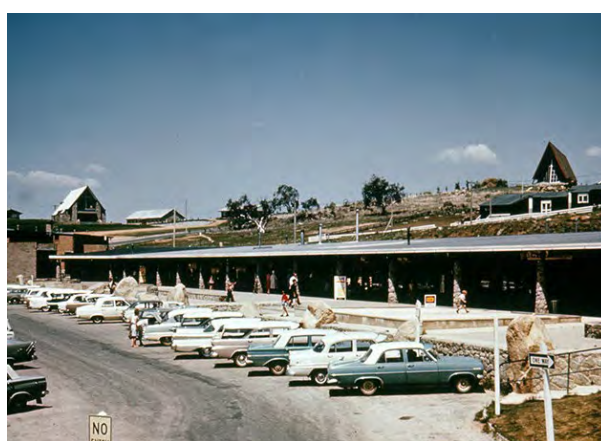
4. New Jindabyne in the 1960s (source: Design Detail Jindabyne: designdetail.com.au).

The original shopping centre is now cluttered with signage, rubbish bins and other unsympathetic additions, particularly at each end of the original arc of shops. However, as originally conceived, the shopping centre was designed to be the centrepiece of the town overlooking the newly formed lake. In its original conception, the shopping centre was arced to embrace the lake and was elevated to afford views over the lake (see **Figure 2-3**, photo 4 for a view of the newly constructed shopping centre).

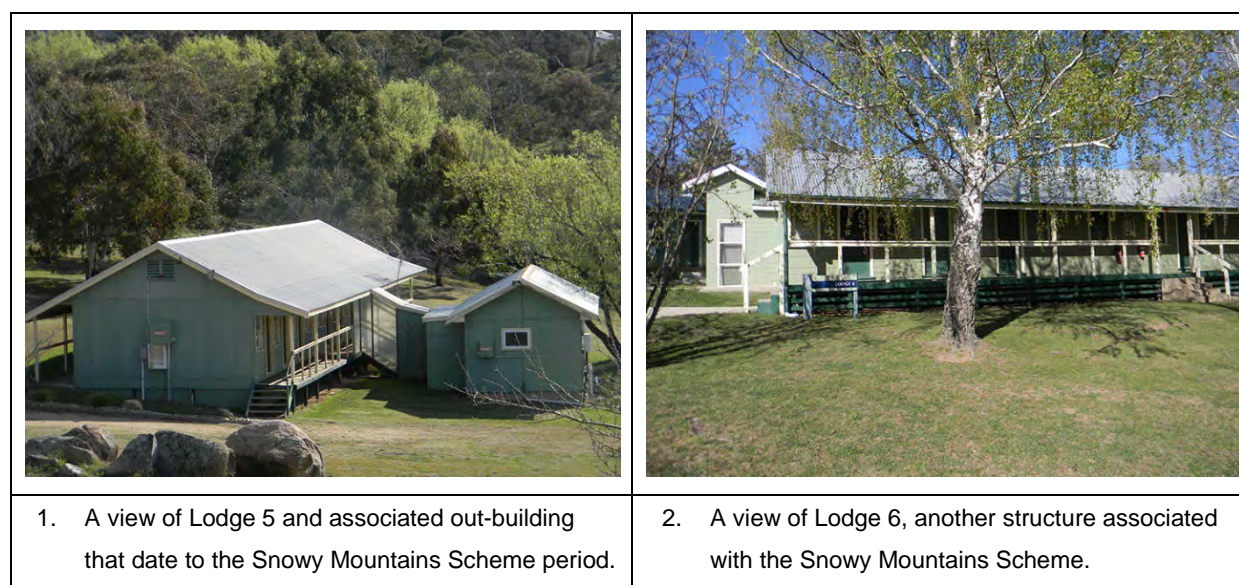
The Jindabyne Sports and Education Centre listing includes lodges that are significant because of their association with the Snowy Mountains Scheme (**Figure 2-7**). The lodges are noted as being tangible evidence of post-World War II temporary workers' single accommodation. The 'Love Shack' is noted as being particularly significant as it was used by Sir William Hudson when visiting the Snowy Mountains Scheme. These older buildings are dotted around the current Sports and Education Centre.

The historic buildings at the Sports and Education Centre are in use and in excellent condition.

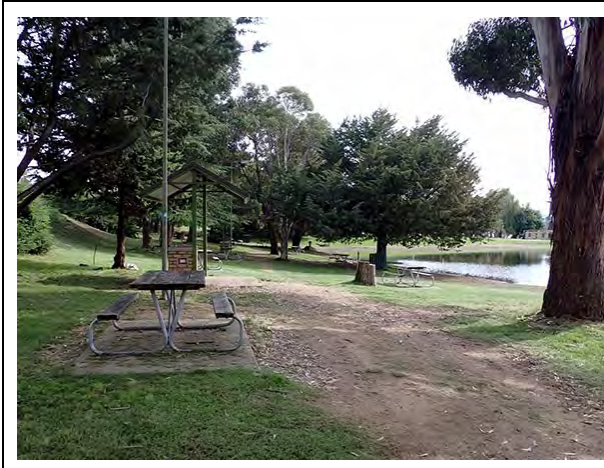
The park is maintained and is in excellent condition.

1. A view of the Jindabyne Foreshore Park.

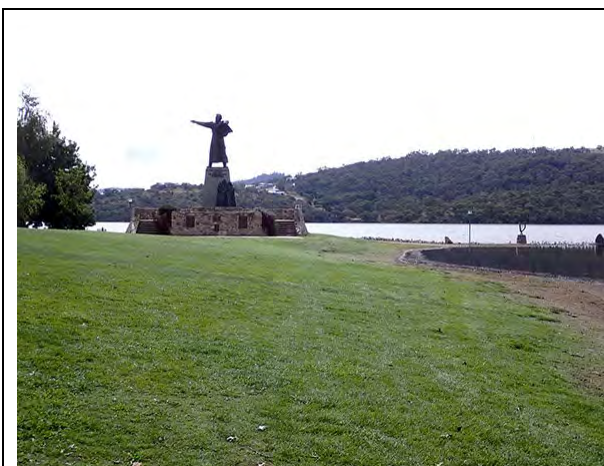
The monument is in excellent condition.

1. A view of the Strzelecki monument.

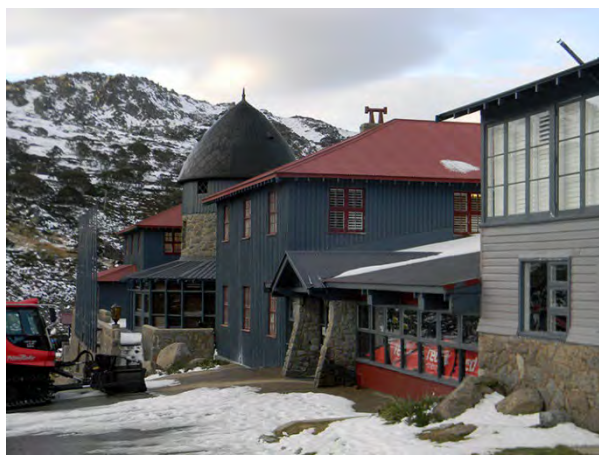
Figure 3-2: Views of The Chalet at the Charlotte Pass Alpine Resort.

<p>1. A view of The Chalet built in 1939 that continues to be the main building at the Charlotte Pass Alpine Resort.</p>	<p>2. A view of The Chalet at the Charlotte Pass Alpine Resort.</p>

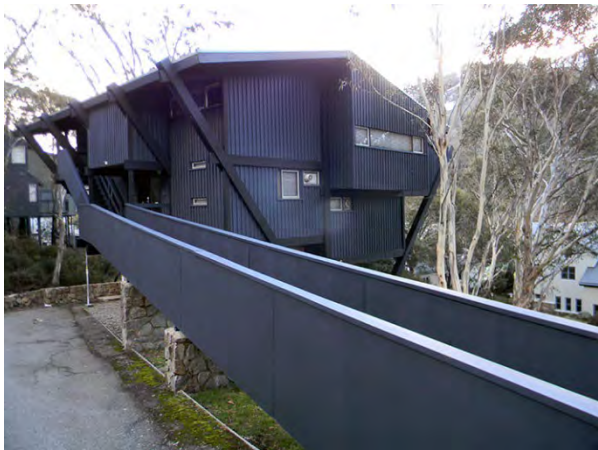
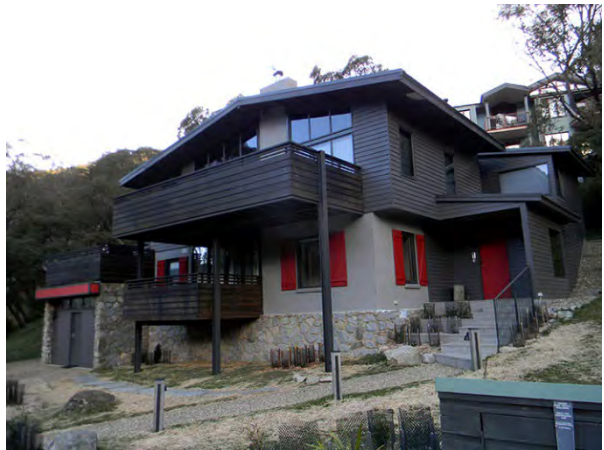
Figure 3-4: Views of significant buildings at the Thredbo Alpine Resort.

<p>1. A view of Seidler Lodge built in 1963.</p>	<p>2. A view of the Da Dacha Lodge built in 1962.</p>

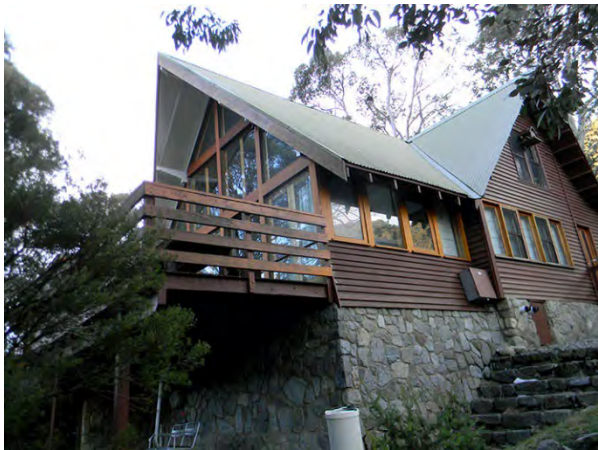
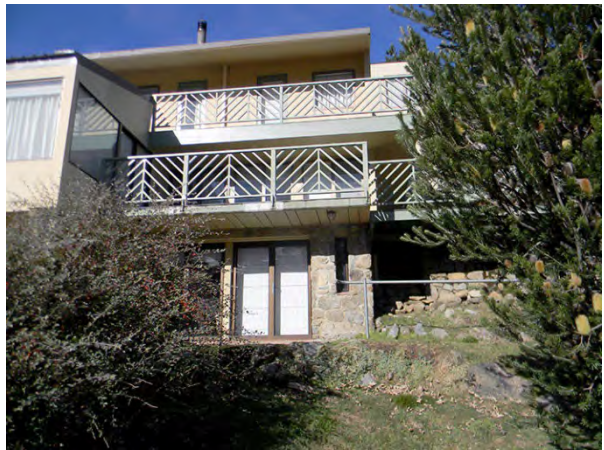
<p>3. The Crackenback Ski Club's lodge was built in 1957 and was the first lodge at Thredbo.</p>	<p>4. Built in 1958, the Thredbo Alpine Club originated from a group of likeminded students from the University of Sydney.</p>

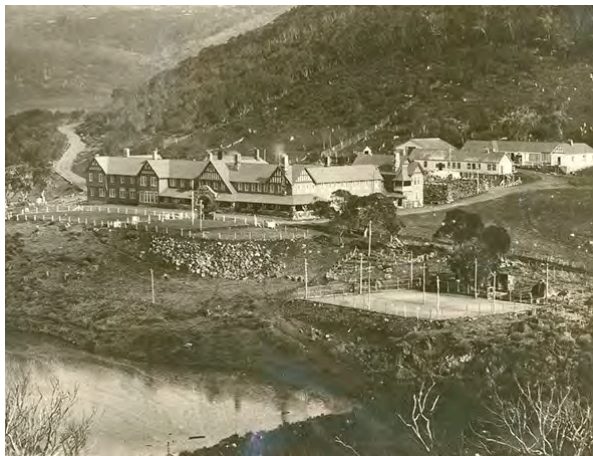
Figure 3-11: Historical views of Hotel Kosciusko.

1. View of the sprawling Hotel Kosciusko when it was first constructed (NSW State Archives).

Hotel Kosciusko was designed by Government Architect Walter Liberty Vernon and operated by the NSW tourist bureau and was constructed in 1909 in the valley of Diggers Creek on Kosciuszko Road about 25 km from Jindabyne (**Figure 3-11**).

As shown in historical photographs (**Figure 3-11**) large portions of the survey area at Sponars Chalet were once occupied by the historically important Hotel Kosciusko and some remains of foundations are visible to the north and east of the existing chalet. Also visible are the surrounds and steps associated with the former tennis court.

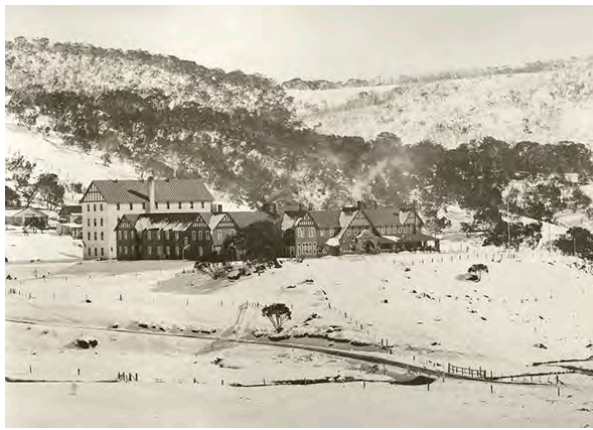
3. View of the Hotel Kosciusko post 1926 after the tall staff quarters had been built (NSW State Archives).

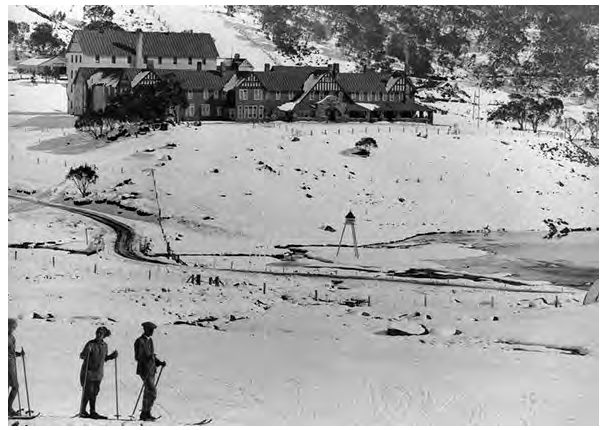
4. View of the Hotel Kosciusko post 1926 after the tall staff quarters had been built (Perisher Historical Society).

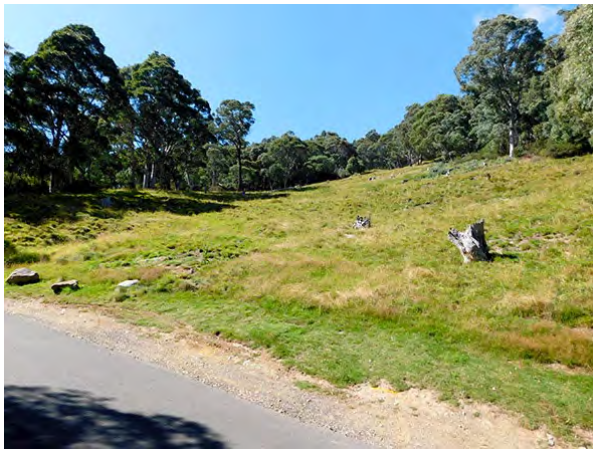
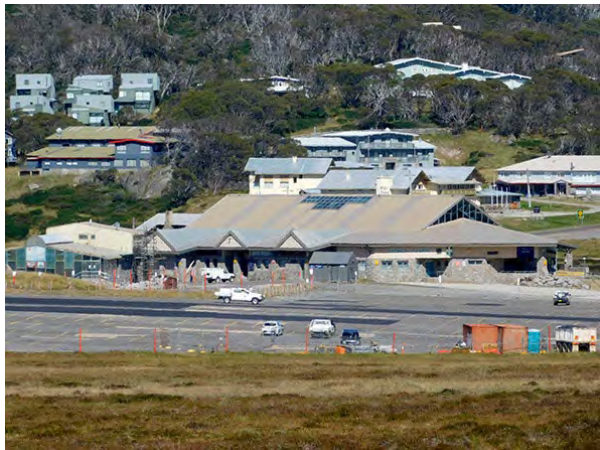
Figure 4-1: Views of a selection of the survey areas.

<p>1. A view of a cleared, sloping block at the Thredbo Alpine Resort Village where potential development could take place. The photo does not accurately capture the steepness of this terrain.</p>	<p>2. View over the central areas of the Perisher Ranges Alpine Resort. The large car park seen here could potentially be developed under the Snowy SAP Master Plan.</p>

sloping land (**Figure 4-1**, photo 1) where there are no historic heritage constraints. The other two key development sites are the car park to the west of the Thredbo Alpine Hotel and the area around the Valley Terminal to the north of Thredbo River. Both these sites contain significant heritage constraints as both the Thredbo Alpine Hotel and the Valley Terminal are listed in Schedule 3 of the *Precincts-Regional SEPP*. While this does not preclude development, any development would be required to consider the heritage values of these buildings and ensure that these values are not diminished. There is little potential for archaeological deposits in these areas.

- **Perisher Range Alpine Resort.** The development areas outside of the clusters of existing buildings also includes the large central car park (**Figure 4-1**, photo 2). There is low potential for this area to contain significant historic items or archaeological deposits. As noted in **Section 5.4.3**, the Skitube Terminal would have heritage value associated with the Skitube in its entirety. The terminal building and the NPWS office that flank the car park are listed on the HHIMS as having potential heritage value, although this report does not assign significant heritage values to these items as individual buildings.

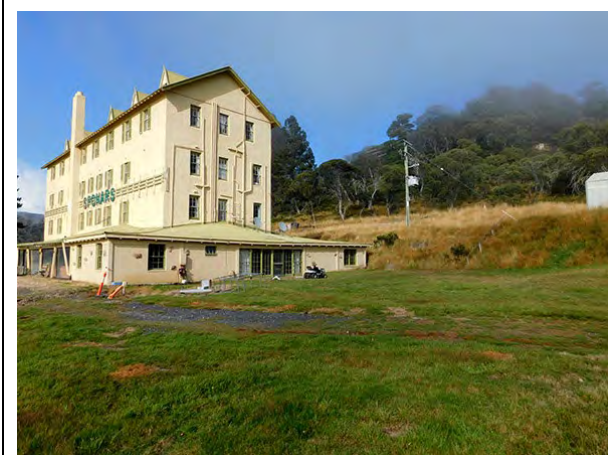
7. View of **Sponars Chalet** showing the remaining building of the Hotel Kosciuszko.

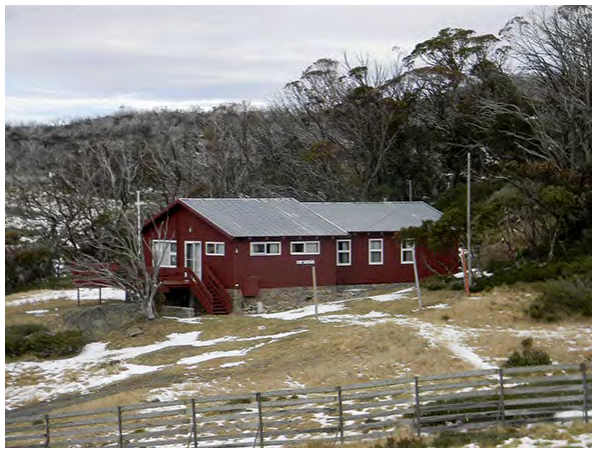
3. A view of the Orana Lodge in the Central Range Precinct that exemplifies the 'lodge in the landscape' aesthetic.

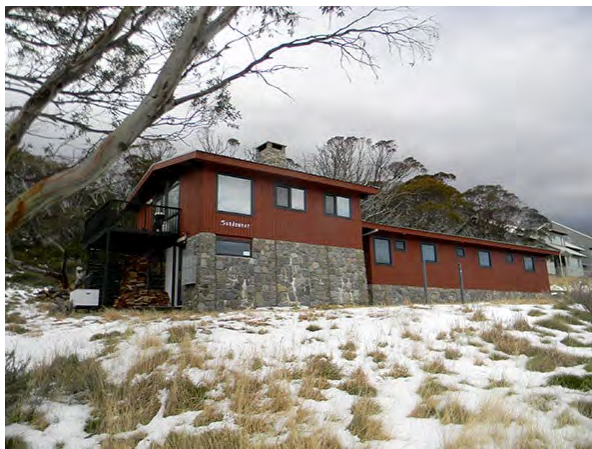
5. The Sundowner Lodge in the East Perisher Precinct illustrating the domestic scale of the architecture and open space around buildings.

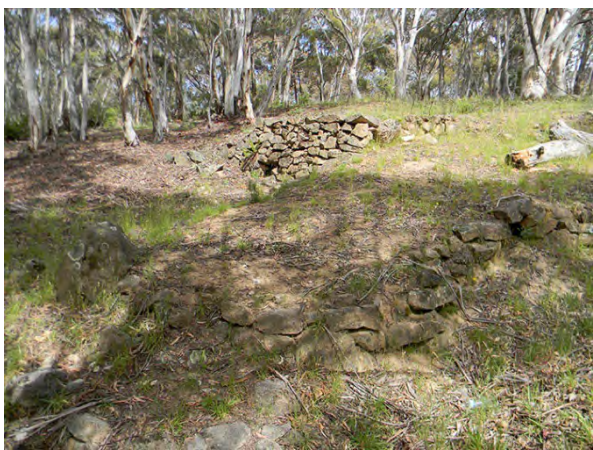
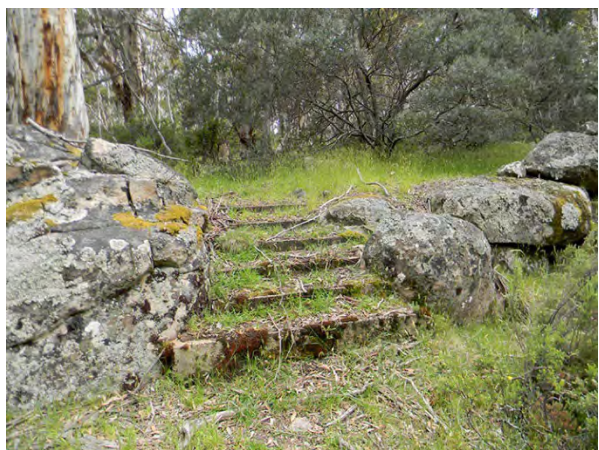
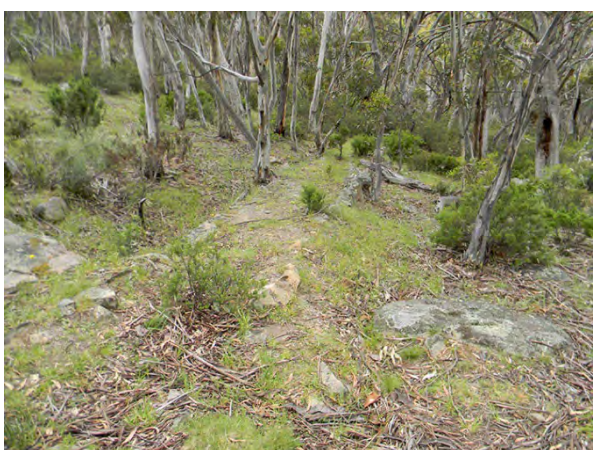
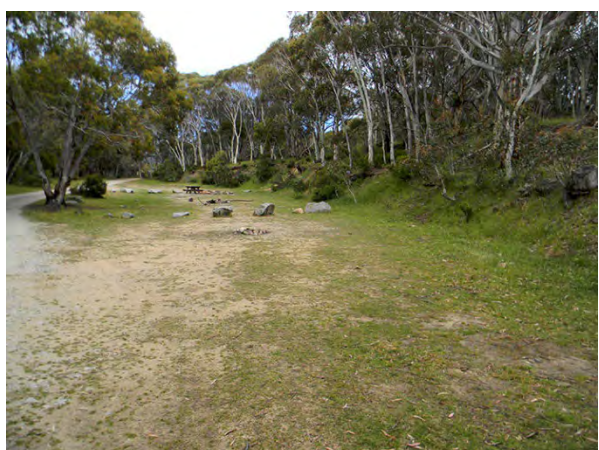
Figure 5-10: Views of the archaeological remains at Island Bend.

1. View of retaining walls.	2. View of steps.

3. View of a raised path.	4. View one of the large cuts at Island Bend.

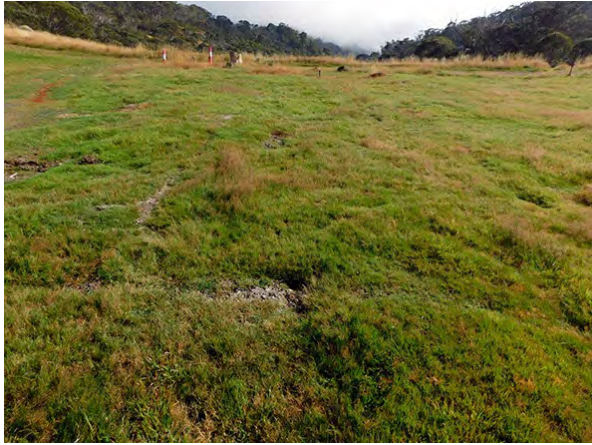
Figure 5-12: Views of the archaeological remains at Sponars Chalet.

<p>1. View of the foundations of Hotel Kosciusko to the north of the existing chalet.</p>	<p>2. View of steps leading to the tennis court at Sponars Chalet.</p>

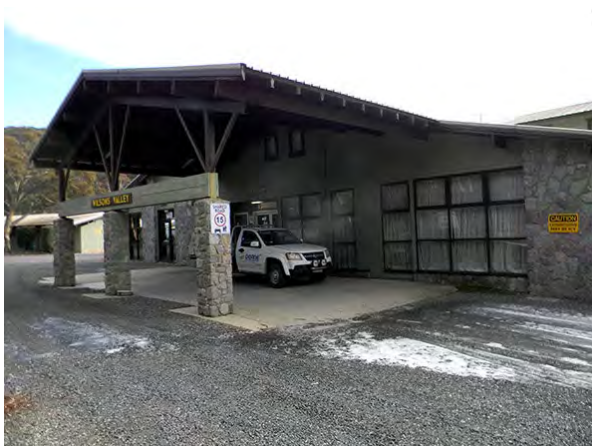
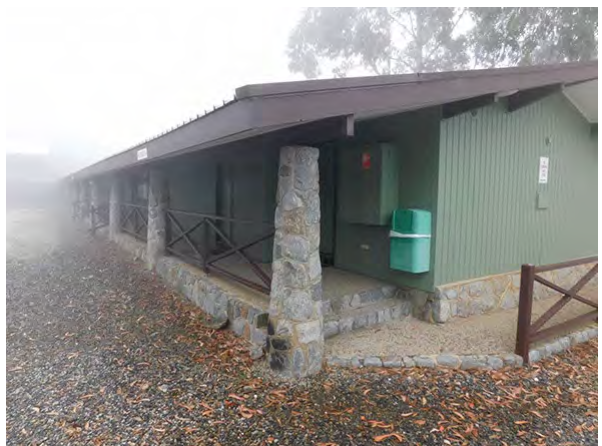
Figure 5-13: Views of the more significant buildings at the Ski Rider Hotel.

The main building of the Ski Rider Hotel, as well as three of the dormitory buildings, have been constructed in the State Park Alpine style using local stone for the base of the buildings and for the verandah pillars. This more significant building style is confined to the first three dormitory buildings to the west of the main building, as well as the main building itself. The other dormitory buildings are constructed in a more vernacular style and do not have heritage values.

<p>1. View of the main building at the Ski Rider Hotel.</p>	<p>2. View of one of the more significant dormitory buildings at the Ski Rider Hotel.</p>

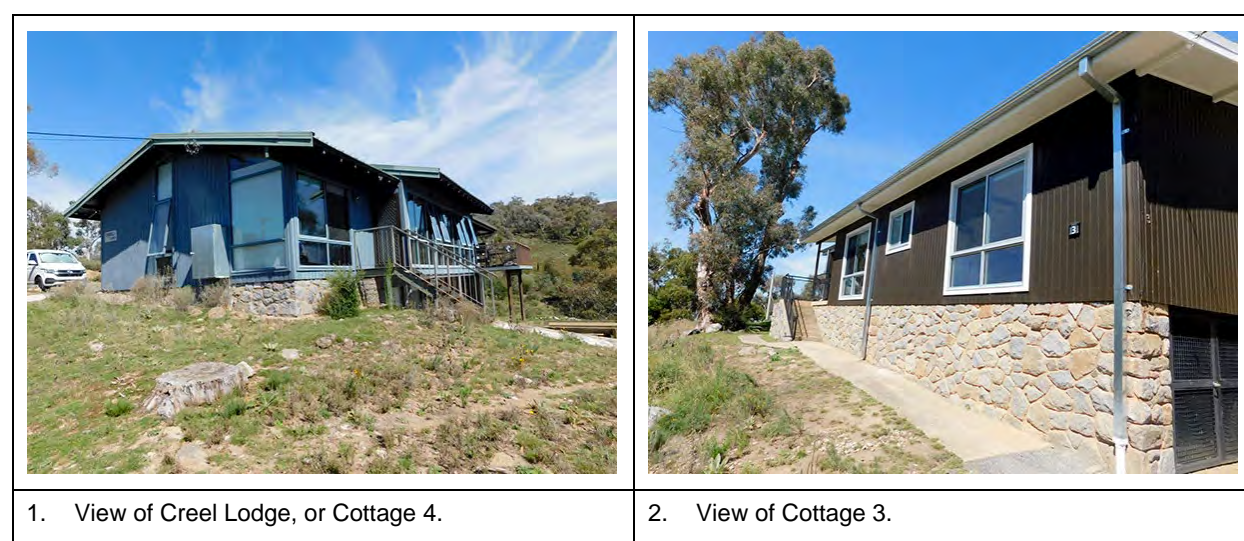
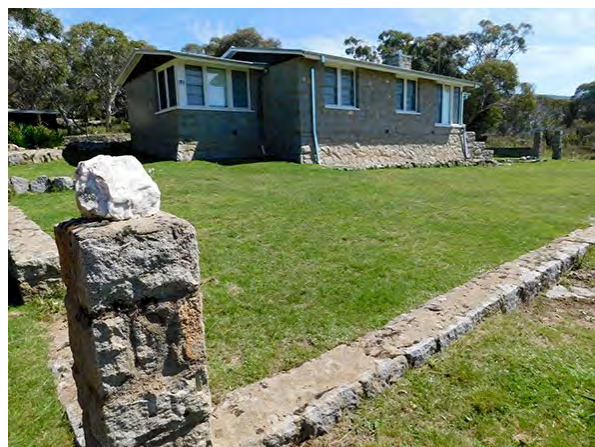
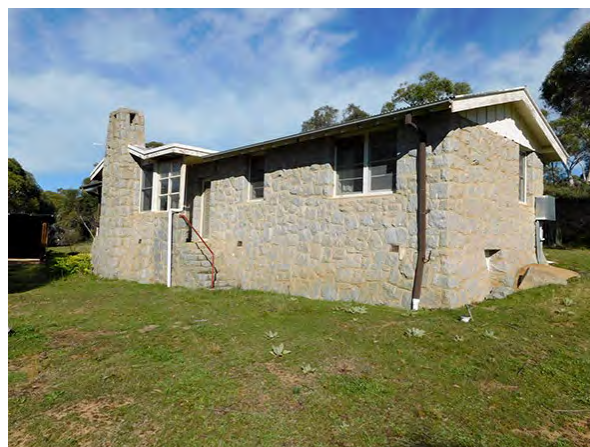
Figure 5-14: Views of the cottages at Creel Bay.

All buildings are in good condition, although some of the older cottages are no longer in use and are deteriorating, particularly the interiors. Other cottages are in excellent condition and continue to be used.

3. View of Cottage 2.

4. View of Cottage 13.

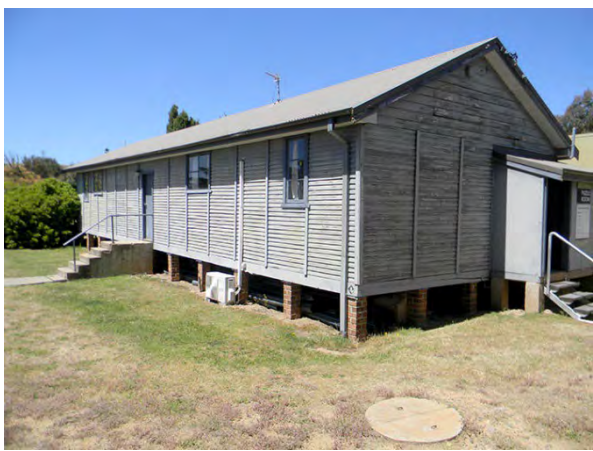
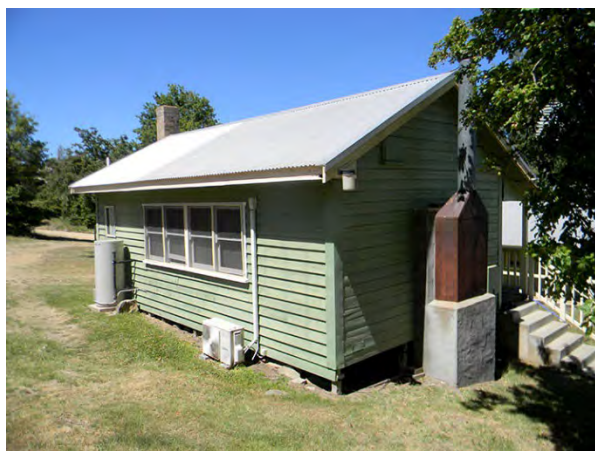
Figure 6-3: Views of historic items at the Sports and Recreation Centre.

At Lodge 6 there is a separate 'kitchen' building immediately adjacent to the main accommodation structure. This weatherboard construction includes what appears to be an original fireplace (**Figure 6-3**). At Lodge 5 there is a similar building associated with the main structure that would also date to the Snowy Mountains Scheme. While this building was also probably a kitchen building, the fireplace and chimney have been removed.

At the south of the Sports and Education Centre is another structure that also probably dates to the period of the Snowy Mountains Scheme. However, unlike Lodges 5 and 6 that have broad weatherboarding, this structure is constructed from thin weatherboards (**Figure 6-3**). Further research would be required to determine the provenance of this structure.

<p>1. View of the building potentially associated with the Snowy Mountains Scheme (see Figure 6-2 for location: marked 'potential item').</p>	<p>2. View of the kitchen building with original fireplace currently behind Lodge 6.</p>

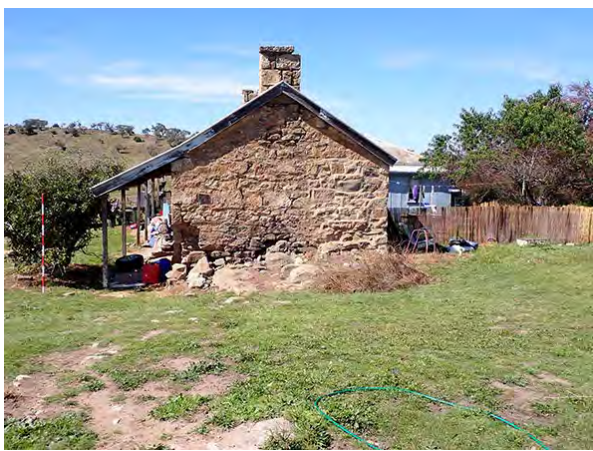
Figure 6-4: Views of the Leesville Hotel.

As noted in **Section 2.6.2**, the Leesville Hotel is currently occupied but is in poor condition. The main areas of deterioration noted include (**Figure 6-4**):

- Peeling paint exposing timber to the weather, particularly on the fascia boards and veranda pillars
- Pointing and rendering has fallen away in many places
- Roof sheets lifting
- Stone masonry missing from two chimneys at the west of the building.
- Major collapse of stonework at the north-eastern corner of the building.

Apart from lack of maintenance and natural deterioration, there are no immediate threats to the integrity of the building.

<p>1. View of the major collapse of stonework at the north-eastern corner of the building.</p>	<p>2. View of the poor condition of the painted timber elements.</p>

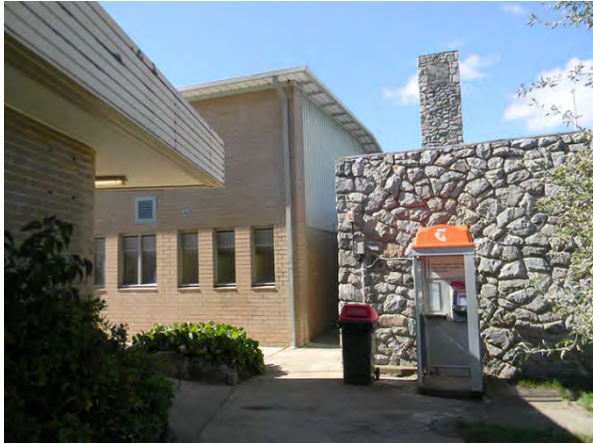
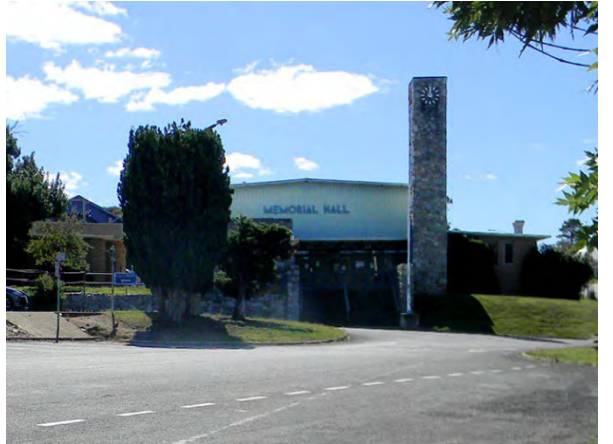
Figure 6-7: Views of the Memorial Hall.

Originally the hall was separated from the shopping centre complex, but this distinction has been lost with the later construction of a toilet block that effectively joins the shopping centre to the Memorial Hall. This later addition has diminished the aesthetic values of the Memorial Hall as it now appears as a continuation of the 'clutter' at the northern end of the shopping centre. However, this impact could be easily remedied with the removal of the toilet block and the aesthetic values of the Memorial Hall could be restored (**Figure 6-7**).

<p>1. View of the stone clock tower (right), the Memorial Hall to the left, and in the foreground, the later construction of the toilet block that effectively joins the shopping centre to the hall.</p>	<p>2. View of the front façade of the Memorial Hall viewed from the shopping centre car park.</p>

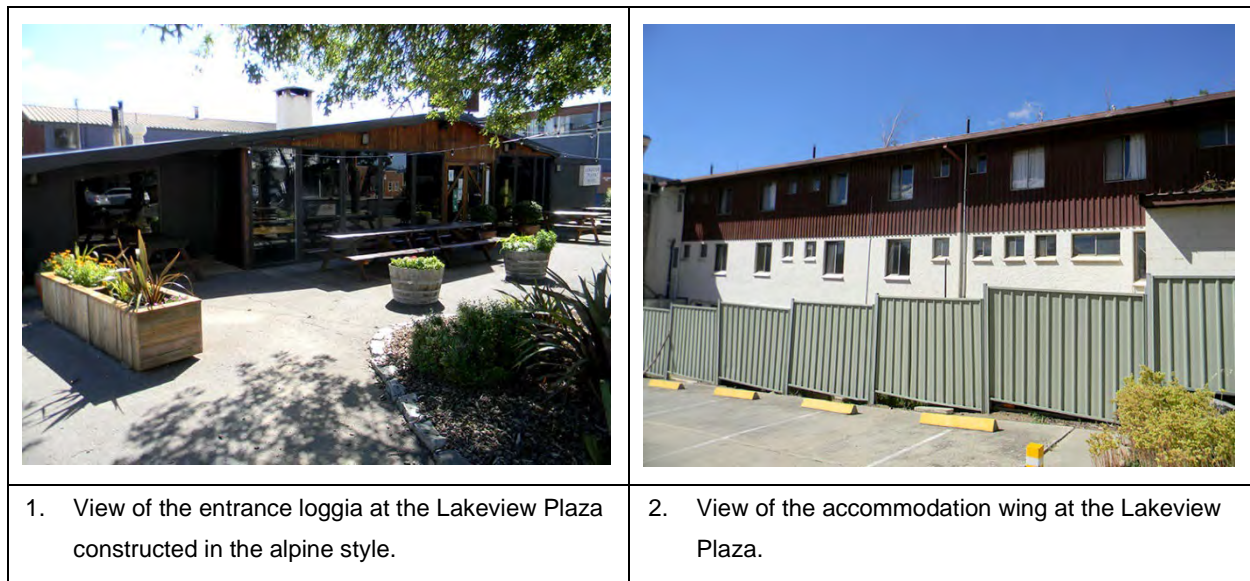
Figure 6-16: Views of the Lakeview Plaza.

While further research would be necessary to determine when the Lakeview Plaza was built, it is suspected that it dates to the construction of new Jindabyne. The entrance loggia is designed in the alpine style commonly adopted for buildings in 1960's Jindabyne. The accommodation hall behind the loggia has lost a lot of its original appearance as it has been hemmed in by other buildings and fences that makes it difficult to appreciate (**Figure 6-16**).

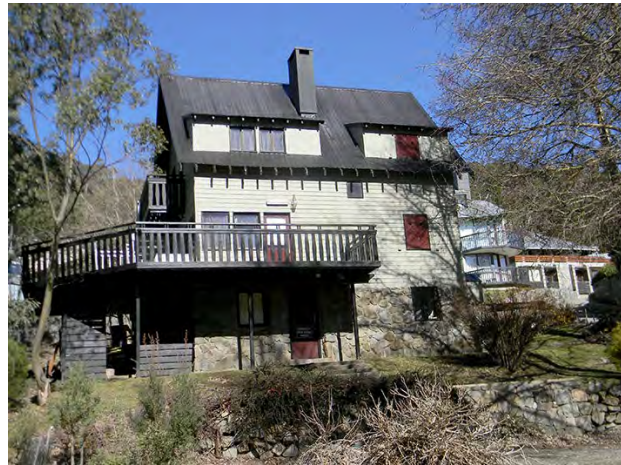
Place name	Key dates, characteristics, and integrity	Meets heritage criteria?	Photo
Sequoia	<p>Rebuilt in 1994. Good stone base. Mainly timber external construction, with faux European alpine timber details. Looks to have been largely rebuilt. Good condition</p> <p>Large Sequoia tree at the front is of historical interest.</p> <p>D—Lacks integrity, has largely been rebuilt</p>	3. Unlikely to meet the NSW heritage criteria.	—
Schlupfwinkel Original Name – Ashtons, then Club 19	<p>1958 designed early club lodge –European Alpine style. Designed by an immigrant architect at the earliest stage of Thredbo's development. Good stone base. Original A-frame has been added to and extended. Timber construction. Painted grey colour.</p> <p>B—Retains integrity</p>	<p>2. Possible likelihood for meeting one or more criteria.</p> <p>Should be formally assessed.</p> <p>Likely to meet heritage criteria a), c), and g).</p>

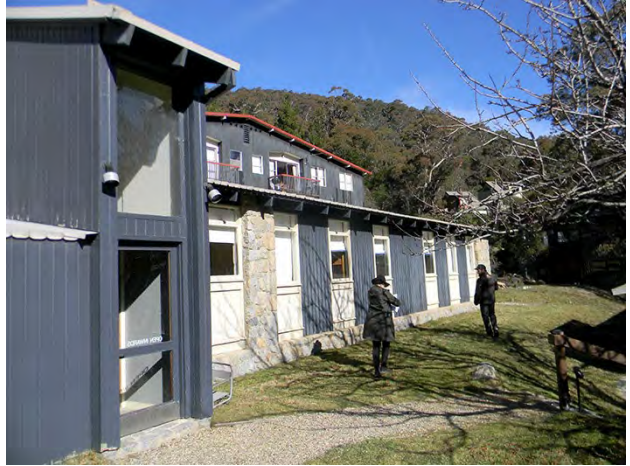
Place name	Key dates, characteristics, and integrity	Meets heritage criteria?	Photo
Ski Club of Australia	<p>Original construction dates from 1958, with Ramshead Hut (SMA building).</p> <p>Excellent group of well-maintained buildings (x3), with central open landscape (incl. old eucalypts).</p> <p>Located in a distinct landscape precinct with Athol, Wombiana, Obergurgl, Alpenhorn and Seidler lodges.</p> <p>B–Retains integrity, with some alterations</p>	<p>2. Possible likelihood for meeting one or more criteria.</p> <p>Should be assessed as an individual item and with the precinct.</p> <p>Likely to meet heritage criteria a), c), and g).</p>

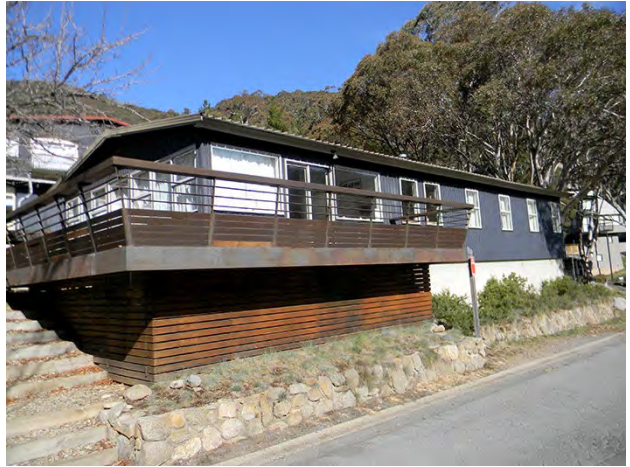
Ramshead Hut	<p>This is a SMA building, relocated from the Snowy Mountains Scheme in 1958</p> <p>B–Retains integrity, with some alterations</p>	Retain on SEPP.

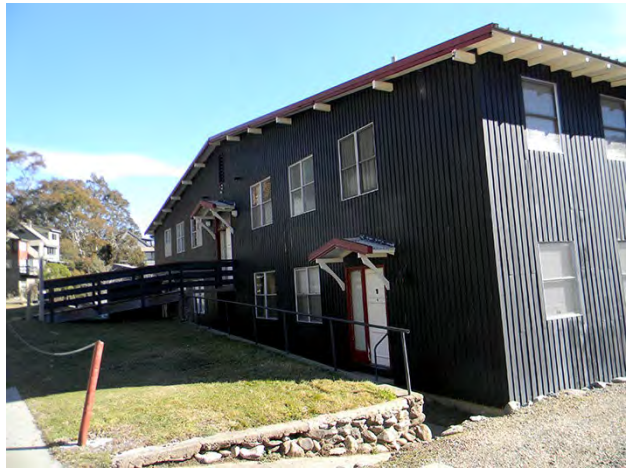
Obergurgl	<p>An original 1961 architectural lodge, designed by Peter Muller (Brewster, Murray and Partners)</p> <p>Grey besser block used as the architectural feature, with black painted timber panelling feature. Maintenance problems and needs conservation work to retain the architectural integrity and improve condition.</p> <p>B—Retains integrity, with alterations</p>	<p>Retain on SEPP.</p>

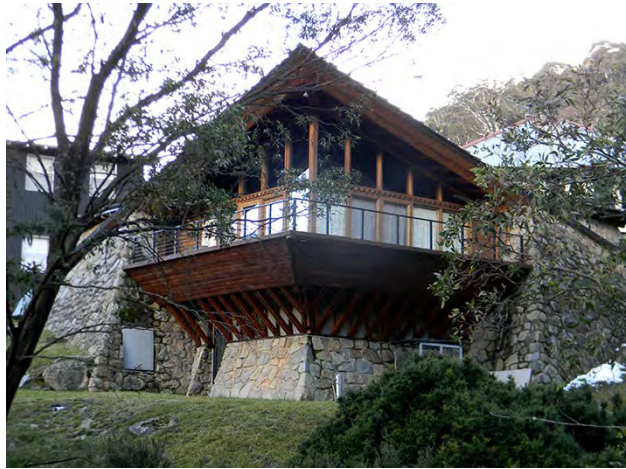
Athol	<p>Originally designed in 1959 and is significant for historic association with Thredbo's development. Architect: Peter Storey of Civil & Civic.</p> <p>Athol 2 and Athol 5 (size of accommodation). In good condition. Although bubbling paint should be redone.</p> <p>No longer a club. Strata title for two separate apartments.</p> <p>B–Retains integrity, despite alterations and recladding</p>	Retain on SEPP.

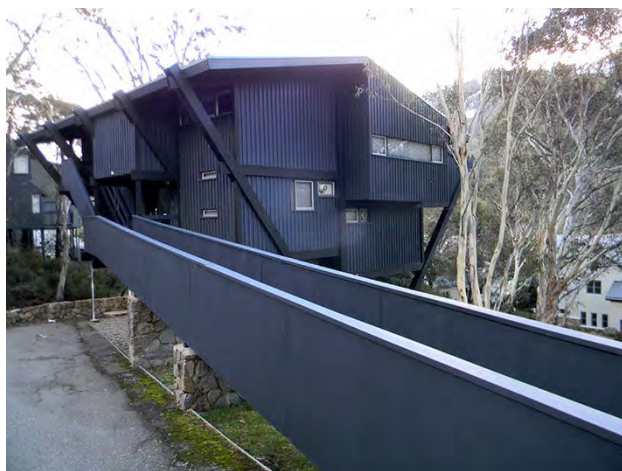
Alpenhorn	The lodge has been changed considerably and has lost integrity. C–Diminished integrity, through major changes and alterations	3. Unlikely to meet the NSW heritage criteria.	—
Snowgums	Original early lodge burnt down in 1980s. Replaced in 1992 with a reasonably sympathetic building. D–Lacks integrity, original burnt down, and has been rebuilt	3. Unlikely to meet the NSW heritage criteria.	—
Attunga	Original early lodge. Replaced in 1986. Good architectural character. D–Lacks integrity, original demolished and has been rebuilt	3. Unlikely to meet the NSW heritage criteria.	—

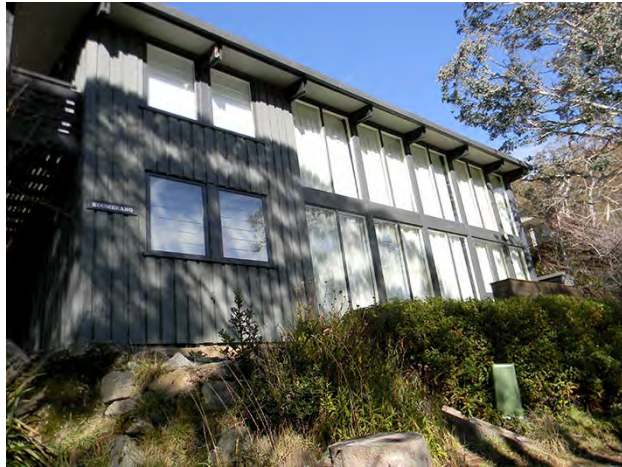
Place name	Key dates, characteristics, and integrity	Meets heritage criteria?	Photo
Koomerang Ski Club	<p>1965 lodge</p> <p>Modernised cladding, retains architectural form despite renovations in 2005, and exceptional, intact interior of the living room area.</p> <p>B–Retains integrity</p>	<p>2. Possible likelihood for meeting one or more criteria.</p> <p>Should be formally assessed.</p> <p>Likely to meet heritage criteria a), c), and g).</p>

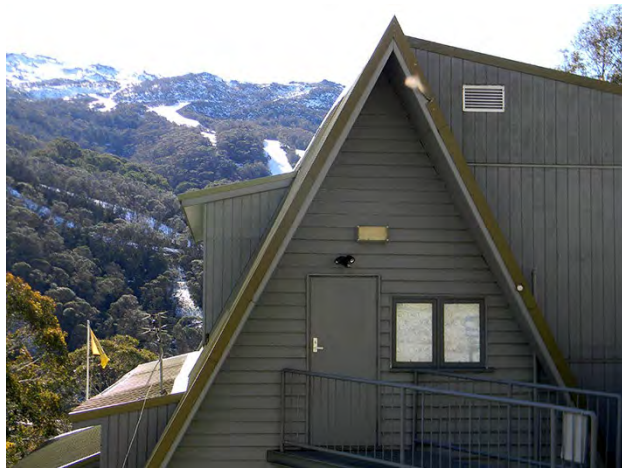
Berghutte	<p>1958 A-frame, which is still visible, despite multiple extensions.</p> <p>B–Retains integrity</p>	<p>2. Possible likelihood for meeting one or more criteria.</p> <p>Should be formally assessed.</p> <p>Likely to meet heritage criteria a), c), and g).</p>

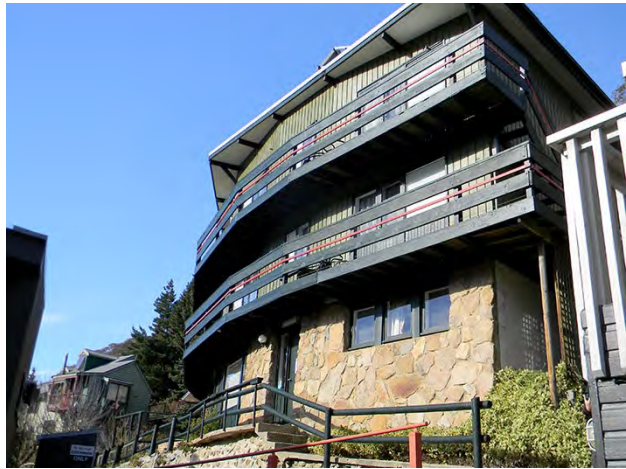
Place name	Key dates, characteristics, and integrity	Meets heritage criteria?	Photo
Kasees	<p>Historic, European Alpine design. Nine-bedroom apartment building, with open verandah along the front.</p> <p>Social history and connection with Thredbo's early stage of development. Tall mature trees, historic cultural plantings.</p> <p>B–Retains integrity, with minor changes</p>	Retain on SEPP

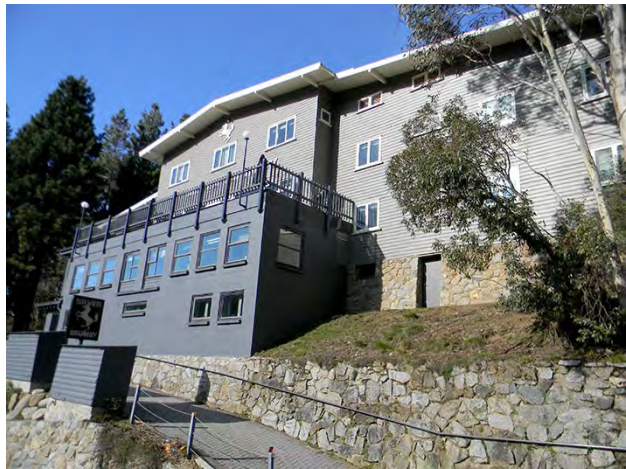
Crackenback Castle	<p>1988 lodge. Well maintained and in good condition but lacking architectural interest and historical significance.</p> <p>B–Retains integrity</p>	3. Unlikely to meet the NSW heritage criteria.	—

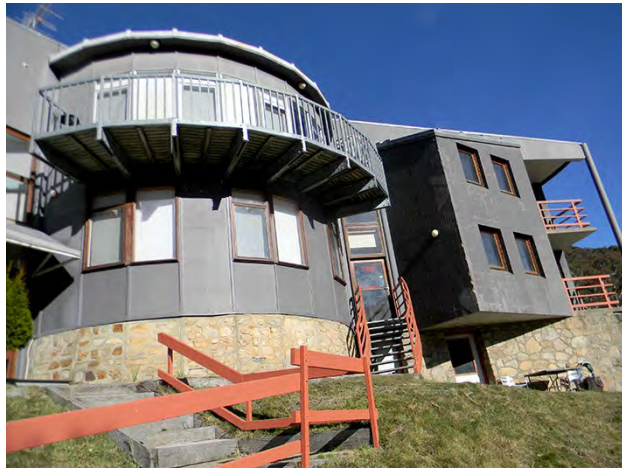
Thredbo Alpine Club	1958 lodge. The upper levels have been altered (windows, extension, and cladding). B—Retains integrity, with some alterations and extension	Retain on SEPP

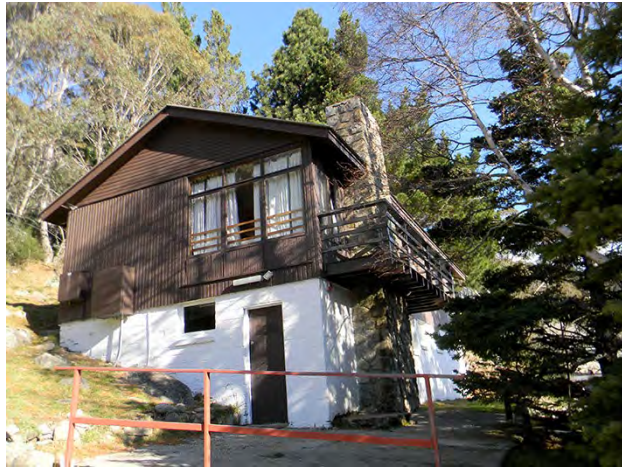
Place name	Key dates, characteristics, and integrity	Meets heritage criteria?	Photo
Gore Hill	<p>1959 historic lodge. Intact vernacular Alpine style lodge.</p> <p>Hidden by planted and self-sown exotic trees which add to the historic aesthetic of the lodge.</p> <p>A–Intact, very high integrity as it appears unchanged</p>	<p>1. High likelihood for meeting two or more criteria for SEPP/NSW heritage criteria.</p> <p>Should be formally assessed.</p> <p>Likely to meet heritage criteria a), c), d), and g).</p>

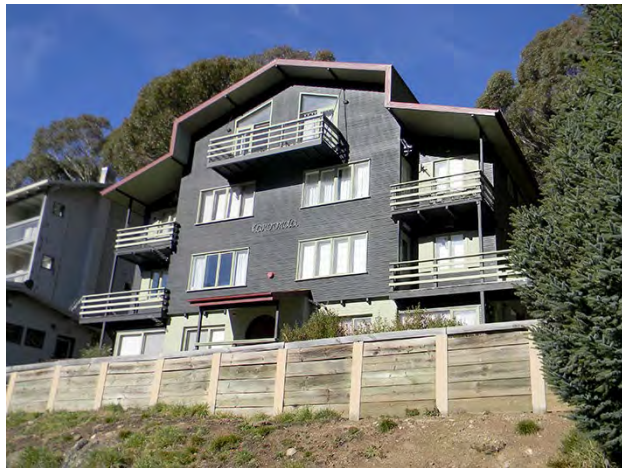
Karoonda	<p>1961 lodge with some alterations (windows, extension, and cladding).</p> <p>B–Retains integrity</p>	<p>2. Possible likelihood for meeting one or more criteria.</p> <p>Should be formally assessed.</p> <p>Likely to meet heritage criteria a), c), and g).</p>

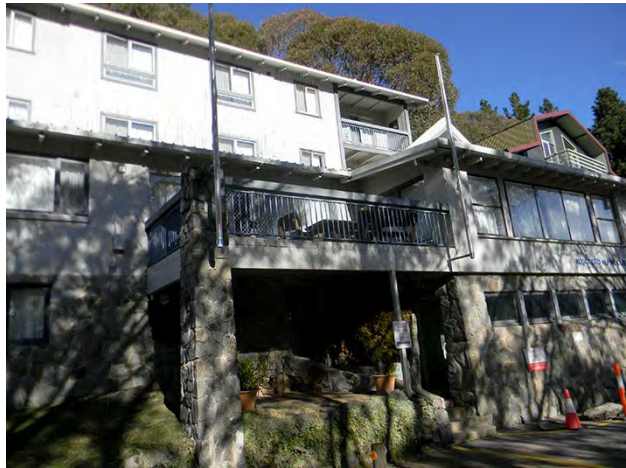
Mittabah, now Belevarde	The original 1961 lodge has been demolished. New tall apartment building—at least two storeys too high for the area, and architectural not in keeping with the village aesthetic of Thredbo. D–Lacks integrity, rebuilt	3. Unlikely to meet the NSW heritage criteria.	—
Winterhaus	1961 Commercial lodge. Original configuration is not clear (also noted in Lucas Stapleton 1997: 9). C–Diminished integrity	2. Possible likelihood for meeting one or more criteria. Should be formally assessed. Likely to meet heritage criteria a), c), and g).

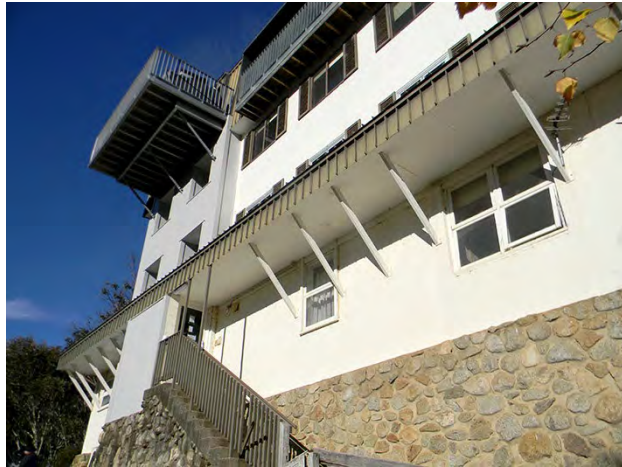
Site of 1997 Landslide – Lots 78 and 96	Site of Bimbadeen Lodge (lower), and Carinya (Brindabella Ski Club). Foundations of Carinya lodge have been retained. Lower lodge site is a stepped open, landscaped space. B–Retains integrity	Retain on SEPP

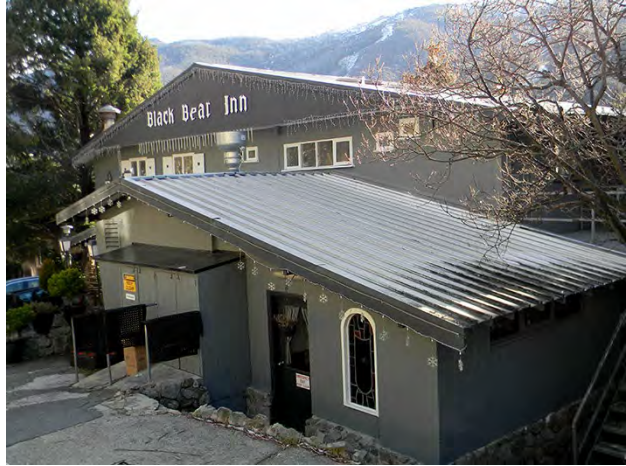
A photograph of the Black Bear Inn, a two-story building with a dark, gabled roof and light-colored walls. The name 'Black Bear Inn' is visible on the upper part of the building. The building is surrounded by trees and a paved area.
CandleLight	1958 commercial lodge – European Alpine style. Some alterations from 1960–1992. Architect: Otto A. Ernegg. Some intact interior elements. B–Retains integrity, despite alterations	2. Possible likelihood for meeting one or more criteria. Should be formally assessed individually and as part of the Banjo Precinct. Likely to meet heritage criteria a), c), and g).

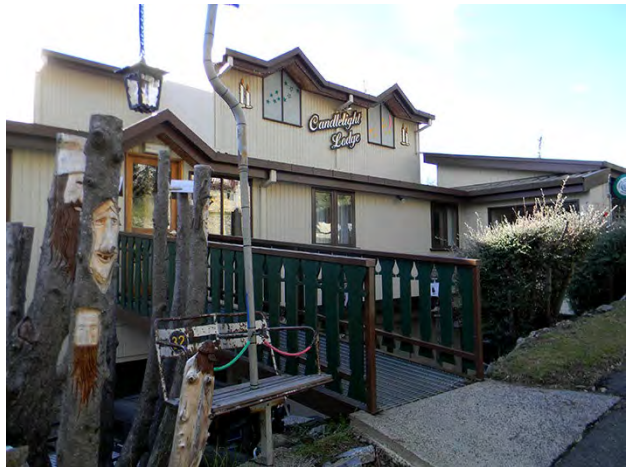
A photograph of the CandleLight Lodge, a two-story building with a light-colored, gabled roof and dark trim. The name 'CandleLight Lodge' is visible on the upper part of the building. The building is surrounded by trees and a paved area.

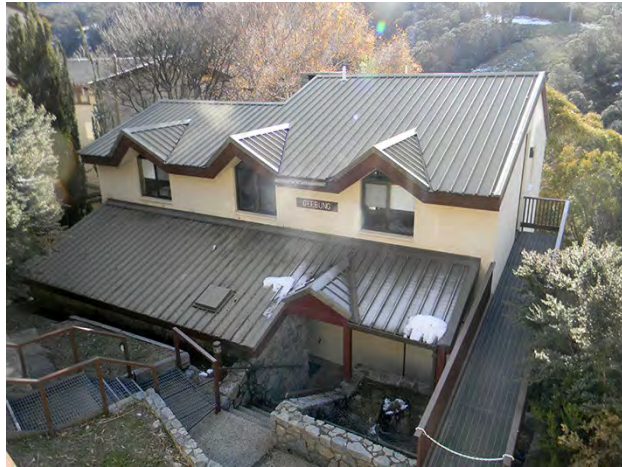
Place name	Key dates, characteristics, and integrity	Meets heritage criteria?	Photo
Geebung	1958 lodge Interior is good. B–Retains integrity	2. Possible likelihood for meeting one or more criteria. Should be formally assessed individually and as part the Banjo Precinct. Likely to meet heritage criteria a), c), and g).

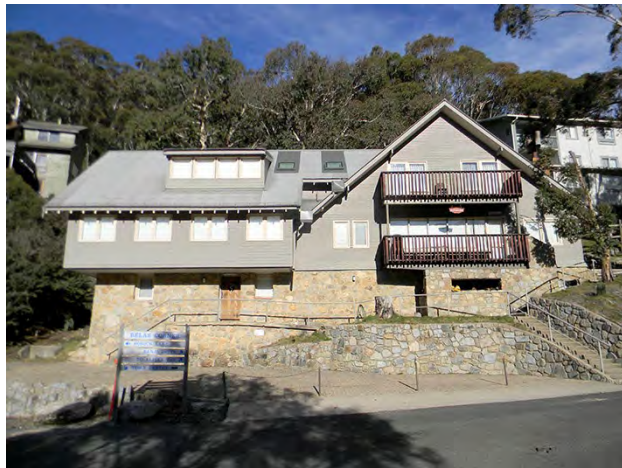
Pindari	1959 lodge, with historic characteristics. Some elements rebuilt. B–Retains integrity, despite external additions	2. Possible likelihood for meeting one or more criteria. Should be formally assessed as part the Banjo Precinct. Likely to meet heritage criteria a), c), and g).

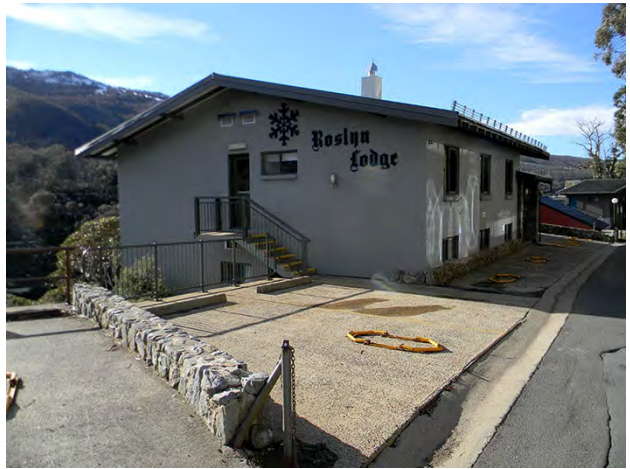
Place name	Key dates, characteristics, and integrity	Meets heritage criteria?	Photo
Roslyn	1974 lodge, with better block construction and some historic characteristics B–Retains integrity, despite external additions	2. Possible likelihood for meeting one or more criteria. Should be formally assessed. As part of a precinct, it is likely to meet heritage criteria a), c), and g).

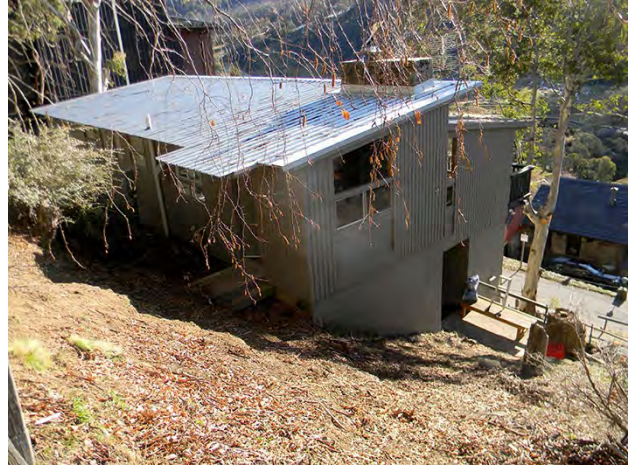
Christiania Southern Alps Ski Club	1961 lodge. Alpine style Partially retains original form. Reclad. Good condition. B–Retains integrity, despite changes	2. Possible likelihood for meeting one or more criteria. Should be formally assessed. Likely to meet heritage criteria a), c), and g).
