REVISED HISTORIC HERITAGE ASSESSMENT

SNOWY MOUNTAINS SPECIAL ACTIVATION PRECINCT

SNOWY MONARO REGIONAL COUNCIL LGA

JUNE 2022

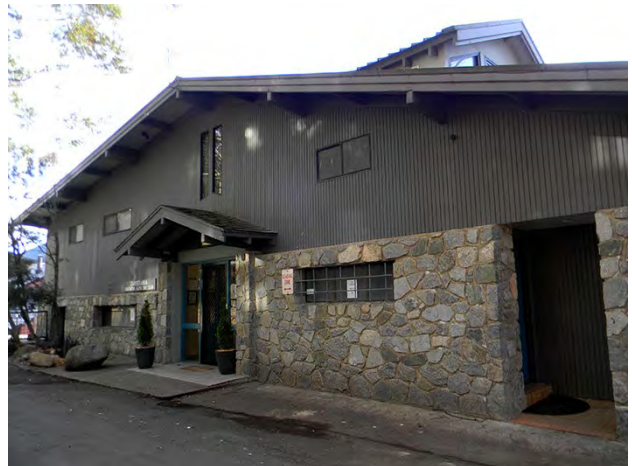
Christiania Southern Alps Ski Club	1961 lodge. Alpine style Partially retains original form. Reclad. Good condition. B–Retains integrity, despite changes	2. Possible likelihood for meeting one or more criteria. Should be formally assessed. Likely to meet heritage criteria a), c), and g).

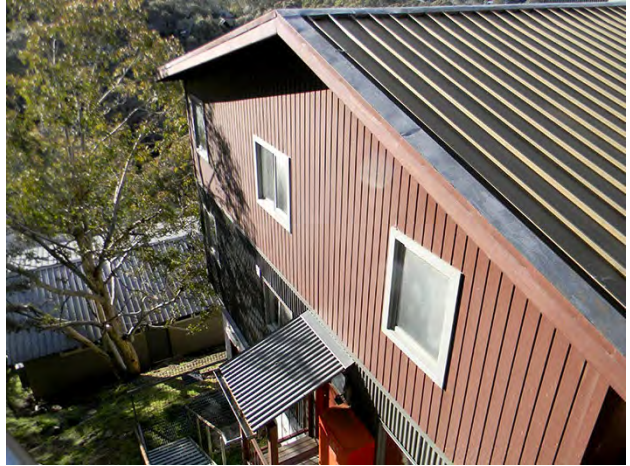
Place name	Key dates, characteristics, and integrity	Meets heritage criteria?	Photo
Sonnblik	1972 staff accommodation Good condition. B–Retains integrity	2. Possible likelihood for meeting one or more criteria. Should be formally assessed. Likely to meet heritage criteria a), c), and g).

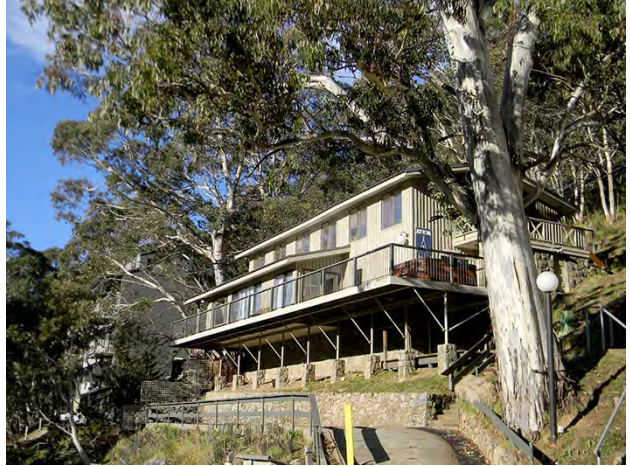
Place name	Key dates, characteristics, and integrity	Meets heritage criteria?	Photo
Avior	1968 lodge B—Retains integrity	2. Possible likelihood for meeting one or more criteria. Should be formally assessed. Likely to meet heritage criteria a), c), and g).

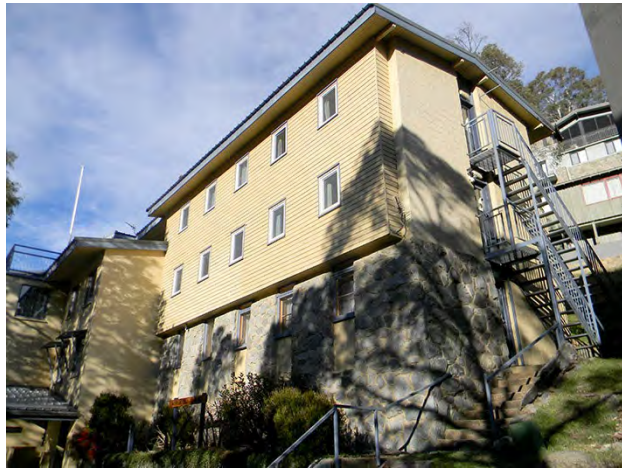
Place name	Key dates, characteristics, and integrity	Meets heritage criteria?	Photo
RAN Royal Australian Navy	Circa 1962: Lot 92 – also referred to as ‘Army Alpine’, or ‘Eastern Command’. B–Retains integrity	2. Possible likelihood for meeting one or more criteria. Should be formally assessed. Likely to meet heritage criteria a), c), d) and g).

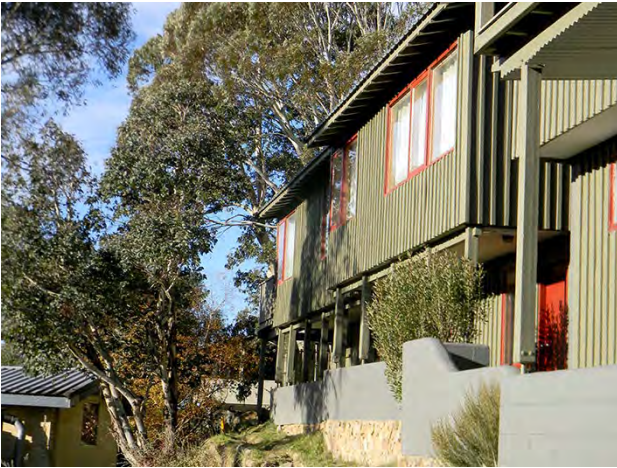
Place name	Key dates, characteristics, and integrity	Meets heritage criteria?	Photo
Happy Jacks	<p>Early 1960's European Alpine style lodge, with 1980's addition designed to match.</p> <p>B–Retains integrity, with modifications to interior apartments</p>	<p>2. Possible likelihood for meeting one or more criteria.</p> <p>Should be formally assessed.</p> <p>Likely to meet heritage criteria a), c), and g).</p>

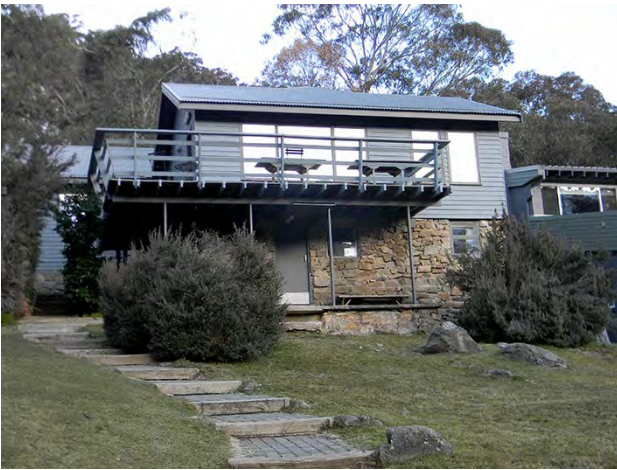
Neewalla Ski Club	<p>1958 lodge</p> <p>Recently renovated keeping the original form and architectural character intact.</p> <p>B–Retains integrity, with modifications</p>	<p>2. Possible likelihood for meeting one or more criteria.</p> <p>Should be formally assessed.</p> <p>Likely to meet heritage criteria a), c), and g).</p>

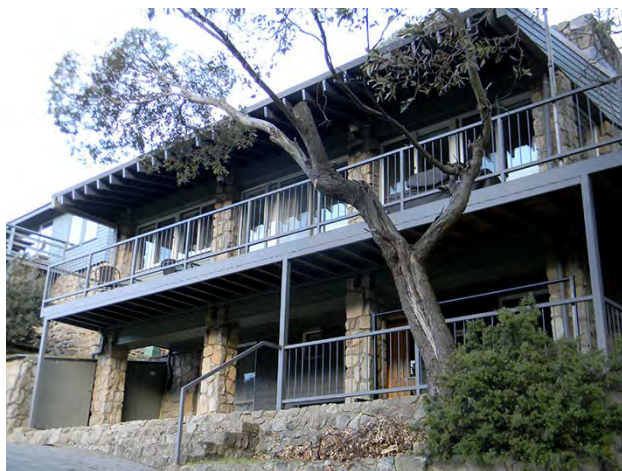
Place name	Key dates, characteristics, and integrity	Meets heritage criteria?	Photo
Isere	<p>Rebuilt in 1980.</p> <p>Good architectural integrity</p> <p>B–Retains integrity, despite recent adaptations</p>	<p>2. Possible likelihood for meeting one or more criteria.</p> <p>Should be formally assessed.</p> <p>Likely to meet heritage criteria a), c), and g).</p>

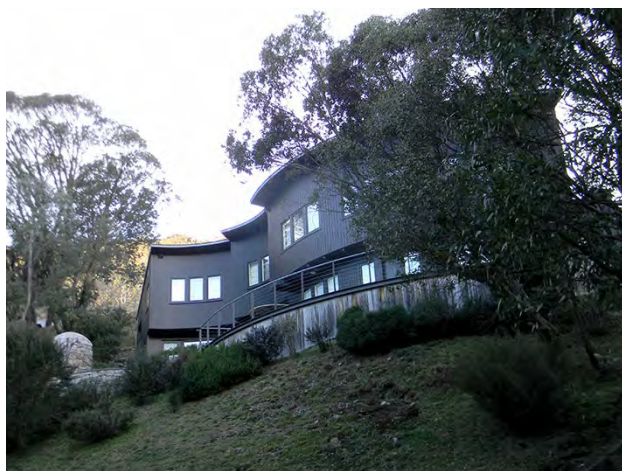
Denman	<p>Commercial lodge, with public bar and restaurant.</p> <p>C–Diminished integrity</p>	<p>3. Unlikely to meet the NSW heritage criteria.</p>

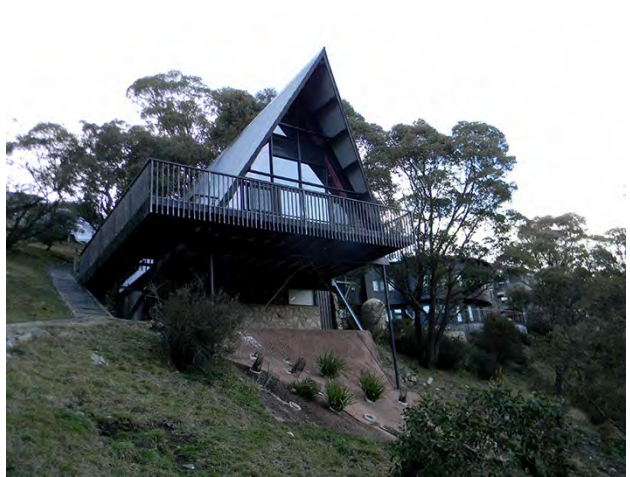
Place name	Key dates, characteristics, and integrity	Meets heritage criteria?	Photo
Moonbah	<p>1960 designed A-frame, with 3-level stone base, an 'Abstract Modernist Expressionist style' building.</p> <p>Architect: W.E. (Bill) Lucas, and interior decorator Marion Hall Best.</p> <p>Exceptional architectural integrity, interior and exterior. Needs urgent conservation and maintenance work to improve condition.</p> <p>A-Intact, high integrity</p>	<p>Retain on SEPP</p> <p>Should be formally assessed for state-level heritage significance.</p>

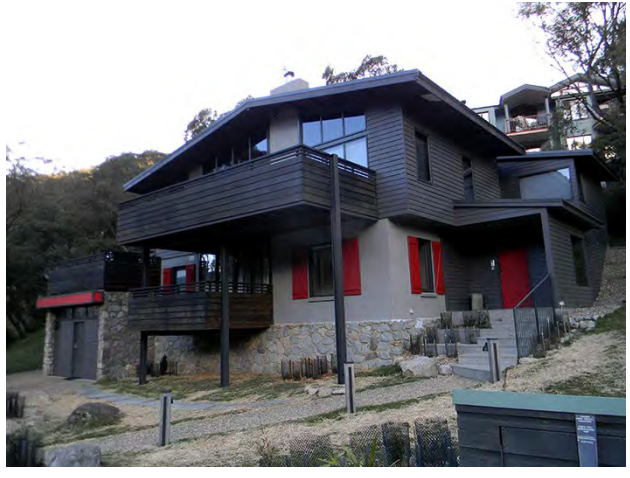
De Dacha Original name: Manager's Residence.	<p>1967 two level lodge in the European Alpine style.</p> <p>B-Retains integrity, despite recent alterations (historic features and colour scheme should be re-instated)</p>	<p>Retain on SEPP</p> <p>Should be formally assessed for state-level heritage significance.</p> <p>The scale model of the lodge, originally in the nearby pond should be restored and returned to the pond (with an interpretation sign).</p> <p>The nearby pond should be part of the curtilage.</p>

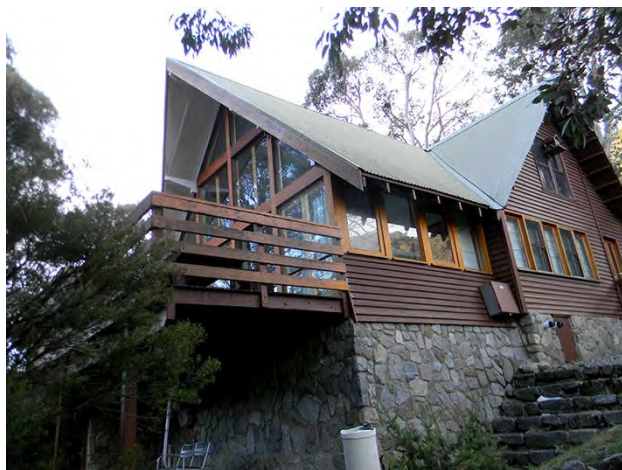
Place name	Key dates, characteristics, and integrity	Meets heritage criteria?	Photo
Crackenback	1957 lodge, European Alpine style lodge, with 1980s additions. B–Retains integrity, despite alterations and additions	Retain on SEPP.

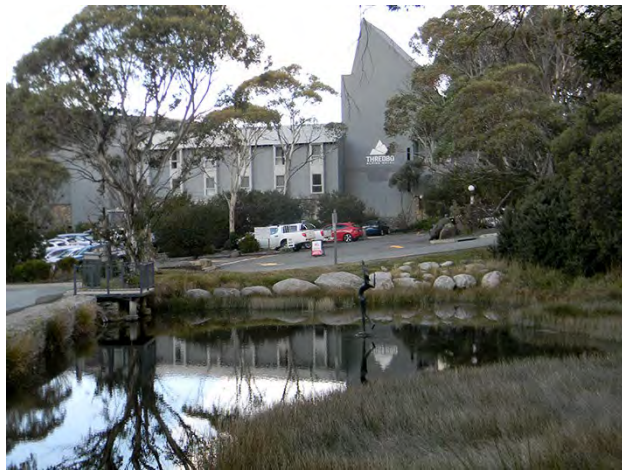
Thredbo Alpine Hotel Original name: Coach House Inn	Original 1961 hotel building. it has been extended 1963, 1968 and 1985. Alpine style architecture. Retains original form and large proportion of original fabric, despite colour changes and some recladding. B–Retains integrity, including adaptations and additions	Retain on SEPP

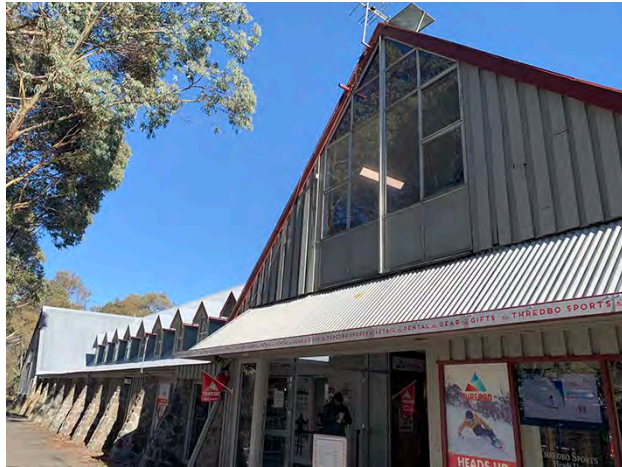
Place name	Key dates, characteristics, and integrity	Meets heritage criteria?	Photo
Valley Terminal Original name: Bottom Station	Original 1960 and 1962 extensions. Alpine style architecture. Retains original form and large proportion of original fabric. Including central staircase, interior organisation of commercial shops, pub, etc and open outdoor spaces. Retains original proportions. B–Retains integrity	Retain on SEPP

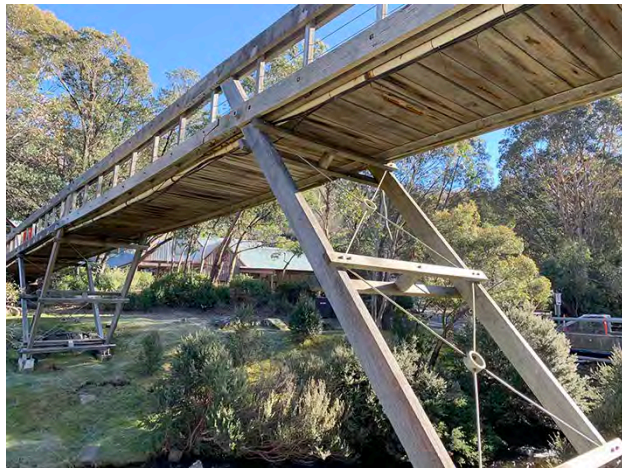
Timber Pedestrian Bridge	1962 bridge. A–Intact, high integrity	Retain on SEPP

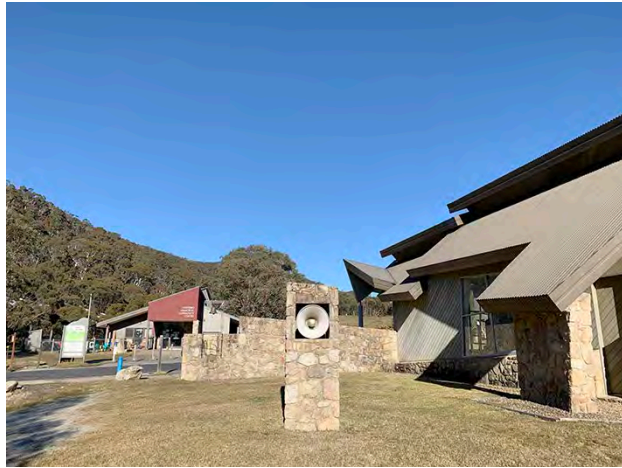
Place name	Key dates, characteristics, and integrity	Meets heritage criteria?	Photo
John Paul II Ecumenical Church and Thredbo Memorial Community Centre	1990's construction? High community value A—Intact, high integrity	2. Possible likelihood for meeting one or more criteria. Should be formally assessed. Likely to meet heritage criteria b), c) and g).

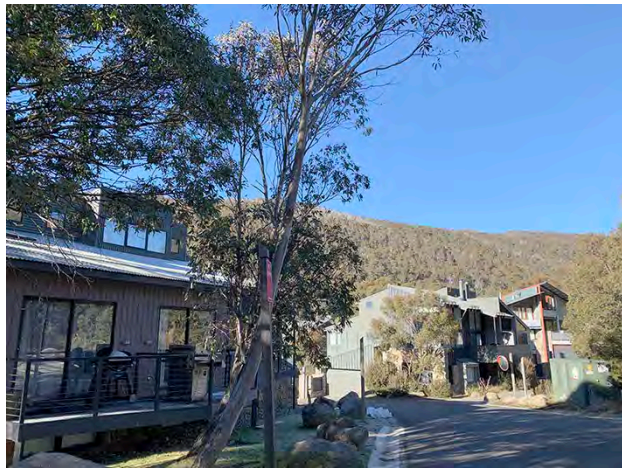
Crackenback Drive Precinct	Residential precinct of complementary value to Thredbo's historic character. A—Intact, high integrity	2. Possible likelihood for meeting one or more criteria. Should be formally assessed. Likely to meet heritage criteria b), c), and g).

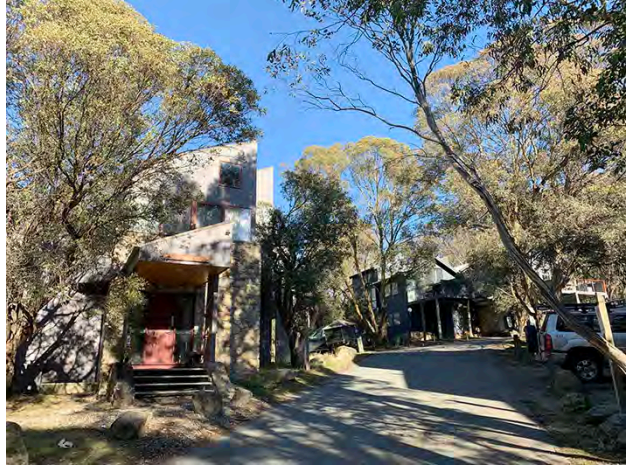
Place name	Key dates, characteristics, and integrity	Meets heritage criteria?	Photo
Riverview Terrace Precinct	Residential precinct of complementary value to Thredbo's historic character. A—Intact, high integrity	2. Possible likelihood for meeting one or more criteria. Should be formally assessed. Likely to meet heritage criteria b), c), and g).

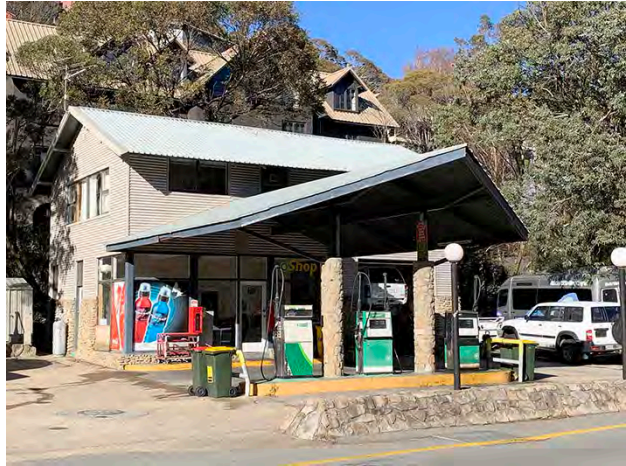
Ampol Petrol Station and Fire Station.	1963 petrol station is a landmark on the main road. Fire station dates from 1984 (recently rebuilt?). B—Retains integrity	2. Possible likelihood for meeting one or more criteria. Should be formally assessed. Likely to meet heritage criteria a), c), and g).

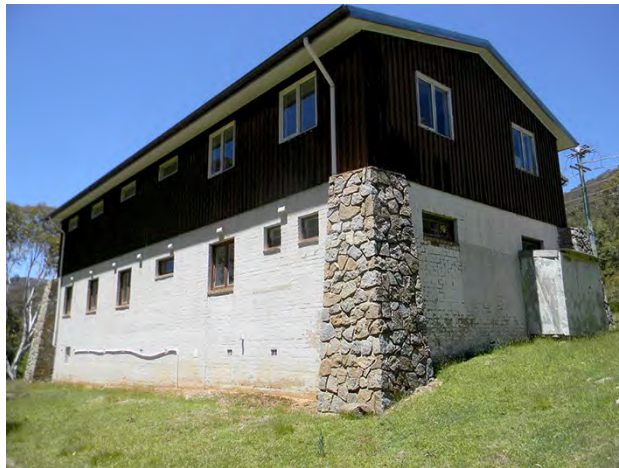
Appendix 1 Table 3: Assessment of the Thredbo Rangers Station.

Place name	Key dates, characteristics, and integrity	Meets heritage criteria?	Photo
Thredbo Rangers Station	Outside the SEPP area. A—Intact, high integrity	1. High likelihood for meeting two or more criteria for SEPP/NSW heritage criteria. Should be formally assessed. Likely to meet heritage criteria a), c), and g).

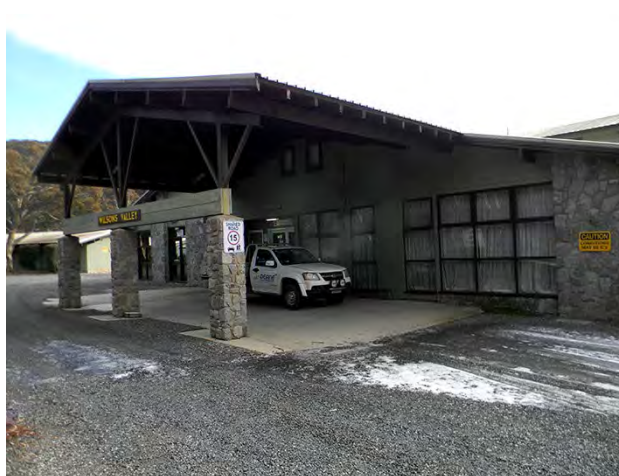
Appendix 1 Table 4: Assessment of the Ski Rider Hotel.

Place name	Key dates, characteristics, and integrity	Meets heritage criteria?	Photo
Ski Rider Hotel	<p>Ski Rider Hotel, specifically the 'old petrol station' in the NPWS Alpine style (circa 1980s) and now front of house and main building for the commercial 'camp-style', cabin accommodation.</p> <p>A—Intact, high integrity</p>	<p>1. High likelihood for meeting two or more criteria for SEPP/NSW heritage criteria.</p> <p>Should be formally assessed.</p> <p>Likely to meet heritage criteria a), c), and g).</p>

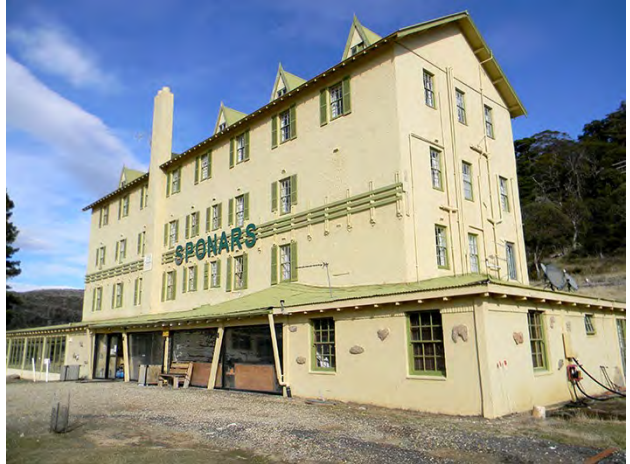
Appendix 1 Table 5: Assessment of Sponars Chalet.

Place name	Key dates, characteristics, and integrity	Meets heritage criteria?	Photo
Sponars Chalet	<p>Sponars Chalet is a place included on the SEPP dating to 1926 and a remnant of the former Hotel Kosciusko.</p> <p>A—Intact, high integrity</p>	<p>Retain on SEPP</p> <p>Could meet state heritage level—should be formally assessed against criteria.</p>

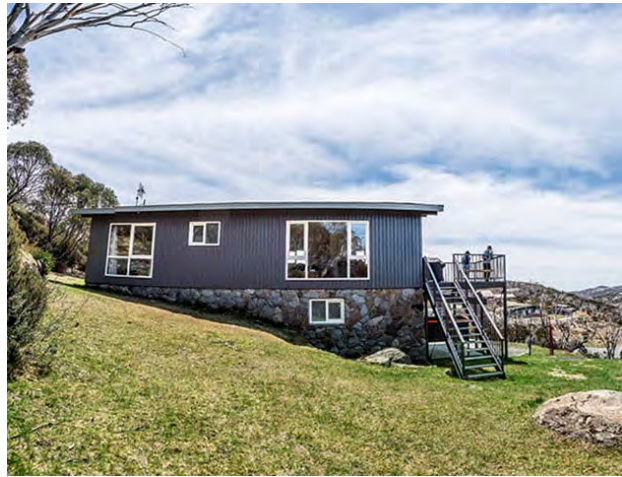
Place name and SEPP	Key dates, characteristics, and integrity	Meets heritage criteria	Photo
Numbananga	Original 1960 vernacular style building. owned by NPWS (outside DPE jurisdiction) A–Intact, high integrity	Retain on SEPP Could meet state heritage level— should be formally assessed against criteria.

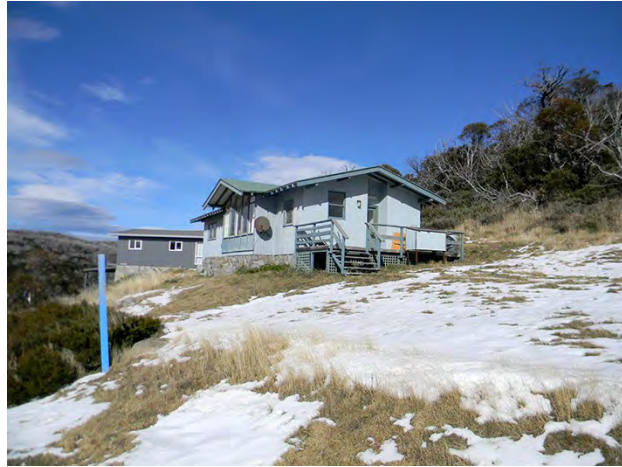
KAR Spruce Hall Now referred to as Perisher Staff Accommodation	Original 1962 vernacular style building, used as staff lodge. Continuous use as a staff lodge by Perisher. A–Intact, high integrity	1. High likelihood for meeting two or more criteria for SEPP/NSW. The precinct is likely to meet heritage criteria a), b), c), and g).

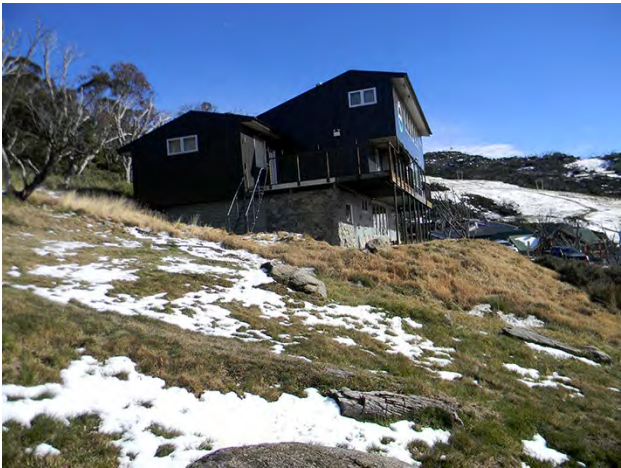
Illoura	1962–63 building in the vernacular style. Good condition, very little upgrade. Continuous leasehold (from 1968). A–Intact, high integrity	Retain on SEPP Could meet state heritage level—should be formally assessed against criteria.

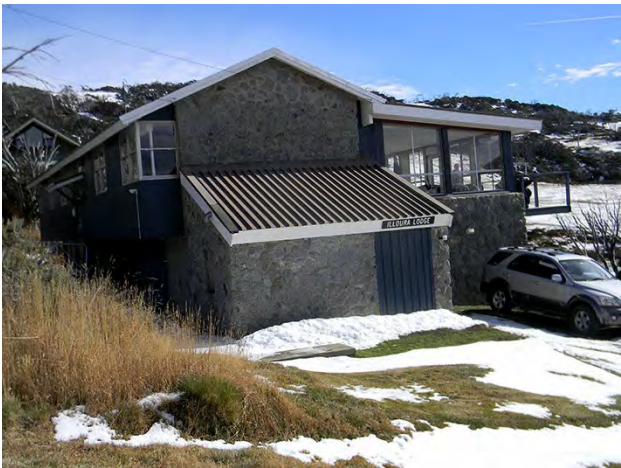
Lodge 39	1962 building, in the vernacular style. Historic character has been degraded through extensive alterations and external cladding. C–Diminished integrity, substantially altered, reclad	3. Unlikely to meet the NSW heritage criteria.	—

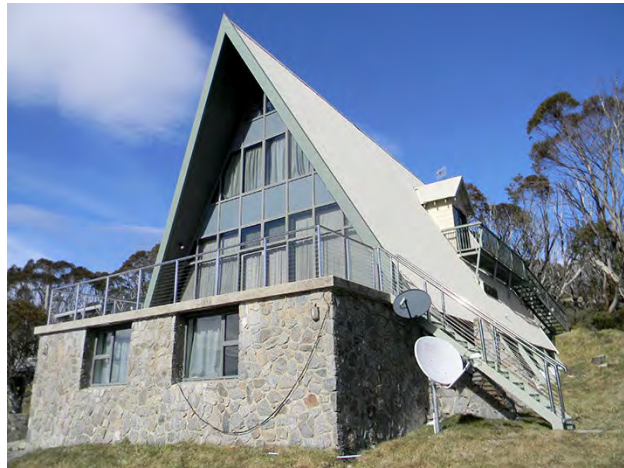
Place name and SEPP	Key dates, characteristics, and integrity	Meets heritage criteria	Photo
Muniong	<p>1962 building, in the vernacular style.</p> <p>A-Frame, with some minor additions, otherwise intact and retains architectural integrity through form, scale, and materials.</p> <p>Historically significant, architectural and a landmark on the southern hill of the Smiggin Holes' landscape setting.</p> <p>B—Retains integrity</p>	<p>2. Possible likelihood for meeting one or more criteria.</p> <p>Should be formally assessed.</p> <p>Likely to meet heritage criteria a), c), and g).</p>

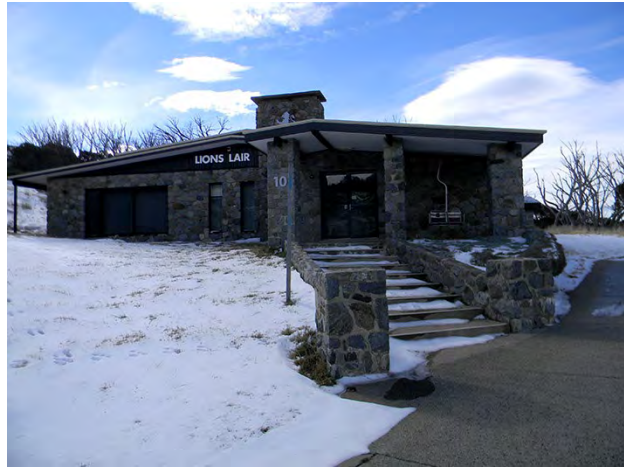
Place name and SEPP	Key dates, characteristics, and integrity	Meets heritage criteria	Photo
Lodge 21	1962 building, in the vernacular style. Commercial enterprise. Loss of integrity through poor condition. Should be conserved. B—Retains integrity, despite poor condition	Retain on SEPP Owner should be requested to undertake conservation before the poor condition leads to demolition by neglect.

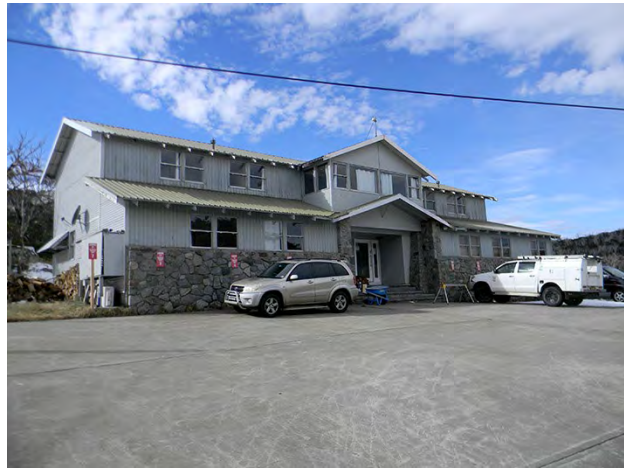
Royal Coachman	1962 building in the SPA style. Generally, retains external architectural integrity in the form and footprint. It has been altered externally and internally. Important contribution as a prominent building at the entry to Smiggin Holes. It is visible from the main road. C—Diminished integrity, substantially altered, reclad	3. Unlikely to meet the NSW heritage criteria.	—
Snowline Ski Centre (Now Rhythm Sports)	1963 building in the SPA style. Apart from modern signs, the building retains architectural integrity in its form and materials and is in good condition. A—Intact, high integrity	1. High likelihood for meeting two or more criteria for SEPP/NSW heritage criteria. Should be formally assessed. Likely to meet heritage criteria a), c), and g).

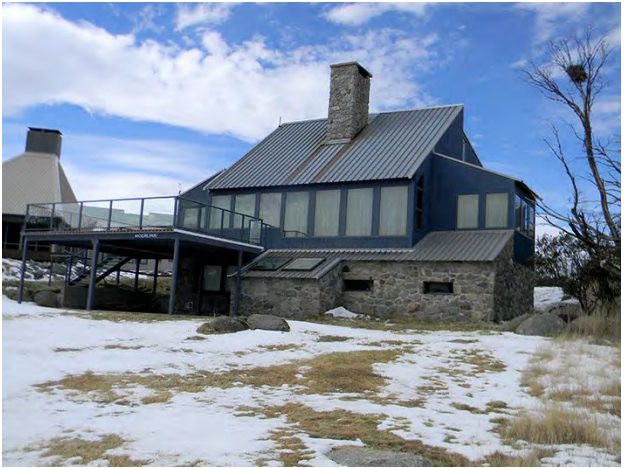
Place name and SEPP	Key dates, characteristics, and integrity	Meets heritage criteria	Photo
<p>Moerlina "Fellowship Lodge"</p>	<p>1971 building in the Alpine style, innovative style of architecture.</p> <p>Retains external architectural integrity in the form and footprint. It has been altered externally and internally.</p> <p>A—Intact, high integrity</p>	<p>1. High likelihood for meeting two or more criteria for SEPP/NSW heritage criteria.</p> <p>Should be formally assessed.</p> <p>Likely to meet heritage criteria a), c), and g).</p>

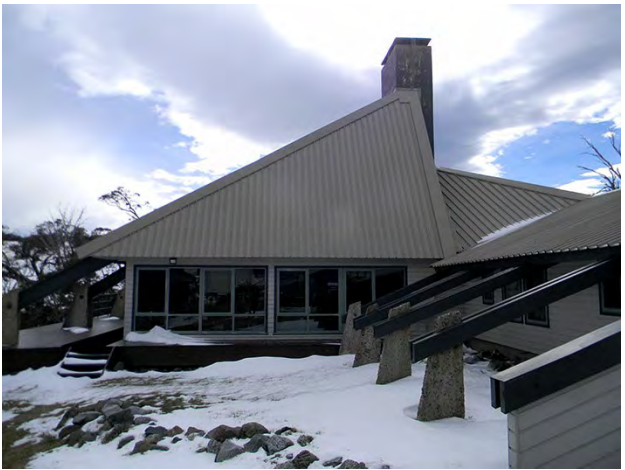
<p>Wildspitze Ski Club</p>	<p>1976 building in the 'innovative' design style.</p> <p>Good integrity in its architectural style and form. Wide I-beam structure and angled composite concrete 'feet'. New cladding.</p> <p>A—Intact, high integrity</p>	<p>1. High likelihood for meeting two or more criteria for SEPP/NSW heritage criteria.</p> <p>Should be formally assessed.</p> <p>Likely to meet heritage criteria a), c), and g).</p>

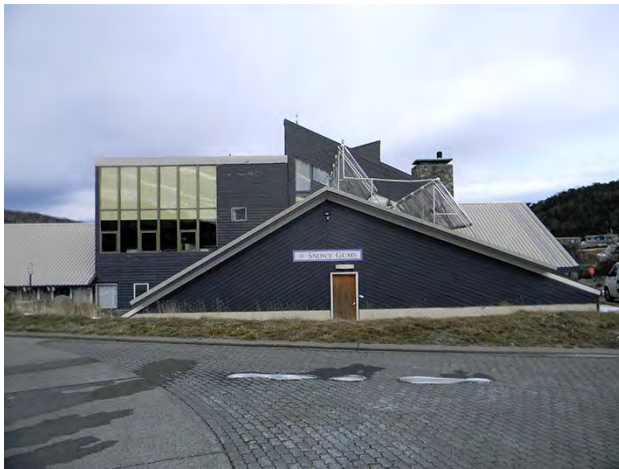
Place name and SEPP	Key dates, characteristics, and integrity	Meets heritage criteria	Photo
Snowy Gums Original/historic name not known	Needs major maintenance works. B—Retains integrity, despite alterations	2. Possible likelihood for meeting one or more criteria. Should be formally assessed. Likely to meet heritage criteria a), c), and g).

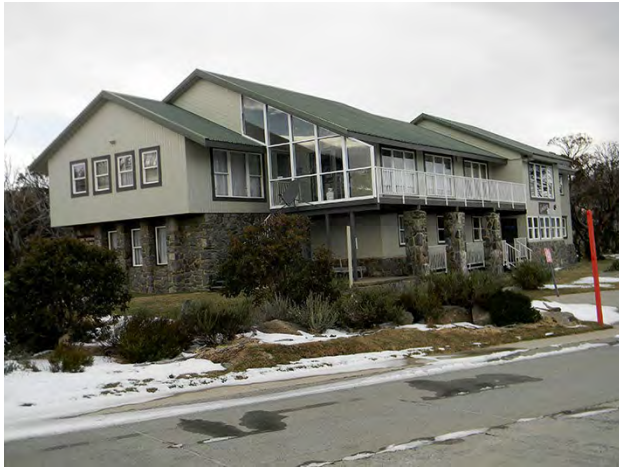
Illawarra Master Builders Alpine Club (IMBAC)	1966 building in the vernacular style. Changes to the exterior, new cladding. White colour balustrades detract from the historic character. Historic architectural form is intact. B—Retains integrity	2. Possible likelihood for meeting one or more criteria. Should be formally assessed. Likely to meet heritage criteria a), c), and g).

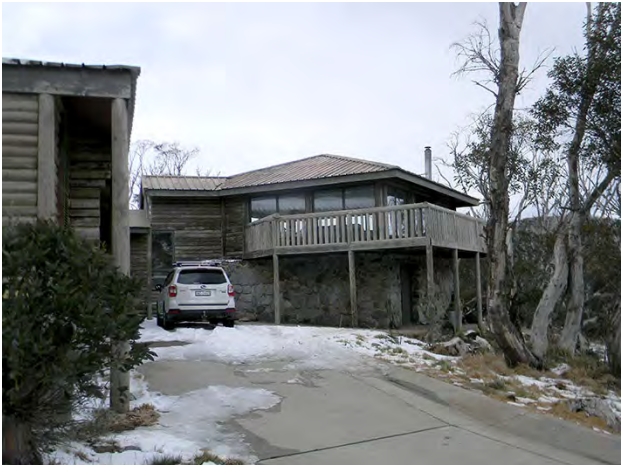
Place name and SEPP	Key dates, characteristics, and integrity	Meets heritage criteria	Photo
Clancy	<p>1977 Log cabin style lodge, with three structures, including the accommodation structure, a manager's residence at the back, and a games and ski room at front (two storey). B—Retains integrity</p>	<p>2. Possible likelihood for meeting one or more criteria. Should be formally assessed. Likely to meet heritage criteria a), c), and g).</p>

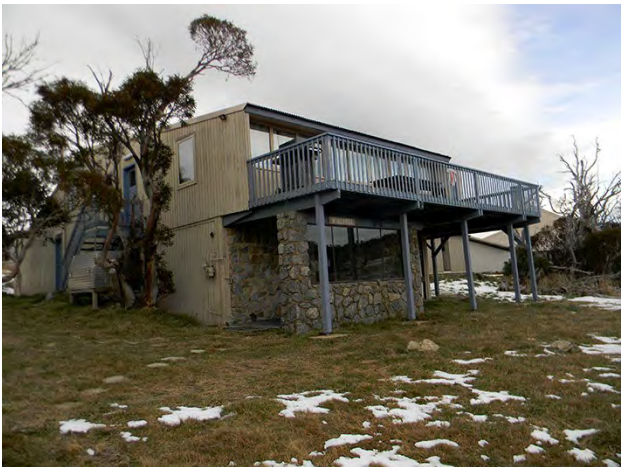
Windarra	<p>1974 building in the vernacular style. Small in architectural form and size. Very basic lodge. Currently intact, with a deck extension proposed. B—Retains integrity</p>	<p>2. Possible likelihood for meeting one or more criteria. Should be formally assessed. Likely to meet heritage criteria a), c), and g).</p>

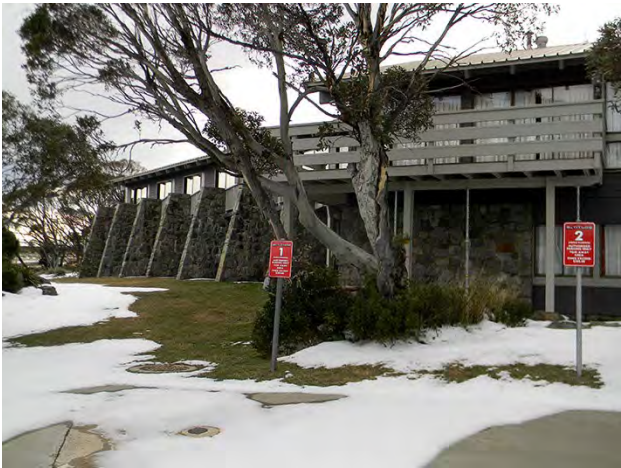
Place name and SEPP	Key dates, characteristics, and integrity	Meets heritage criteria	Photo
The Lodge (Altitude)	1980 vernacular style. B—Retains integrity	2. Possible likelihood for meeting one or more criteria. Should be formally assessed. Likely to meet heritage criteria a), c), and g).

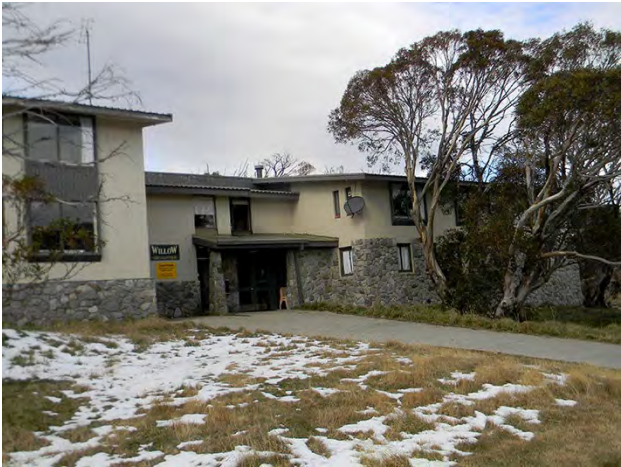
Gunumara lodge	1976 vernacular style A 'pretty' lodge but has lost architectural integrity. D—Lacks integrity, rebuilt	3. Unlikely to meet the NSW heritage criteria.	—
Willow Lodges	1977 vernacular style. B—Retains integrity	2. Possible likelihood for meeting one or more criteria. Should be formally assessed. Likely to meet heritage criteria a), c), and g).

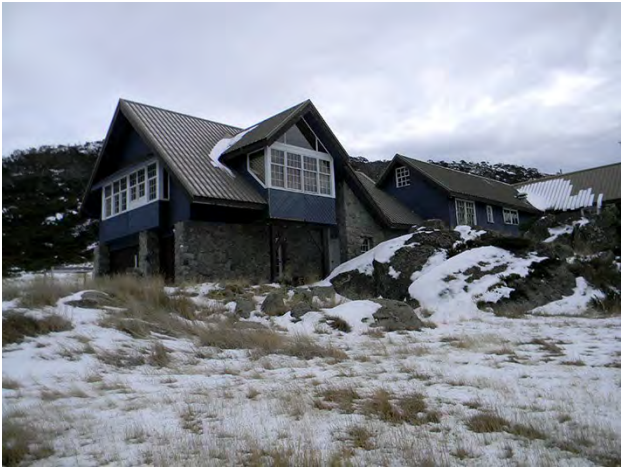
A photograph of the Redwood Ski Lodge, a double A-frame building with a dark roof and stone walls, situated in a snowy landscape. A wooden staircase leads up to the entrance.
North Perisher Lodge North Perisher Precinct	Retains architectural and historic integrity. Unchanged. Built around rock formation. DA in for major redevelopment, including demolition of original. Privately owned by Oatley's (Hamilton Island), retains architectural integrity. B-Retains integrity	1. High likelihood for meeting two or more criteria for SEPP/NSW heritage criteria. Should be formally assessed. Likely to meet heritage criteria a), c), and g).

A photograph of the North Perisher Lodge, a large building with a complex roofline and stone walls, situated in a snowy landscape.

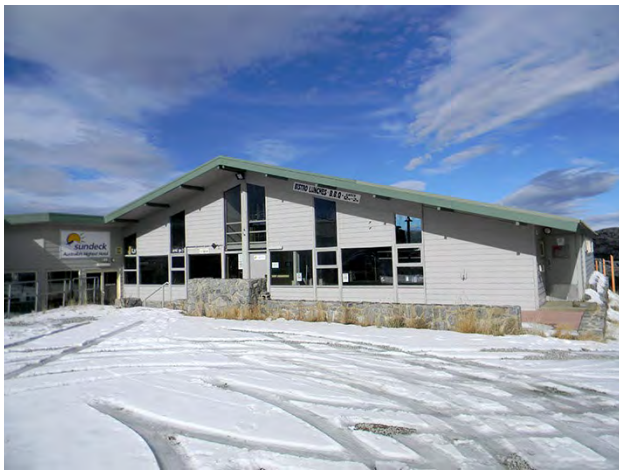
Place name and SEPP	Key dates, characteristics, and integrity	Meets heritage criteria	Photo
Sundeck	The early re-built commercial hotel and public bar (c 1959/60) – remains largely intact in its form (Alpine style) and is a landmark, visible on the northern side of the centre valley slopes. B–Retains integrity ('main' building only)	2. Possible likelihood for meeting one or more criteria. Should be formally assessed. Likely to meet heritage criteria a), c), and g).

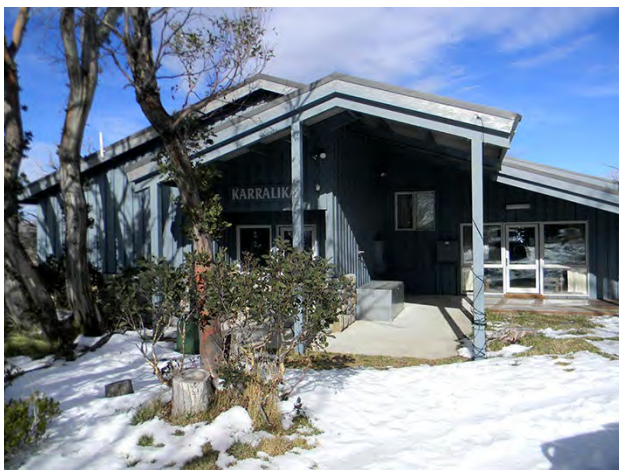
Gumtrees	The original 1960's vernacular style building has been rebuilt. D–Lacks integrity, rebuilt	3. Unlikely to meet the NSW heritage criteria.	—
Karralika	The original 1960's club lodge is an SPA style building. It is possible that much of the original fabric has largely been rebuilt. It is difficult to ascertain from the external view. B–Retains integrity	2. Possible likelihood for meeting one or more criteria. Should be formally assessed. Likely to meet heritage criteria a), c), and g).

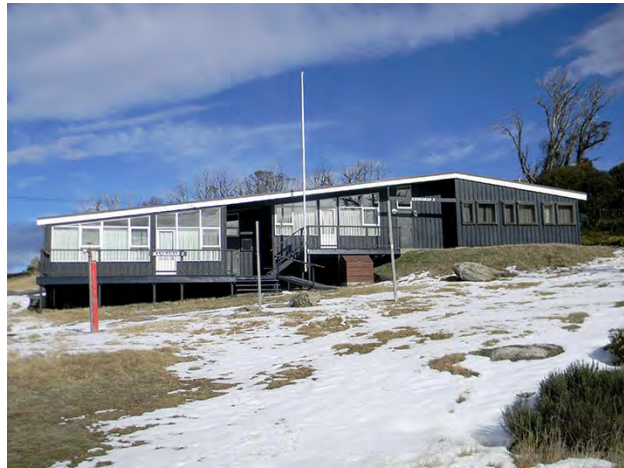
Place name and SEPP	Key dates, characteristics, and integrity	Meets heritage criteria	Photo
Kandahar (1 and 2)	<p>An original 1950's club lodge, built in the SPA style building. A prominent and distinctive building, visible at the top of Telemark T-Bar.</p> <p>A historic significant lodge that retains the original form and architectural integrity.</p> <p>B–Retains integrity</p>	<p>2. Possible likelihood for meeting one or more criteria.</p> <p>Should be formally assessed.</p> <p>Likely to meet heritage criteria a), c), and g).</p>

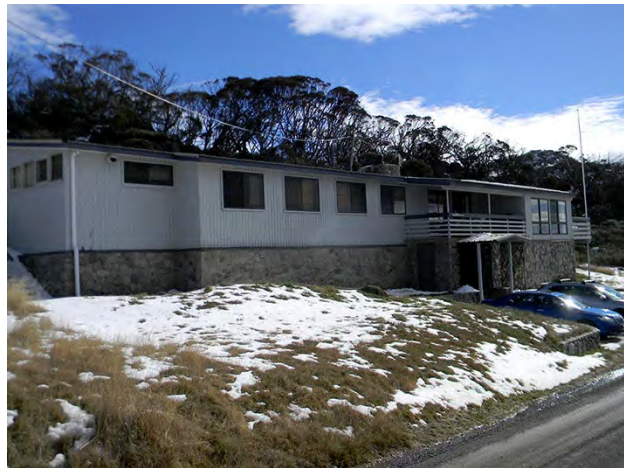
Cronulla	<p>The original 1961 vernacular style building is intact, and largely unchanged. Prominent siting, visible at the top of Telemark T-Bar.</p> <p>The lodge retains the original form and architectural integrity.</p> <p>B–Retains integrity</p>	<p>2. Possible likelihood for meeting one or more criteria.</p> <p>Should be formally assessed.</p> <p>Likely to meet heritage criteria a), c), and g).</p>

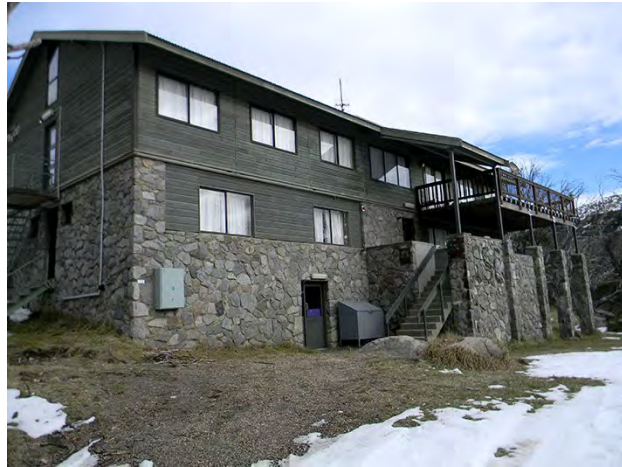
KSRC Kosciuszko Snow Revellers Club	<p>Original 1953 structure, designed in a vernacular style, has been adapted. Blonde timber recladding and new structures/extensions.</p> <p>The original architectural integrity of the dark timber and alpine style decorative features has been altered.</p> <p>B—Retains integrity through the form, style and some original fabric</p>	Retain on SEPP

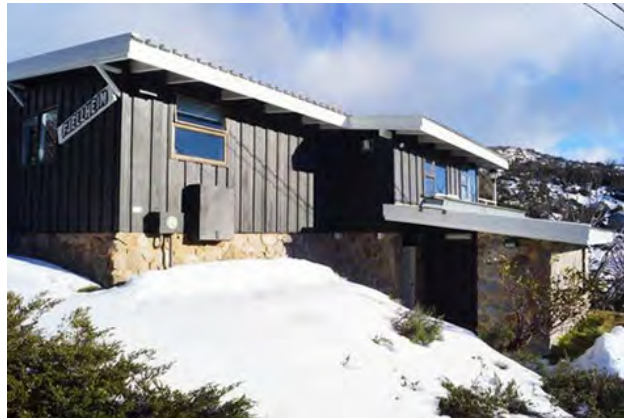
Place name and SEPP	Key dates, characteristics, and integrity	Meets heritage criteria	Photo
Fjellheim	<p>The club lodge was constructed in the 1960s and is important for its contribution to the historic development of Perisher.</p> <p>Minor changes, with the architectural form and historic character are evident.</p> <p>A–Intact, high integrity</p>	<p>1. High likelihood for meeting two or more criteria for SEPP/NSW heritage criteria.</p> <p>Could meet state heritage level—should be formally assessed against criteria</p>

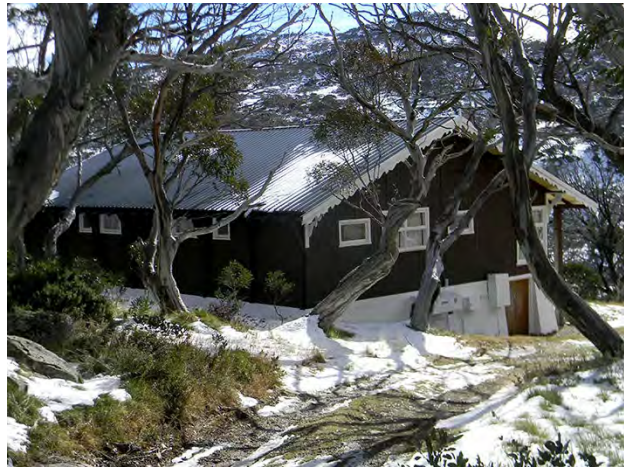
Edelweiss	<p>The original 1957 European Alpine style of the club building is very well maintained. It retains the original form and architectural integrity including materials, colours, and form.</p> <p>It is 'semi-remote' landscape setting amongst snow gums is significant.</p> <p>A–Intact, high integrity</p>	<p>Retain on SEPP</p> <p>Could meet state heritage level—should be formally assessed against criteria.</p>

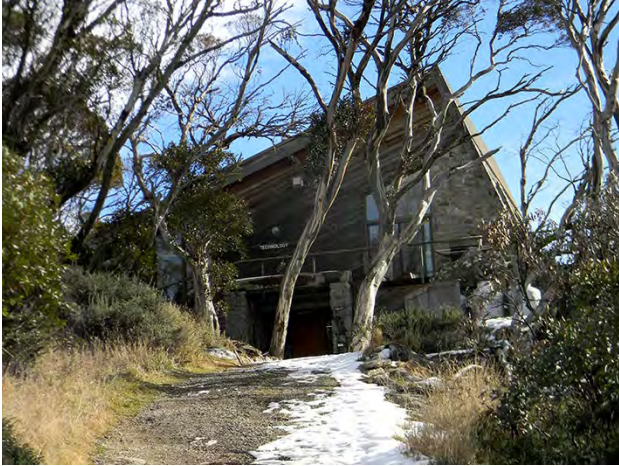
Place name and SEPP	Key dates, characteristics, and integrity	Meets heritage criteria	Photo
Technology	<p>1980's construction in the Alpine style. High architectural design integrity, despite being a 'later' addition to the alpine resort.</p> <p>A—Intact, high integrity</p>	<p>1. High likelihood for meeting two or more criteria for SEPP/NSW heritage criteria.</p> <p>Should be formally assessed.</p> <p>Likely to meet heritage criteria a), c), and g).</p>

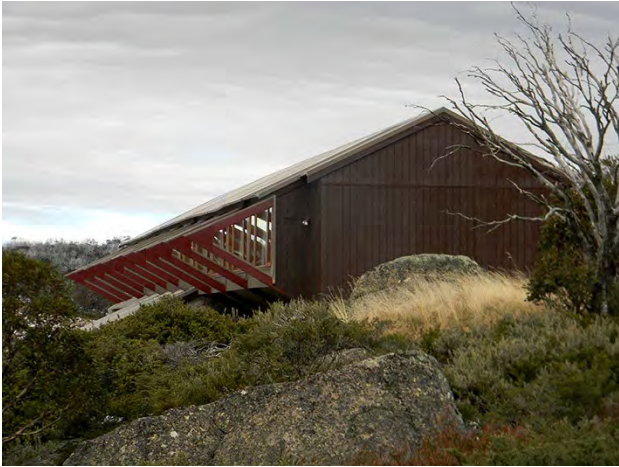
Yarrandoo	<p>1963 club lodge, which is architecturally significant (innovative style).</p> <p>There has been some alteration, yet retains form and much fabric</p> <p>B—Retains integrity</p>	<p>2. Possible likelihood for meeting one or more criteria.</p> <p>Should be formally assessed.</p> <p>Likely to meet heritage criteria a), c), and g).</p>

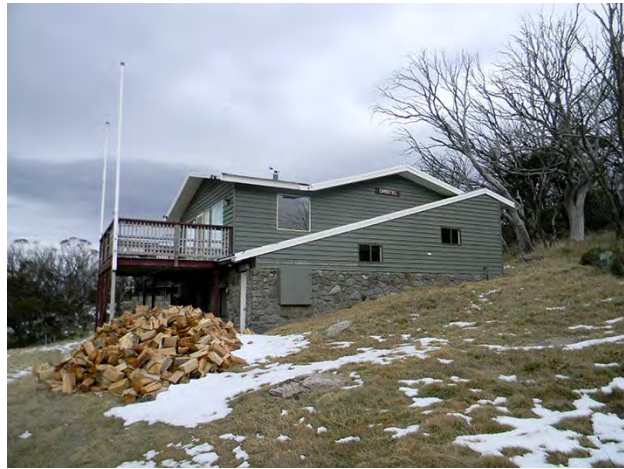
Dulmison Ski Club	<p>Original 1962 structure, designed in an innovative style, has been adapted.</p> <p>Highly significant architectural character replaced in 1990s, with a 'historic' 1960's yet modern design style.</p> <p>B–Retains integrity as a contemporary architectural adaptation</p>	<p>Retain on SEPP</p> <p>Should be formally assessed.</p> <p>Likely to meet heritage criteria a), c), and g).</p>

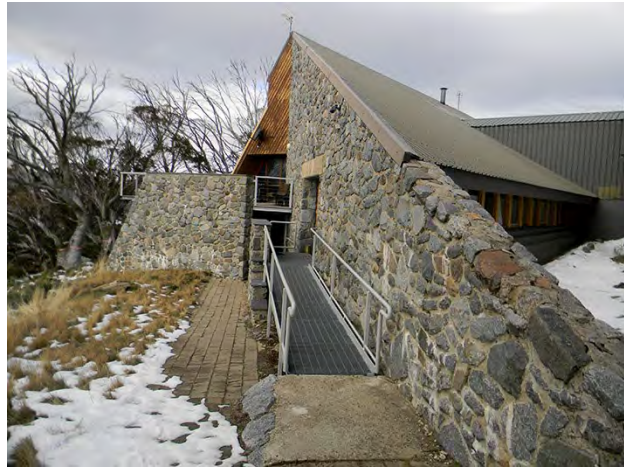
Place name and SEPP	Key dates, characteristics, and integrity	Meets heritage criteria	Photo
Canberra Alpine Club	<p>The original 1961 club building, designed in an 'innovative' style is clearly evident. There is some loss of architectural integrity due to a new metal verandah and walkways. The main architectural features are intact, yet the building requires external maintenance.</p> <p>B–Retains integrity</p>	<p>1. High likelihood for meeting two or more criteria for SEPP/NSW heritage criteria.</p> <p>Should be formally assessed.</p> <p>Likely to meet heritage criteria a), c), and g).</p>

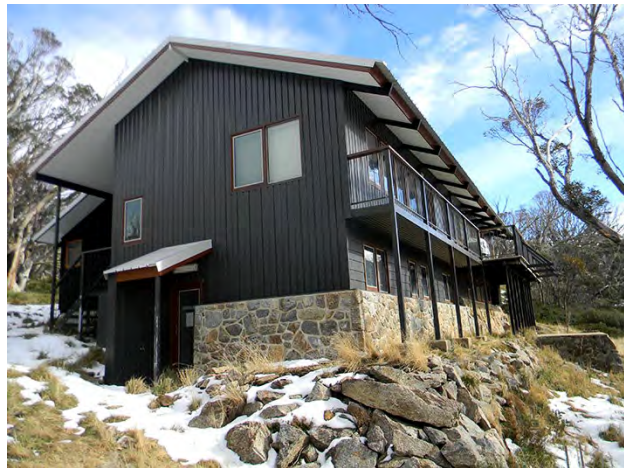
Beachcombers	<p>The original 1962 vernacular style building is evident. There is some loss of architectural integrity due to recladding and changes.</p> <p>The lodge retains form, style, and some original fabric.</p> <p>B–Retains integrity as a contemporary architectural adaptation</p>	<p>2. Possible likelihood for meeting one or more criteria.</p> <p>Should be formally assessed.</p> <p>Likely to meet heritage criteria a), c), and g).</p>

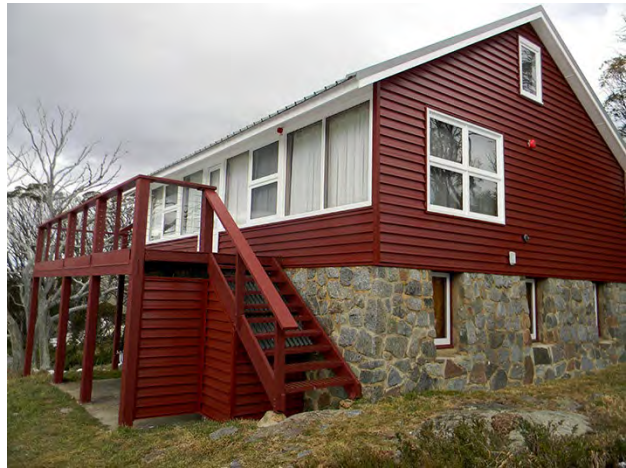
Place name and SEPP	Key dates, characteristics, and integrity	Meets heritage criteria	Photo
Langlauf	<p>The club lodge was constructed in 1960, in the vernacular style, and is important for its contribution to the historic development of Perisher. Reclad, yet retains form and historic character.</p> <p>Minor changes, however, the architectural form and historic character are evident. It is close to an intact and high integrity lodge; however, the modernised cladding reduces the 'original' integrity.</p> <p>B–Retains integrity</p>	<p>1. High likelihood for meeting two or more criteria for SEPP/NSW heritage criteria.</p> <p>Should be formally assessed.</p> <p>Likely to meet heritage criteria a), c), and g).</p>

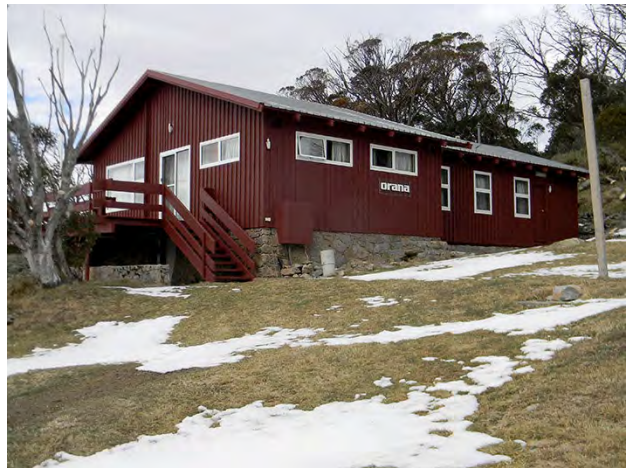
Orana	<p>1960's club lodge in the vernacular design style, from early Perisher development period.</p> <p>A–Intact, high integrity</p>	<p>1. High likelihood for meeting two or more criteria for SEPP/NSW heritage criteria.</p> <p>Should be formally assessed.</p> <p>Likely to meet heritage criteria a), c), and g).</p>

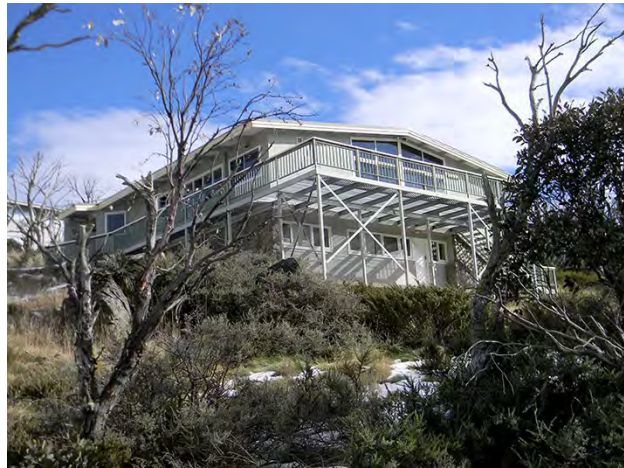
Place name and SEPP	Key dates, characteristics, and integrity	Meets heritage criteria	Photo
Mirrabooka	The original 1962 club building, in the SPA design style and is largely intact. Possible new verandah, cladding and roof. B–Retains integrity	2. Possible likelihood for meeting one or more criteria. Should be formally assessed. Likely to meet heritage criteria a), c), and g).

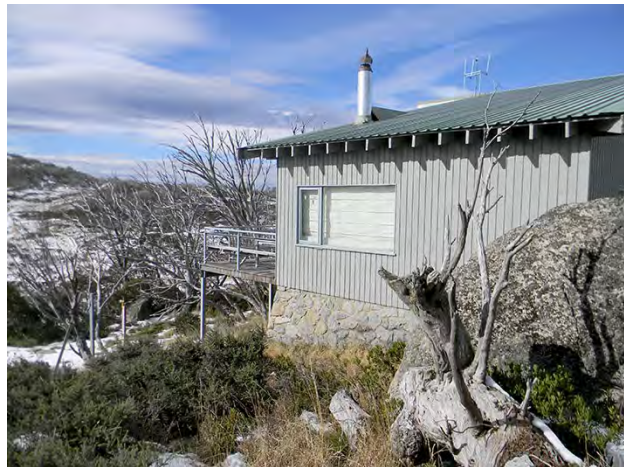
Alexandra	The original 1961 vernacular style of the club building is evident and well maintained. Some cladding changes, however, the lodge retains the original form and architectural integrity. B–Retains integrity	Retain on SEPP

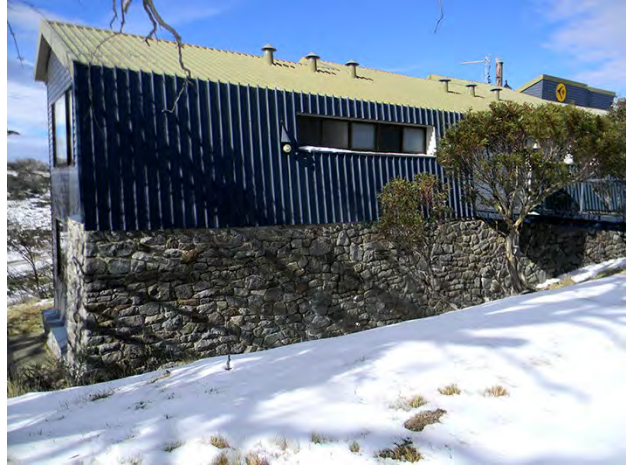
Telemark	<p>1951/1952 European Alpine, vernacular.</p> <p>3x buildings in excellent condition, with a high degree of integrity and historic, aesthetic, and social value.</p> <p>A—Intact, high integrity</p>	<p>Retain on SEPP</p> <p>Could meet state heritage level—should be formally assessed against criteria</p>

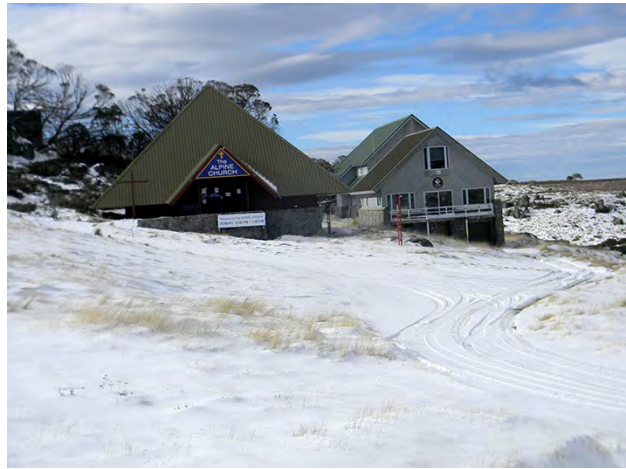
Place name and SEPP	Key dates, characteristics, and integrity	Meets heritage criteria	Photo
Alpine Church and Ski Patrol (No.1)—north of the Perisher Centre	Two 1980's designed buildings, architecturally complementary. The later Ski Patrol Building No.2 is a later structure, and not complementary. B—Retains integrity	2. Possible likelihood for meeting one or more criteria. Should be formally assessed. Likely to meet heritage criteria a), c), and g).

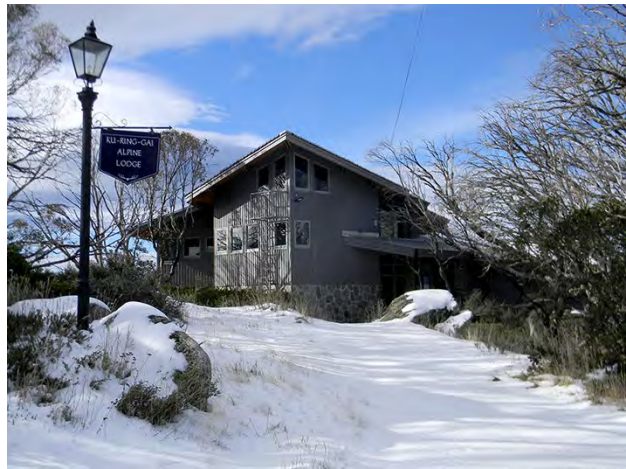
Ku-ring-gai	The original 1960's club lodge is a significant innovative architectural design. Intact and slightly altered to meet fire safety requirements, yet original structure is evident. B—Retains integrity	Retain on SEPP Could meet state heritage level—should be formally assessed against criteria.
