REVISED HISTORIC HERITAGE ASSESSMENT

SNOWY MOUNTAINS SPECIAL ACTIVATION PRECINCT

SNOWY MONARO REGIONAL COUNCIL LGA

JUNE 2022

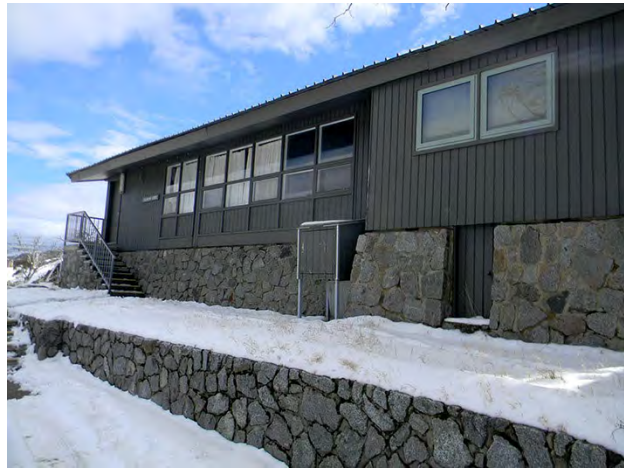
Lampada	Form retained. Original architectural integrity degraded through the replacement of all material. Rebuilt and/or reclad. No longer mission brown or of original character. Adapted, yet architectural form has good integrity for being sympathetic to original. Social value of the club retained. Original stone base. C—Diminished integrity	3. Unlikely to meet the NSW heritage criteria.	—
Kalymaro	Form retained. Original architectural integrity degraded through the replacement of all material. Rebuilt and/or reclad. No longer mission brown or of original character. Adapted, yet architectural form has good integrity for being sympathetic to original. Social value of the club retained. Original stone base. C—Diminished integrity	3. Unlikely to meet the NSW heritage criteria.	—

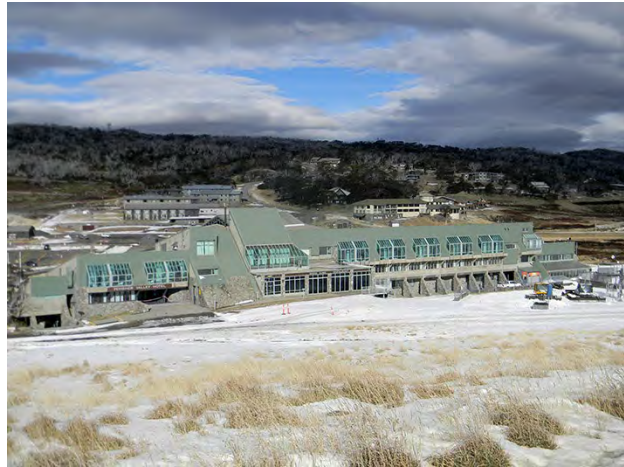
Perisher Manor	<p>The original 1965 building—a commercial hotel and public bar—remains largely intact in its form (hexagonal 'innovative' design) and is a landmark, highly visible place in the centre valley.</p> <p>Altered with some of the original hexagonal building evident. The large extension is not significant.</p> <p>B—Retains integrity</p>	<p>2. Possible likelihood for meeting one or more criteria.</p> <p>Should be formally assessed.</p> <p>Likely to meet heritage criteria a), c), and g).</p>

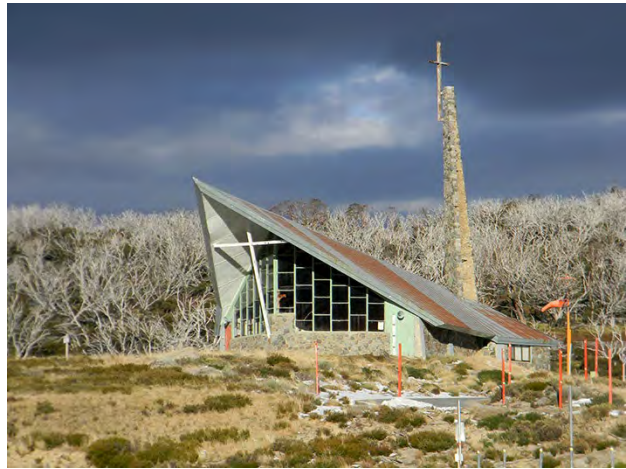
Place name and SEPP	Key dates, characteristics, and integrity	Meets heritage criteria	Photo
Catholic Church	<p>Original and intact 1964 in a mid-century innovative design style.</p> <p>Church in its landmark, prominent setting is highly significant.</p> <p>Needs urgent conservation and maintenance work.</p> <p>A–Intact, high integrity</p>	<p>1. High likelihood for meeting two or more criteria for SEPP/NSW heritage criteria.</p> <p>Could meet state heritage level—should be formally assessed against criteria.</p>

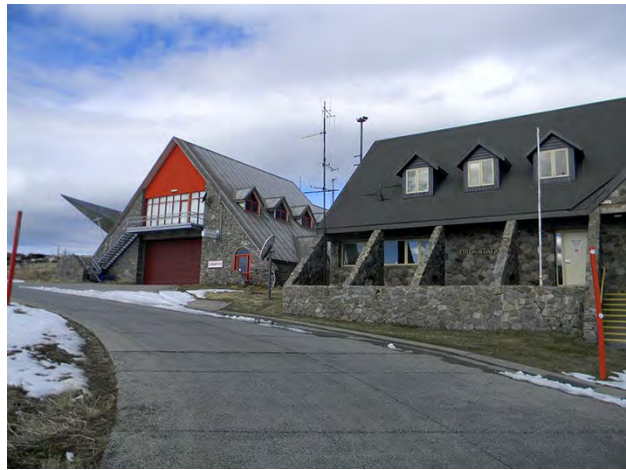
Fire and Rescue Station, Ambulance Station	<p>1984 and 1986 Alpine style buildings, designed to be complementary with each other, and in keeping with the Perisher infrastructure buildings.</p> <p>Intact, with some alterations. altered, yet original structures are evident.</p> <p>A–Intact, high integrity</p>	<p>2. Possible likelihood for meeting one or more criteria.</p> <p>Should be formally assessed.</p> <p>Likely to meet heritage criteria a), c), and g).</p>

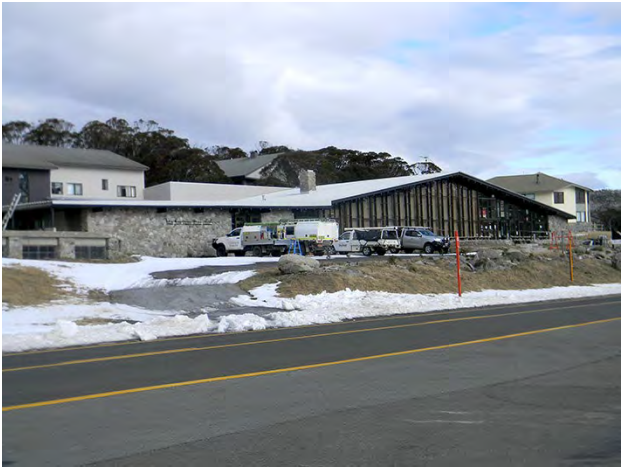
Place name and SEPP	Key dates, characteristics, and integrity	Meets heritage criteria	Photo
Man from Snowy River	<p>The original 1960 building—a commercial hotel and public bar—remains largely intact in its form (SMA vernacular) and is a landmark, highly visible in the centre valley.</p> <p>The original external form is very evident.</p> <p>B—Retains integrity</p>	<p>2. Possible likelihood for meeting one or more criteria.</p> <p>Should be formally assessed.</p> <p>Likely to meet heritage criteria a), c), and g).</p>

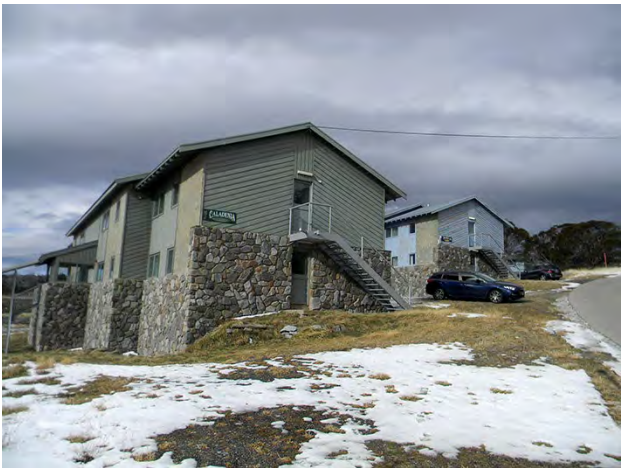
Perisher Staff Lodges (Astelia, Caledonia and Pinelia lodges)	<p>1982 staff lodges, in the Alpine style.</p> <p>Complementary group of buildings to other Perisher Infrastructure in the central valley area.</p> <p>A—Intact, high integrity</p>	<p>2. Possible likelihood for meeting one or more criteria.</p> <p>Should be formally assessed.</p> <p>Likely to meet heritage criteria a), c), and g).</p>

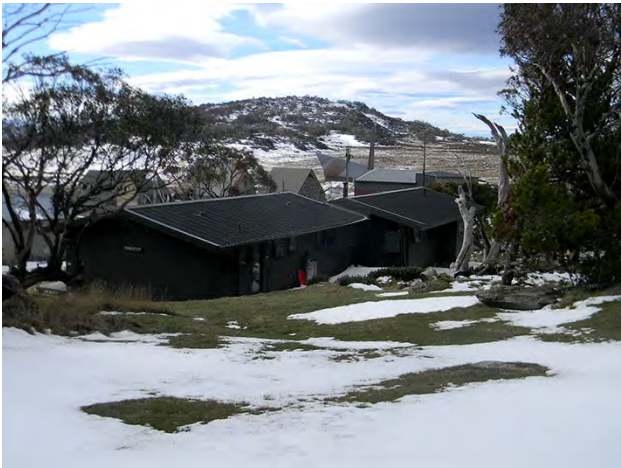
Place name and SEPP	Key dates, characteristics, and integrity	Meets heritage criteria	Photo
Timbertop	1974 (approximate) staff accommodation building in the Alpine style. A—Intact, high integrity	2. Possible likelihood for meeting one or more criteria. Should be formally assessed. Likely to meet heritage criteria a), c), and g).

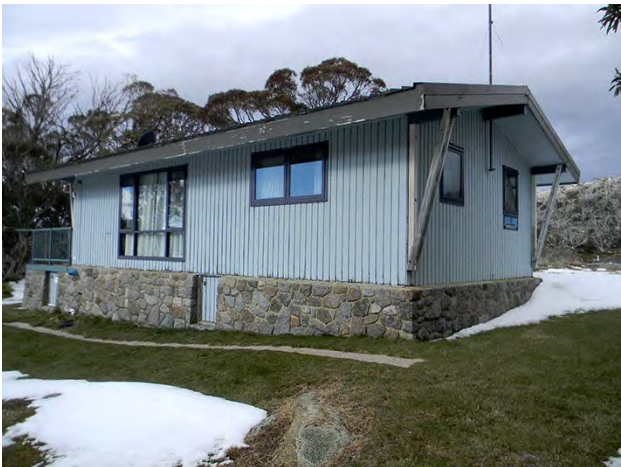
Acacia (next to Timbertop)	No details in Freeman 1998. Staff accommodation? A—Intact, high integrity	2. Possible likelihood for meeting one or more criteria. Should be formally assessed. Likely to meet heritage criteria a), c), and g).

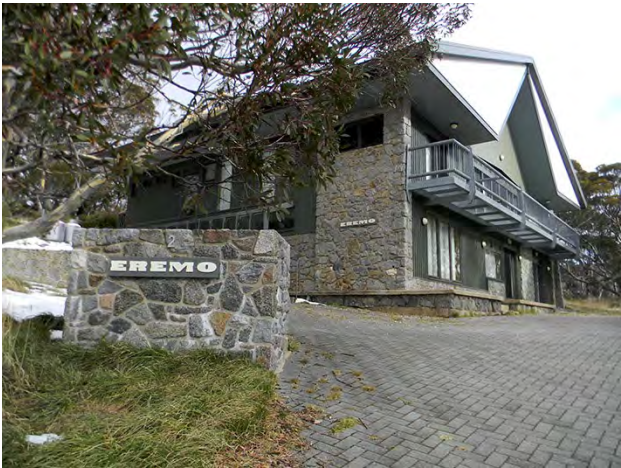
Place name and SEPP	Key dates, characteristics, and integrity	Meets heritage criteria	Photo
Eremo	1962 'innovative' design. Possibly later glass conservatory addition. Retains architectural integrity. B–Retains integrity	2. Possible likelihood for meeting one or more criteria. Should be formally assessed. Likely to meet heritage criteria a), c), and g).

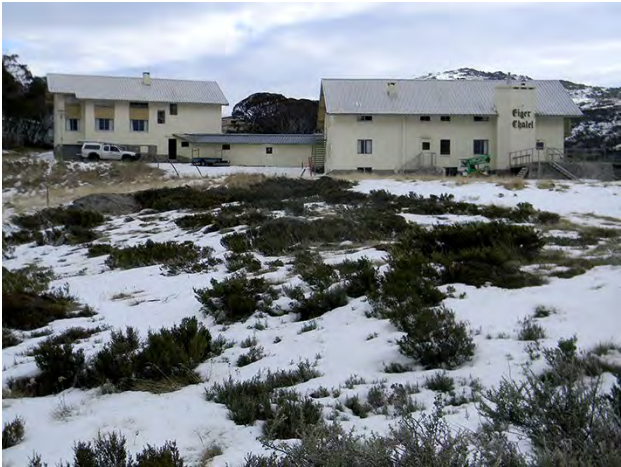
Place name and SEPP	Key dates, characteristics, and integrity	Meets heritage criteria	Photo
Eiger Chalet	<p>1960 European Alpine style – unchanged, retains all historic, and original fabric and paint colours.</p> <p>A–Intact, high integrity</p>	<p>1. High likelihood for meeting two or more criteria for SEPP/NSW heritage criteria.</p> <p>Should be assessed as an individual item and within its precinct.</p> <p>Likely to meet heritage criteria a), c), and g).</p>

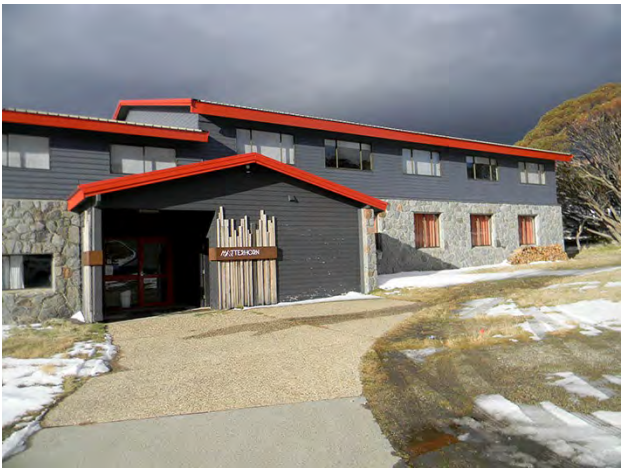
Matterhorn	<p>Commercial lodge.</p> <p>Retains original 1960's vernacular architecture. Recladding, alteration/extension.</p> <p>B–Retains integrity</p>	<p>2. Possible likelihood for meeting one or more criteria.</p> <p>Should be assessed as an individual item and within its precinct.</p> <p>Likely to meet heritage criteria a), c), and g).</p>

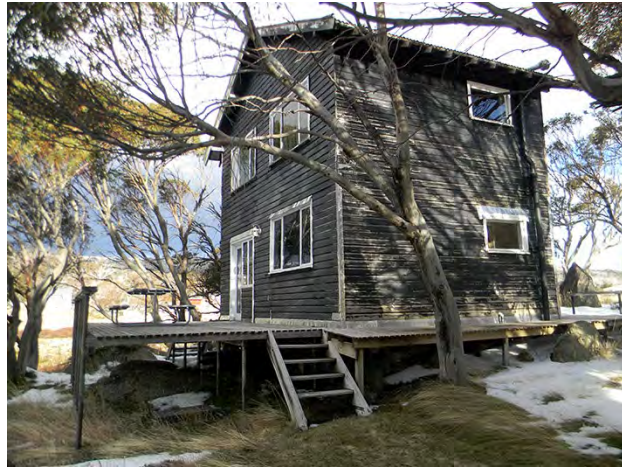
Place name and SEPP	Key dates, characteristics, and integrity	Meets heritage criteria	Photo
Tambaroora	<p>The original 1960's vernacular architecture is evident in this very small two storey club lodge. External cladding needs urgent conservation and maintenance.</p> <p>A—Intact, high integrity</p>	<p>1. High likelihood for meeting two or more criteria for SEPP/NSW heritage criteria.</p> <p>Should be assessed against the heritage criteria.</p> <p>Likely to meet heritage criteria a), c), and g).</p>

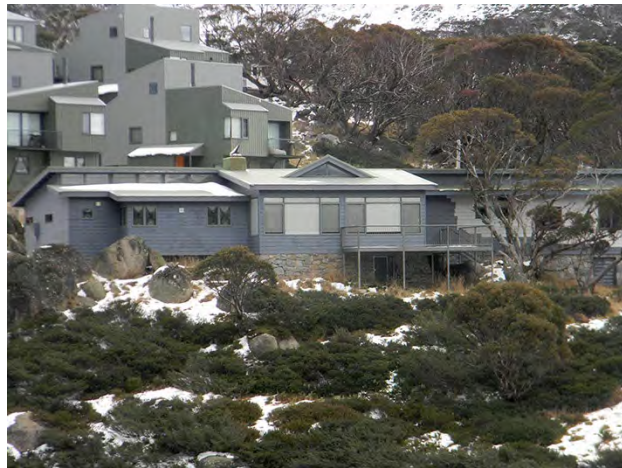
Place name and SEPP	Key dates, characteristics, and integrity	Meets heritage criteria	Photo
Snowgums	1959 club lodge, vernacular architecture. Has been reclad. B–Retains integrity	2. Possible likelihood for meeting one or more criteria. Should be assessed as an individual item and within its precinct. Likely to meet heritage criteria a), c), and g).

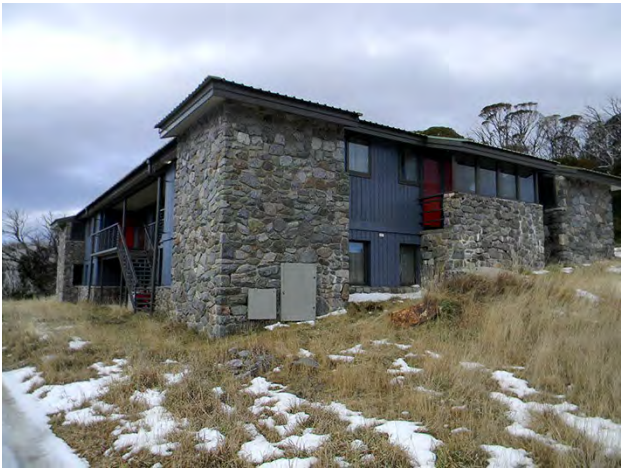
Place name and SEPP	Key dates, characteristics, and integrity	Meets heritage criteria	Photo
CSIRO	1985 Design. Retains architectural and historic integrity. Unchanged. A—Intact, high integrity	1. High likelihood for meeting two or more criteria for SEPP/NSW heritage criteria. Should be formally assessed. Likely to meet heritage criteria a), c), and g).

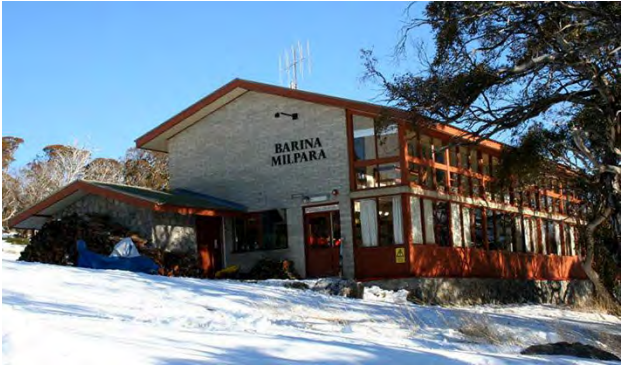
Barina Milpara	Commercial lodge 1977 vernacular style lodge, the front façade has some vernacular characteristics but overall, not very interesting architecturally. B—Retains integrity	2. Possible likelihood for meeting one or more criteria. Should be formally assessed. Likely to meet heritage criteria a), c), and g).

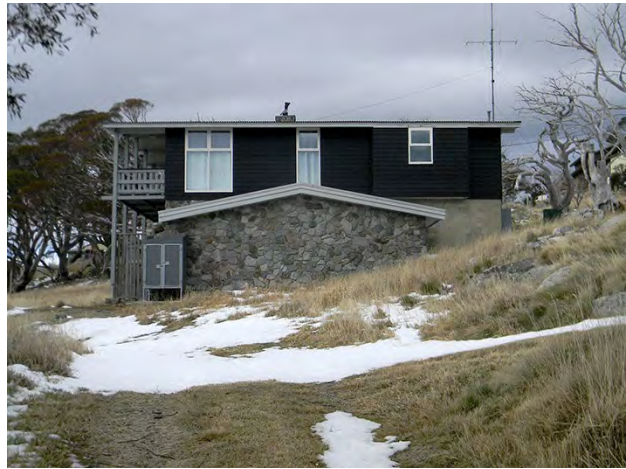
Place name and SEPP	Key dates, characteristics, and integrity	Meets heritage criteria	Photo
Avalanche	1960's vernacular. Old section visible in the centre of the building. B–Retains integrity	2. Possible likelihood for meeting one or more criteria. Should be assessed as an individual item and within its precinct. Likely to meet heritage criteria a), c), and g).

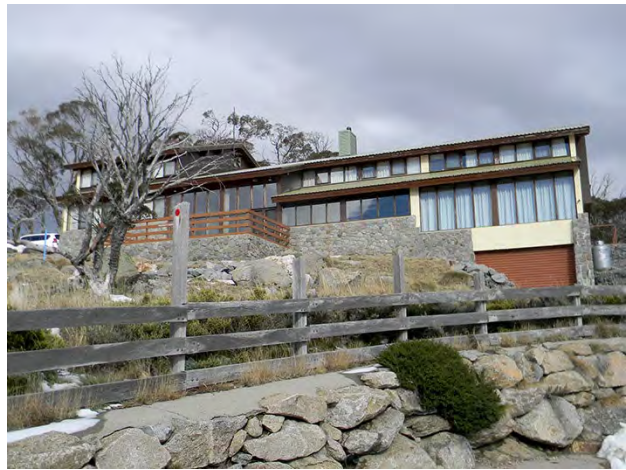
Valhalla	Commercial lodge Original 1960's SPA architecture B–Retains integrity	2. Possible likelihood for meeting one or more criteria. Should be assessed as an individual item and within its precinct. Likely to meet heritage criteria a), c), and g).

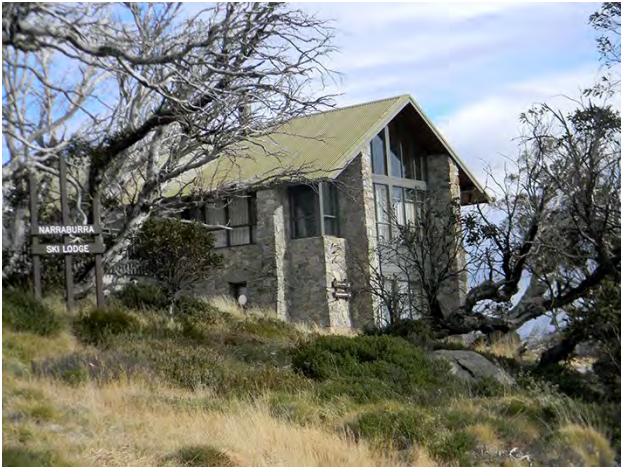
Place name and SEPP	Key dates, characteristics, and integrity	Meets heritage criteria	Photo
Narraburra	1960s. SPA architecture. A–Intact, high integrity	1. High likelihood for meeting two or more criteria for SEPP/NSW heritage criteria. Should be assessed as an individual item and with the surrounding precinct. Likely to meet heritage criteria a), c), and g).

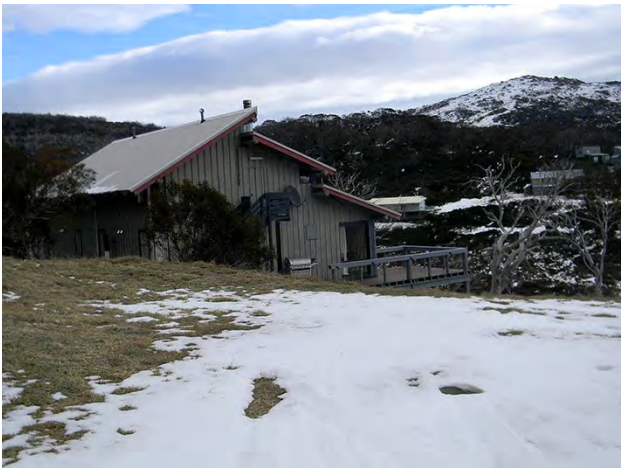
Ullr (house of)	The original 1960 vernacular architecture is evident in this club lodge. External cladding needs maintenance. A–Intact, high integrity	1. High likelihood for meeting two or more criteria for SEPP/NSW heritage criteria. Should be assessed as an individual item and within its precinct. Likely to meet heritage criteria a), c), and g).

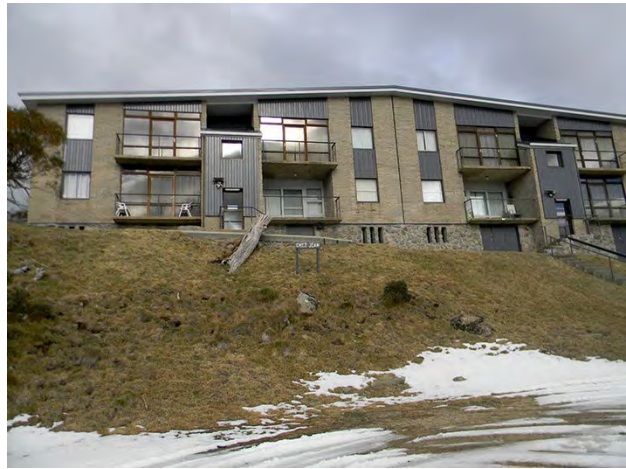
Place name and SEPP	Key dates, characteristics, and integrity	Meets heritage criteria	Photo
Chez Jean	<p>Commercial lodge.</p> <p>Substantial building, with historic characteristics. Front glazed façade and building form is interesting but the remaining building has little architectural interest.</p> <p>B–Retains integrity</p>	<p>2. Possible likelihood for meeting one or more criteria.</p> <p>Should be assessed as an individual item and within its precinct.</p> <p>Likely to meet heritage criteria a), c), and g).</p>

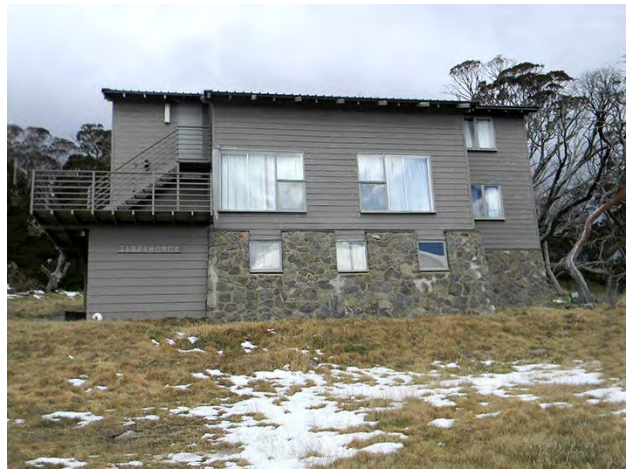
Tarrawonga	<p>The original 1964 vernacular architecture is evident in this club lodge.</p> <p>B–Retains integrity</p>	<p>2. Possible likelihood for meeting one or more criteria.</p> <p>Should be assessed as an individual item and within its precinct.</p> <p>Likely to meet heritage criteria a), c), and g).</p>

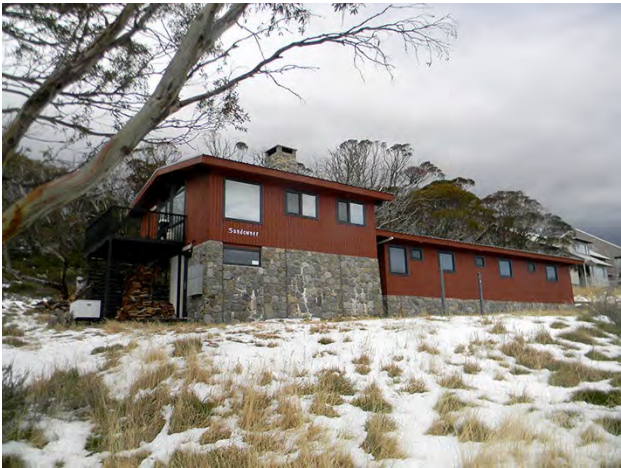
Place name and SEPP	Key dates, characteristics, and integrity	Meets heritage criteria	Photo
Sundowner	The original 1967 vernacular architecture is evident in this club lodge. A—Intact, high integrity	1. High likelihood for meeting two or more criteria for SEPP/NSW heritage criteria. Should be assessed as an individual item and within its precinct. Likely to meet heritage criteria a), c), and g).

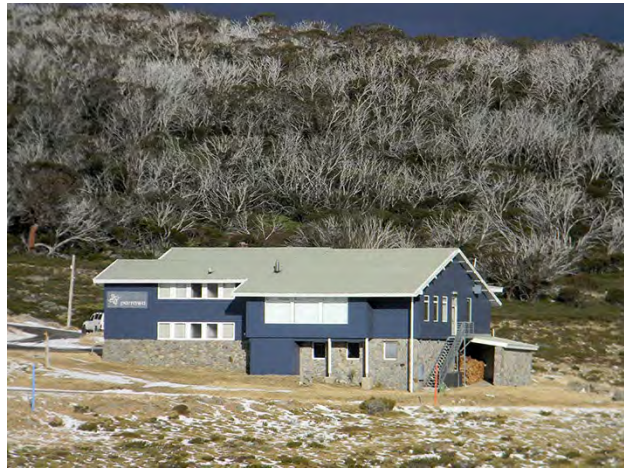
Place name and SEPP	Key dates, characteristics, and integrity	Meets heritage criteria	Photo
Parrawa	1964 vernacular architecture Original building form with some rebuilding. B–Retains integrity	2. Possible likelihood for meeting one or more criteria. Should be assessed as an individual item and within its precinct. Likely to meet heritage criteria a), c), and g).

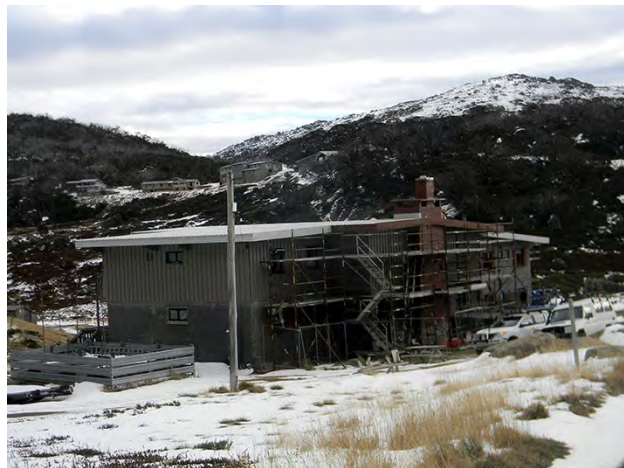
Swagman Chalet Formerly Jolly Swagman	1963 commercial lodge is in the European Alpine style, is still intact. Currently being restored. B–Retains integrity	2. Possible likelihood for meeting one or more criteria. Should be assessed as an individual item and within its precinct. Likely to meet heritage criteria a), c), and g).

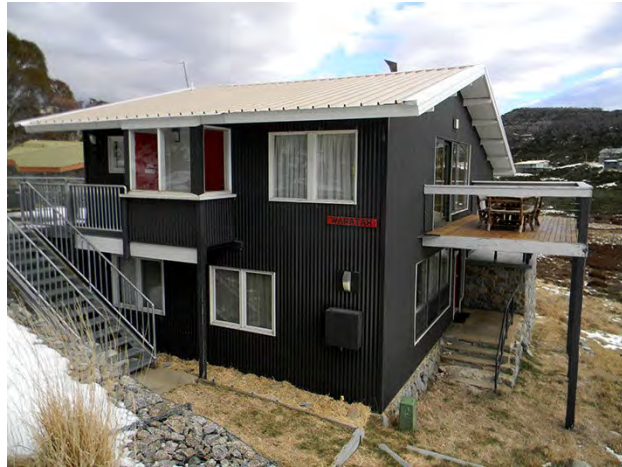
Place name and SEPP	Key dates, characteristics, and integrity	Meets heritage criteria	Photo
Waratah	<p>The original 1961 SPA architecture is evident in this club lodge.</p> <p>A—Intact</p> <p>B—Retains integrity</p>	<p>1. High likelihood for meeting two or more criteria for SEPP/NSW heritage criteria.</p> <p>Likely to meet heritage criteria a), c), and g).</p>

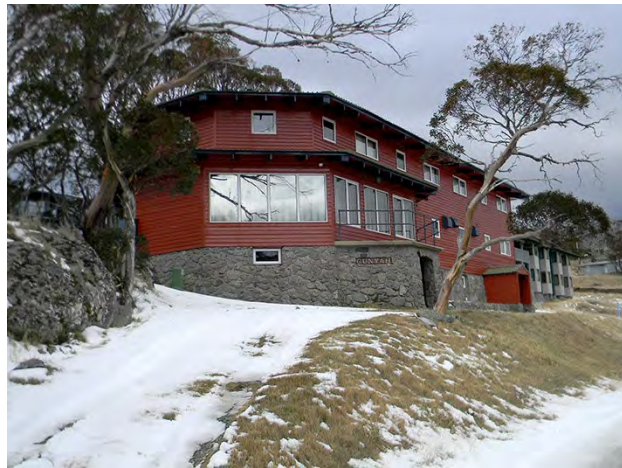
Gunyah	<p>The original 1962–63 vernacular architecture is evident in this club lodge.</p> <p>The lodge has been reclad.</p> <p>B—Retains integrity</p>	<p>2. Possible likelihood for meeting one or more criteria.</p> <p>Should be assessed as an individual item and its potential contribution to the Candle Heath Road Precinct.</p> <p>Likely to meet heritage criteria a), c), and g).</p>

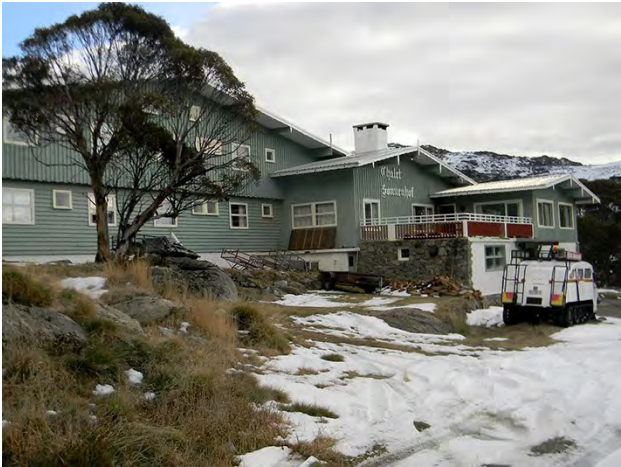
Place name and SEPP	Key dates, characteristics, and integrity	Meets heritage criteria	Photo
Sonnenhof	Chalet Sonnenhof – Commercial Lodge. 1960 European Alpine style – unchanged original roof form, retains historic, and original fabric. Historic paint scheme. A–Intact, high integrity	1. High likelihood for meeting two or more criteria for SEPP/NSW heritage criteria. Should be assessed as an individual item and within its precinct. Likely to meet heritage criteria a), c), and g).

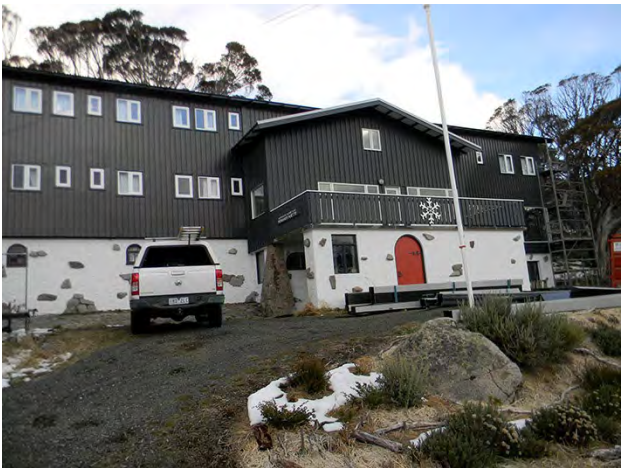
Perisher Huette	1960 European Alpine style – unchanged original roof form, retains historic, and original fabric. Reclad. B–Retains integrity	2. Possible likelihood for meeting one or more criteria. Should be assessed as an individual item and within its precinct. Likely to meet heritage criteria a), c), and g).

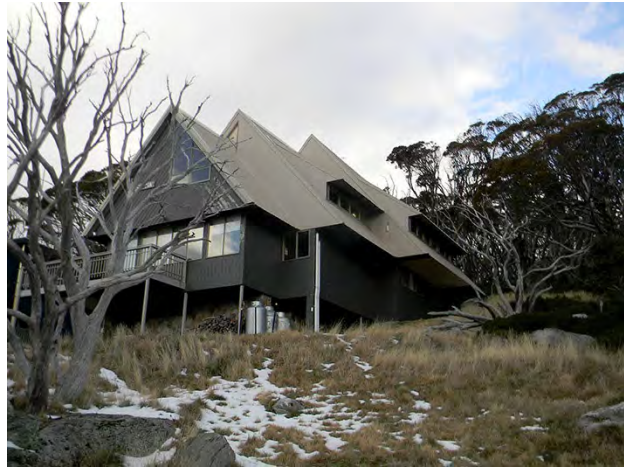
Place name and SEPP	Key dates, characteristics, and integrity	Meets heritage criteria	Photo
Oldina	1981 Alpine style architecture. Replacement of 1960's lodge. B—Retains integrity	2. Possible likelihood for meeting one or more criteria. Should be assessed as an individual item and within its precinct. Likely to meet heritage criteria a), c), and g).

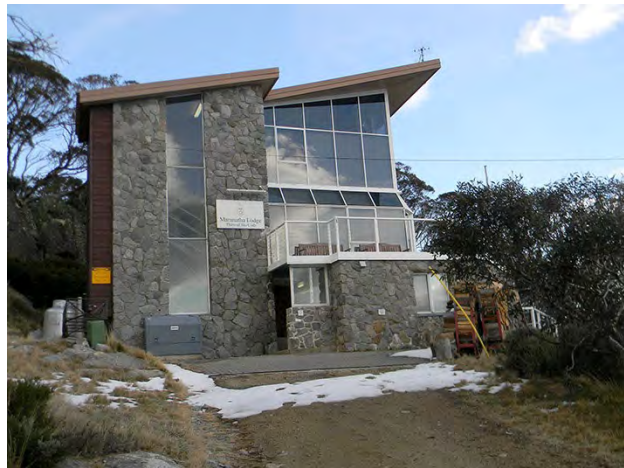
Maranatha	1962 innovative-style architecture. Alterations to glazing frames and other infills has altered the architectural design integrity. B—Retains integrity.	Retain on SEPP

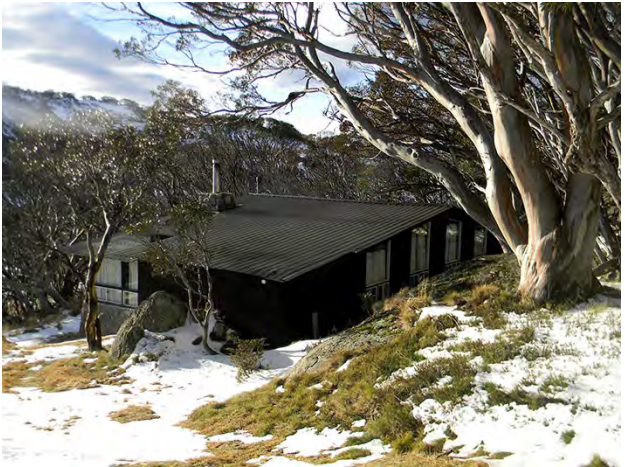
Place name and SEPP	Key dates, characteristics, and integrity	Meets heritage criteria	Photo
Munjarra	1962 SPA style architecture. Black/dark timber boarding and white-painted window frames. A–Intact, high integrity	Retain on SEPP Could meet state heritage level—should be formally assessed against criteria

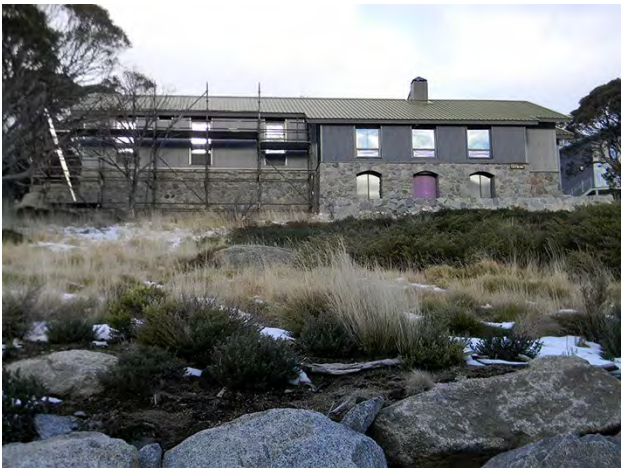
Geebung	1978 lodge. Replaces a 1962 lodge destroyed by fire. B–Retains integrity	2. Possible likelihood for meeting one or more criteria. Should be assessed against the heritage criteria. Likely to meet heritage criteria a), c), and g).

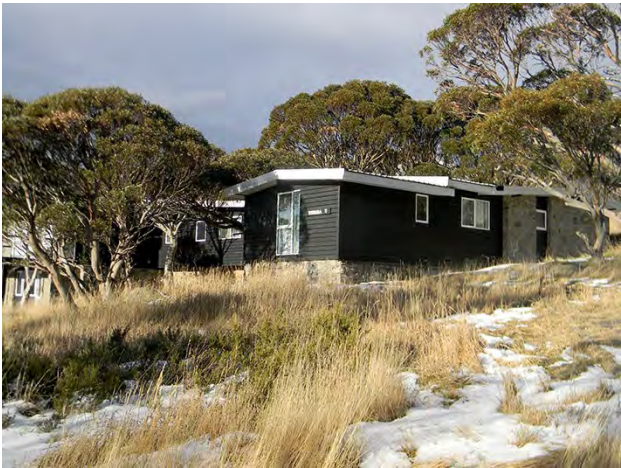
Place name and SEPP	Key dates, characteristics, and integrity	Meets heritage criteria	Photo
Wirruna	1960 SPA style lodge. Black/dark timber boarding and white-painted window frames. A—Intact, high integrity	1. High likelihood for meeting two or more criteria for SEPP/NSW heritage criteria. Should be assessed as an individual item and within its precinct. Likely to meet heritage criteria a), c), and g).

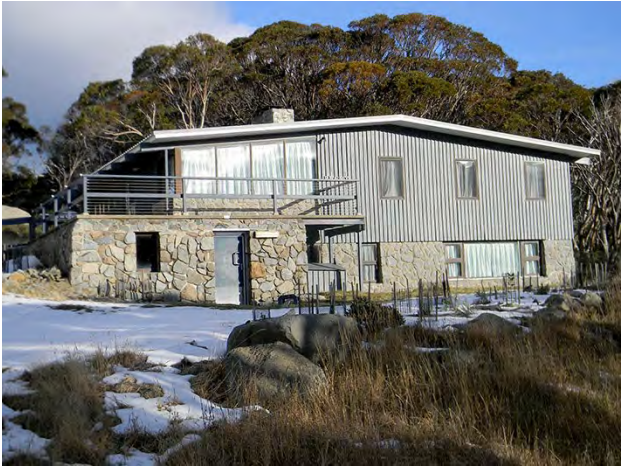
UAC	University lodge, 1952 vernacular architecture. Reclad. C—Diminished integrity	3. Unlikely to meet the NSW heritage criteria.	—
Rugby Union	1966 SPA style lodge B—Retains integrity	Retain on SEPP

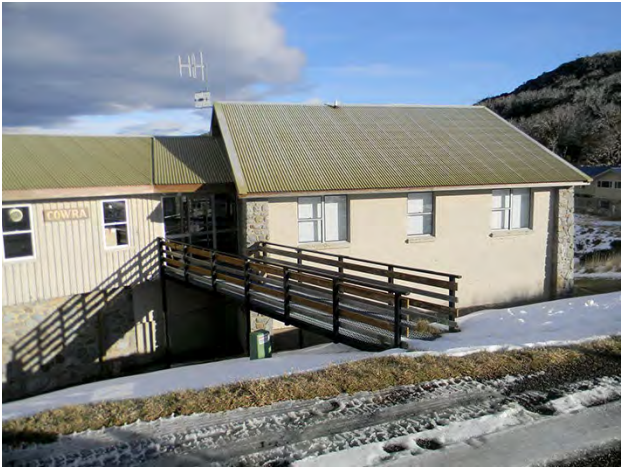
Place name and SEPP	Key dates, characteristics, and integrity	Meets heritage criteria	Photo
Cowra	1960's vernacular style architecture B–Retains integrity	2. Possible likelihood for meeting one or more criteria. Should be assessed against heritage criteria. Likely to meet heritage criteria a), c), and g).

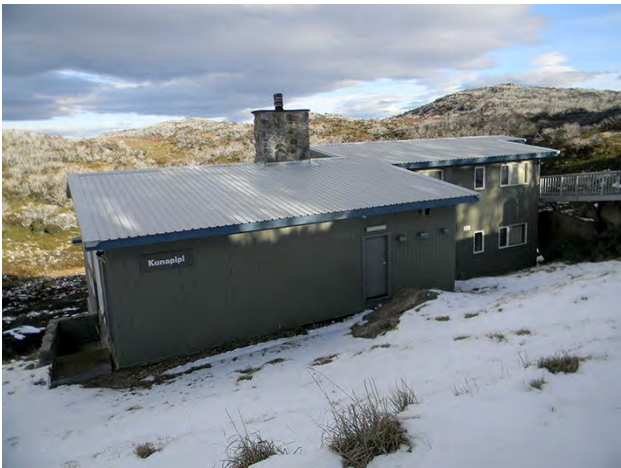
Kunapipi	1960's vernacular style architecture. B–Retains integrity	2. Possible likelihood for meeting one or more criteria. Should be assessed against heritage criteria. Likely to meet heritage criteria a), c), and g).

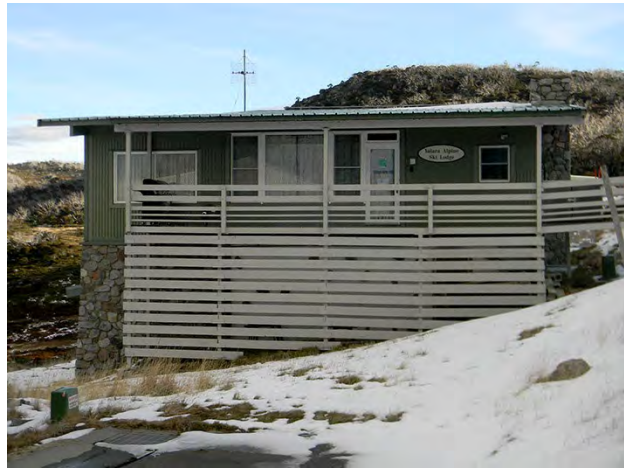
Place name and SEPP	Key dates, characteristics, and integrity	Meets heritage criteria	Photo
Yalara Alpine	1960's (1963) SPA style architecture. B–Retains integrity	2. Possible likelihood for meeting one or more criteria. Should be assessed against heritage criteria. Likely to meet heritage criteria a), c), and g).

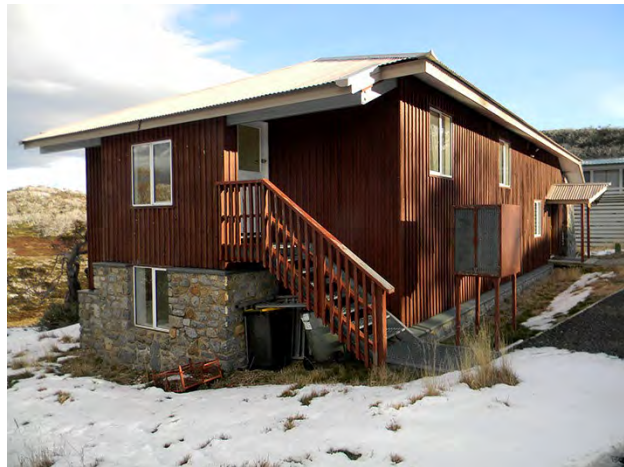
Highway Alpine	1963 vernacular style architecture B–Retains integrity	2. Possible likelihood for meeting one or more criteria. Should be assessed against heritage criteria. Likely to meet heritage criteria a), c), and g).

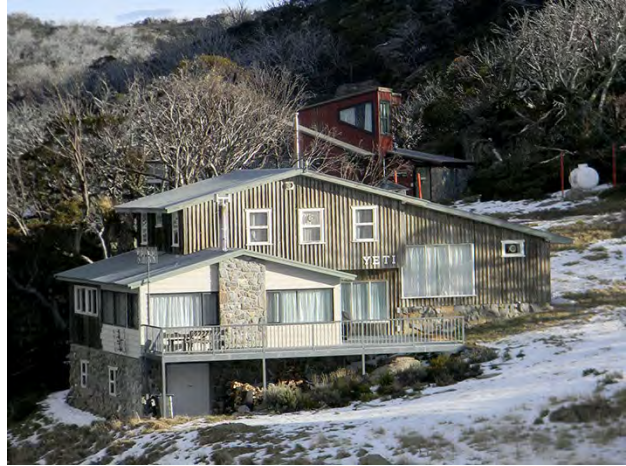
Place name and SEPP	Key dates, characteristics, and integrity	Meets heritage criteria	Photo
Yeti	1960's (1963) SPA style architecture. B–Retains integrity	2. Possible likelihood for meeting one or more criteria. Should be assessed against heritage criteria. Likely to meet heritage criteria a), c), and g).

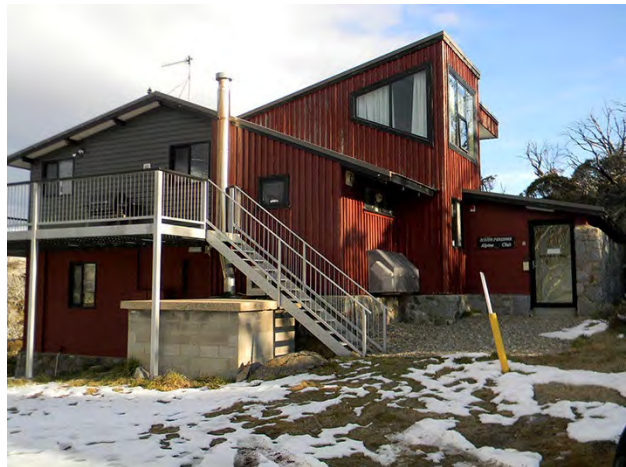
South Perisher Alpine	1974 vernacular style architecture. B–Retains integrity	2. Possible likelihood for meeting one or more criteria. Should be assessed against heritage criteria. Likely to meet heritage criteria a), c), and g).

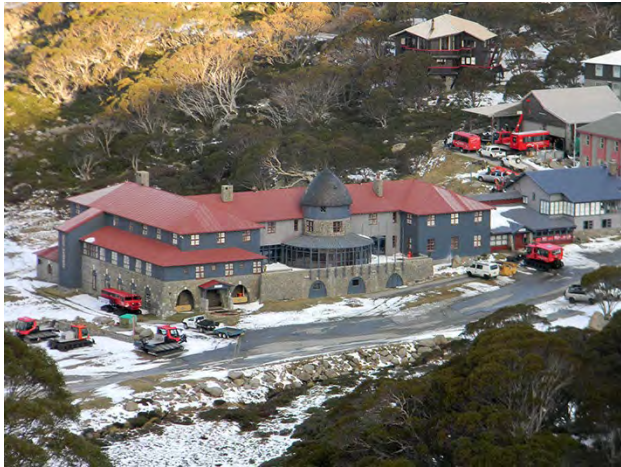
Place name and SEPP	Key dates, characteristics, and integrity	Meets heritage criteria	Photo
The Chalet	Commercial lodge Historically significant, landmark building with social and aesthetic values. A–Intact, high integrity	Retain on SEPP. Could meet state heritage level—should be formally assessed against criteria.

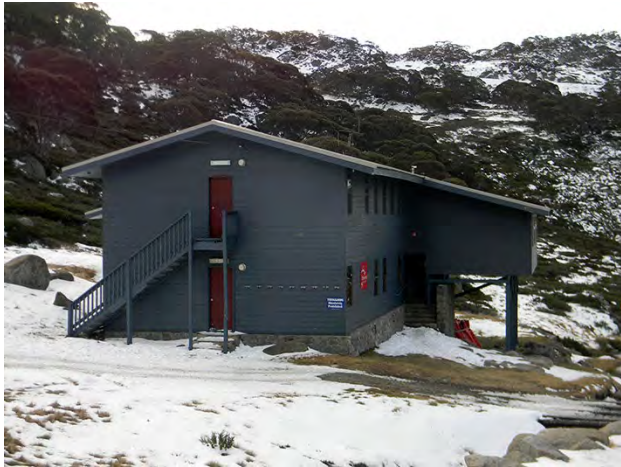
Cellblock (Staff)	Historically significant. B–Retains integrity	2. Possible likelihood for meeting one or more criteria. Should be assessed as an individual item and with the village setting. Likely to meet heritage criteria a), c), and g).

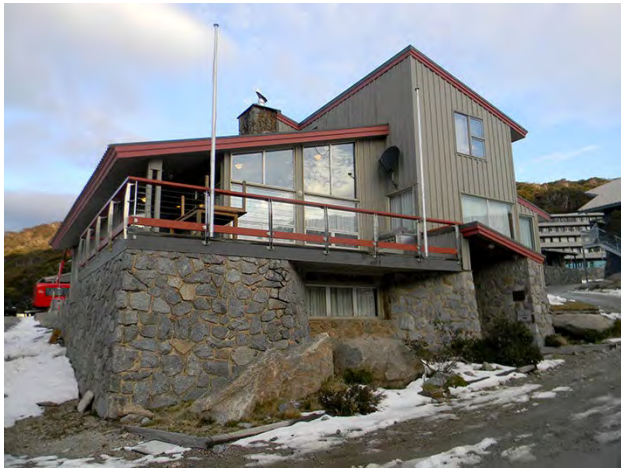
Place name and SEPP	Key dates, characteristics, and integrity	Meets heritage criteria	Photo
Kosciusko Alpine Club	Historically significant. B—Retains integrity	2. Possible likelihood for meeting one or more criteria. Should be assessed as an individual item and with the village setting. Likely to meet heritage criteria a), c), and g).

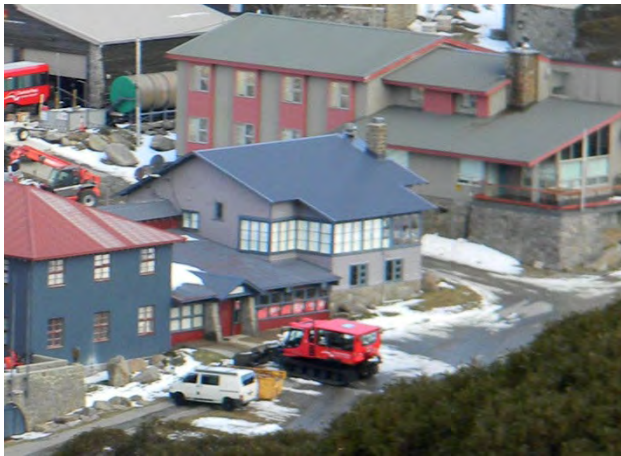
Kosciuszko Alpine Club (Managers)	Historically significant. B—Retains integrity	2. Possible likelihood for meeting one or more criteria. Should be assessed as an individual item and with the village setting. Likely to meet heritage criteria a), c), and g).

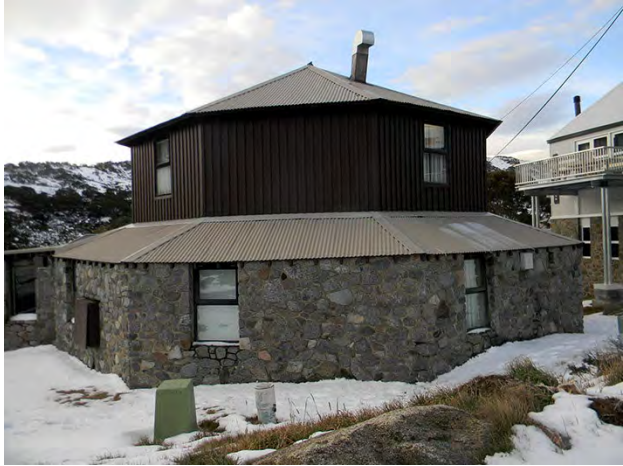
Place name and SEPP	Key dates, characteristics, and integrity	Meets heritage criteria	Photo
Knockshannoch	Historically important, architecturally interesting Location and circular shape are a landmark in the village B—Retains integrity, despite being rebuilt	2. Possible likelihood for meeting one or more criteria. Should be assessed as an individual item and with the village setting. Likely to meet heritage criteria a), c), and g).

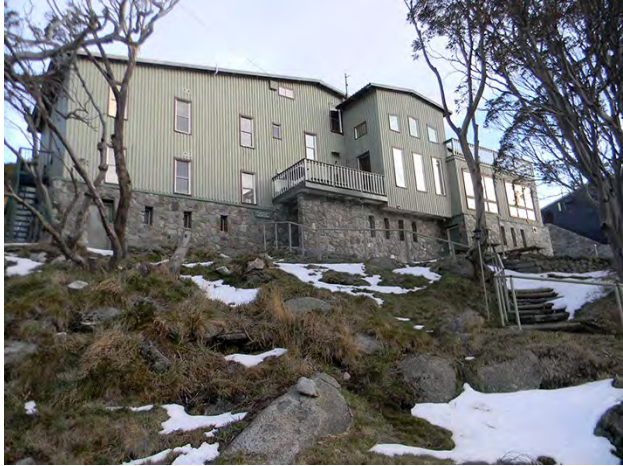
Place name and SEPP	Key dates, characteristics, and integrity	Meets heritage criteria	Photo
Southern Alps	Historically significant A—Intact, high integrity	1. High likelihood for meeting two or more criteria for SEPP/NSW heritage criteria. Should be assessed as an individual item and with the village setting. Likely to meet heritage criteria a), c), and g).

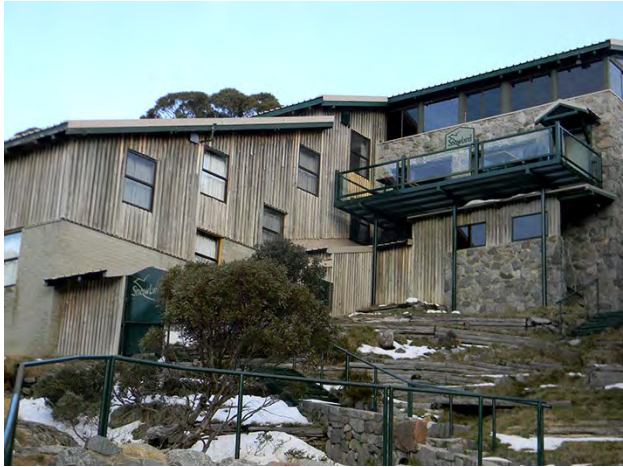
Snowbird	1979 commercial lodge. Similar architectural style to Yeti and Snow Revellers lodges at Perisher. B—Retains integrity	2. Possible likelihood for meeting one or more criteria. Should be assessed as an individual item and with the village setting. Likely to meet heritage criteria a), c), and g).

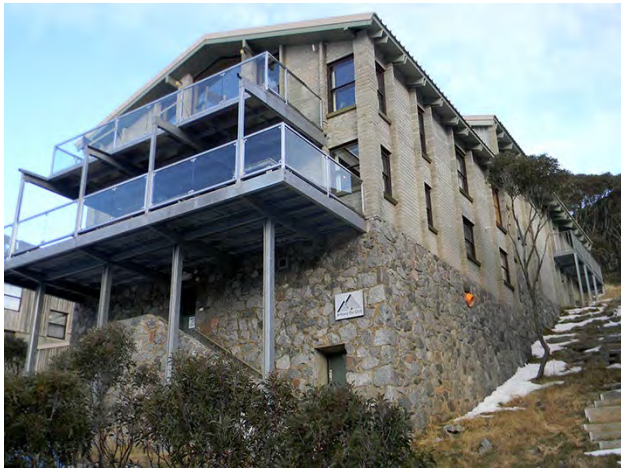
Place name and SEPP	Key dates, characteristics, and integrity	Meets heritage criteria	Photo
Alberg	Historically significant. B—Retains integrity	2. Possible likelihood for meeting one or more criteria. Should be assessed as an individual item and with the village setting. Likely to meet heritage criteria a), c), and g).

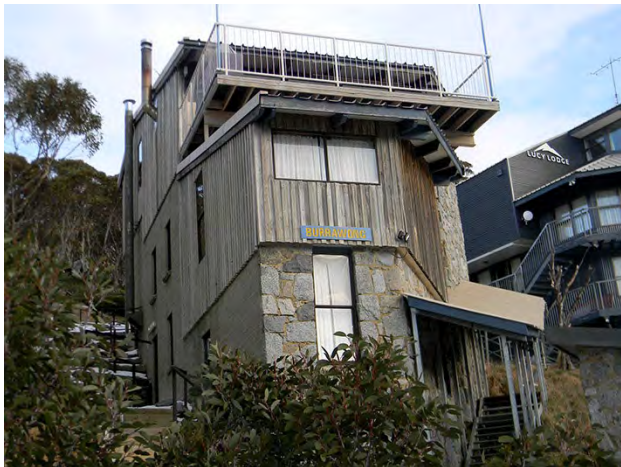
Burrawong	1979 lodge. B—Retains integrity	2. Possible likelihood for meeting one or more criteria. Should be assessed as an individual item and with the village setting. Likely to meet heritage criteria a), c), and g).

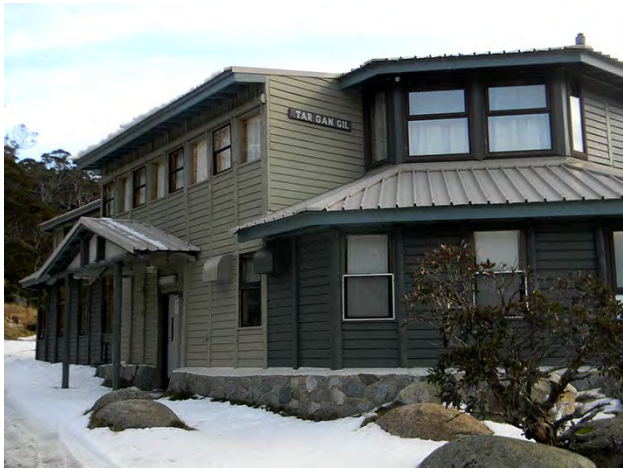
Place name and SEPP	Key dates, characteristics, and integrity	Meets heritage criteria	Photo
Olivetti Original name: Tar-gan-gil	Historically significant. B—Retains integrity	2. Possible likelihood for meeting one or more criteria. Should be assessed as an individual item and with the village setting. Likely to meet heritage criteria a), c), and g).

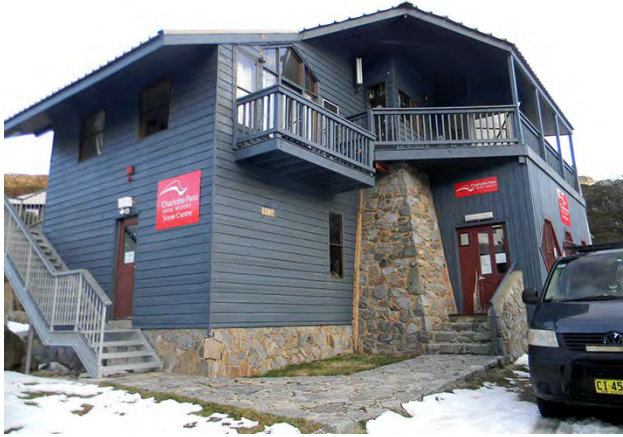
Administration	Historically significant. B—Retains integrity	2. Possible likelihood for meeting one or more criteria. Should be assessed as an individual item and with the village setting. Likely to meet heritage criteria a), c), and g).

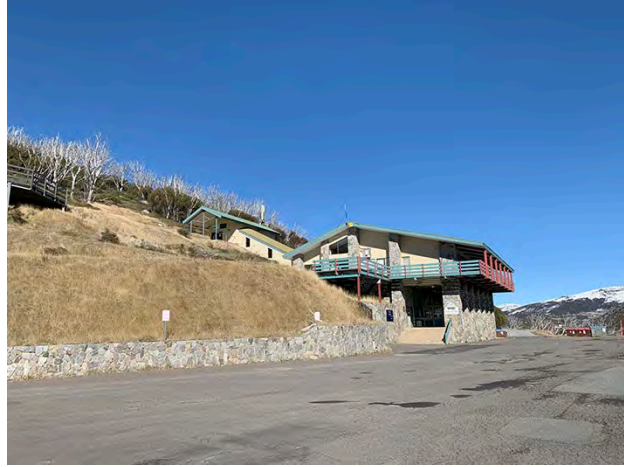
Place name and SEPP	Key dates, characteristics, and integrity	Meets heritage criteria	Photo
Ski Centre	1985 Ski Centre and associated 1989 workshop. B—Retains integrity	2. Possible likelihood for meeting one or more criteria. Should be formally assessed. Likely to meet heritage criteria a), c), and g).

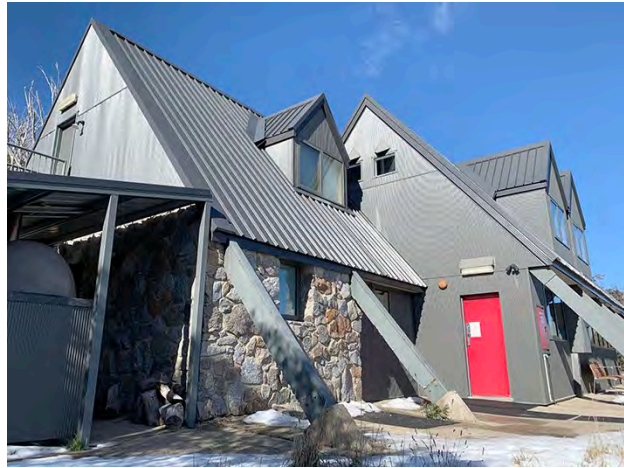
Kyilla Lodge	The 1960 original vernacular style, 'A-frame' building has been extended and adapted extensively, including recladding. The original lodge form can be partially seen externally. Architecturally good adaptation, although much of the original fabric has been lost. The original club name remains, some original architectural integrity, with sensitive extensions. B—Retains integrity	2. Possible likelihood for meeting one or more criteria. Should be formally assessed. Likely to meet heritage criteria a), c), and g).

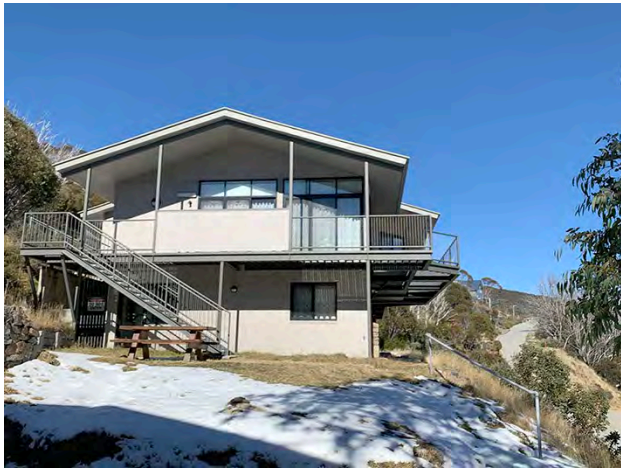
Place name and SEPP	Key dates, characteristics, and integrity	Meets heritage criteria	Photo
Tiobunga (YMCA) (Brindabella Ski Club)	The original 1955 building has been demolished and the site developed with a 'new' lodge (same name). Rebuilt. D—Lacks integrity	Suggest removing from SEPP.

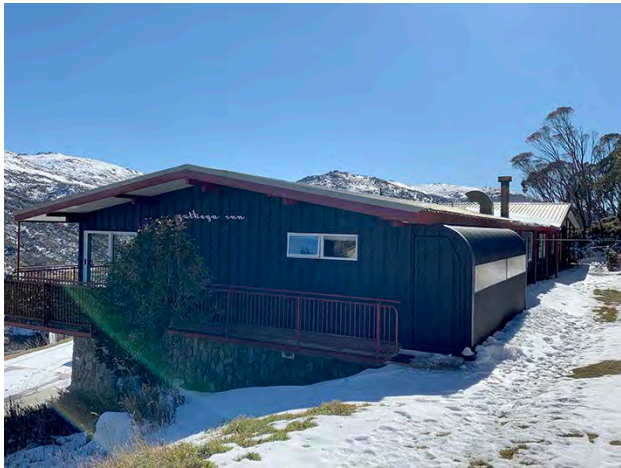
Place name and SEPP	Key dates, characteristics, and integrity	Meets heritage criteria	Photo
Guthega Alpine Hotel (Guthega Lodge) Renamed 'Guthega Inn'	The only intact Alpine style building remaining at Guthega (of the four original). Freeman 1998 says constructed 1971 (although it looks older). Historical, architectural, and social significance. A—Intact, high integrity	1. High likelihood for meeting two or more criteria for SEPP/NSW heritage criteria. Should be formally assessed. Likely to meet heritage criteria a), c), and g).

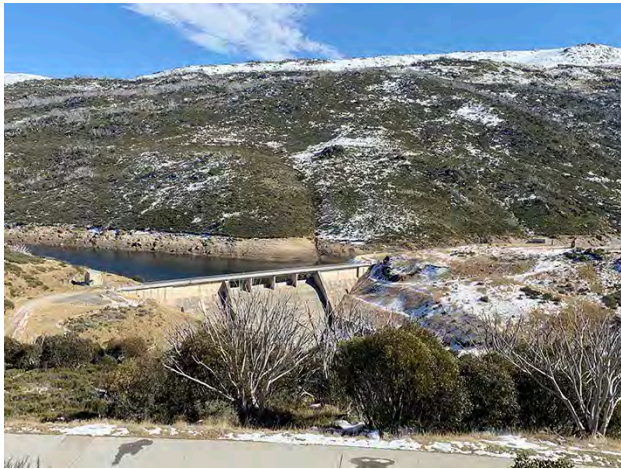
Place name and SEPP	Key dates, characteristics, and integrity	Meets heritage criteria	Photo
Guthega Dam	Historical and engineering feat. A—Intact, high integrity	1. High likelihood for meeting two or more criteria for SEPP/NSW heritage criteria. Likely state-level significance due to its association with the Snowy Mountains Scheme.
