# Riverstone East Precinct (Stage 3) Package C

Non-Indigenous Heritage Assessment

Department of Planning and Environment

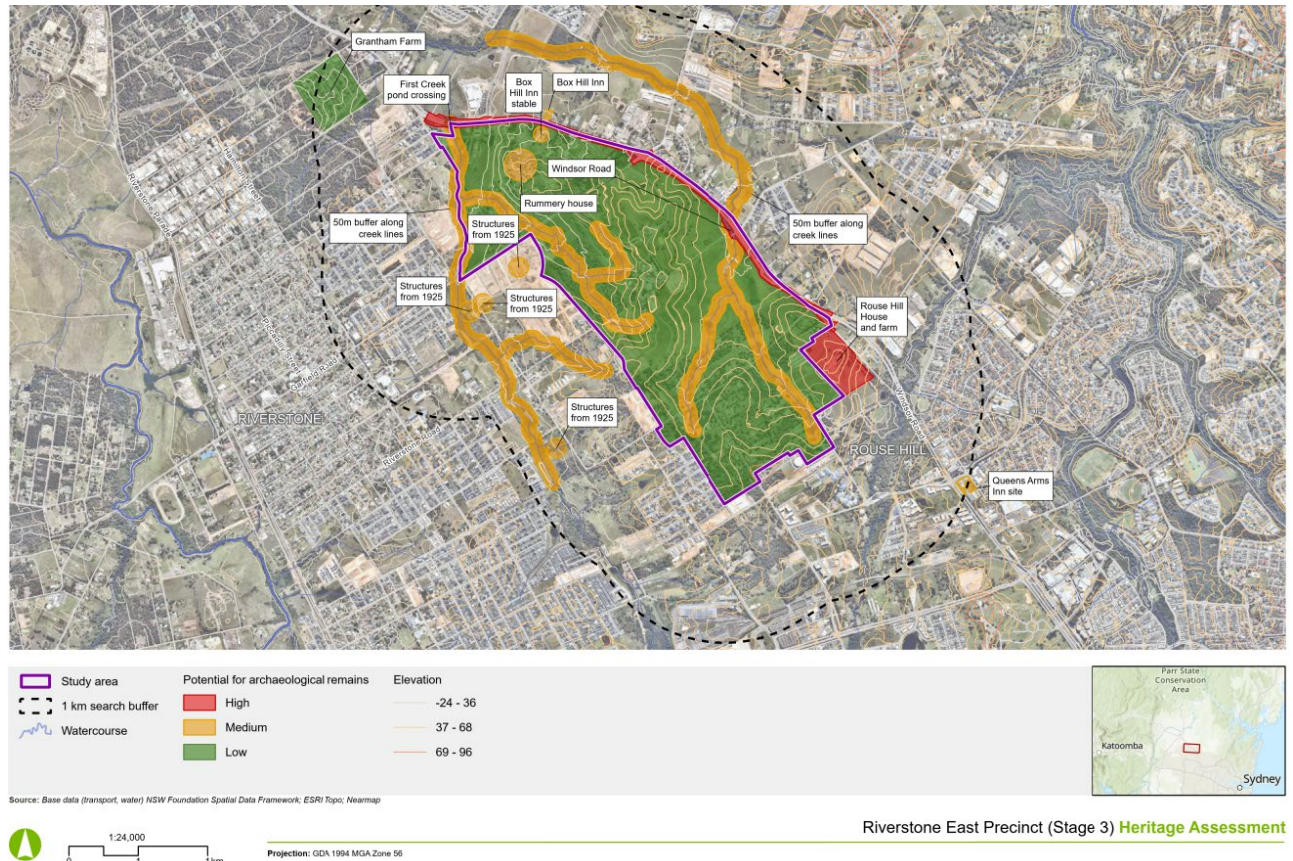
- An assessment of archaeological potential within the Precinct found a number of sites of which are considered to have a medium to high level of archaeological significance (Figure 2). The former Rummery House, Box Hill Inn Stable and Windsor Road corridor was found to have medium archaeological potential due to its historical associations and relatively low disturbance, located towards the north-east of

the Precinct. Furthermore, moderate archaeological potential is associated with creek lines which traverse the site.

Figure 2 – Riverstone East Stage 3 – Archaeological Potential Map (Aurecon, July 2023)

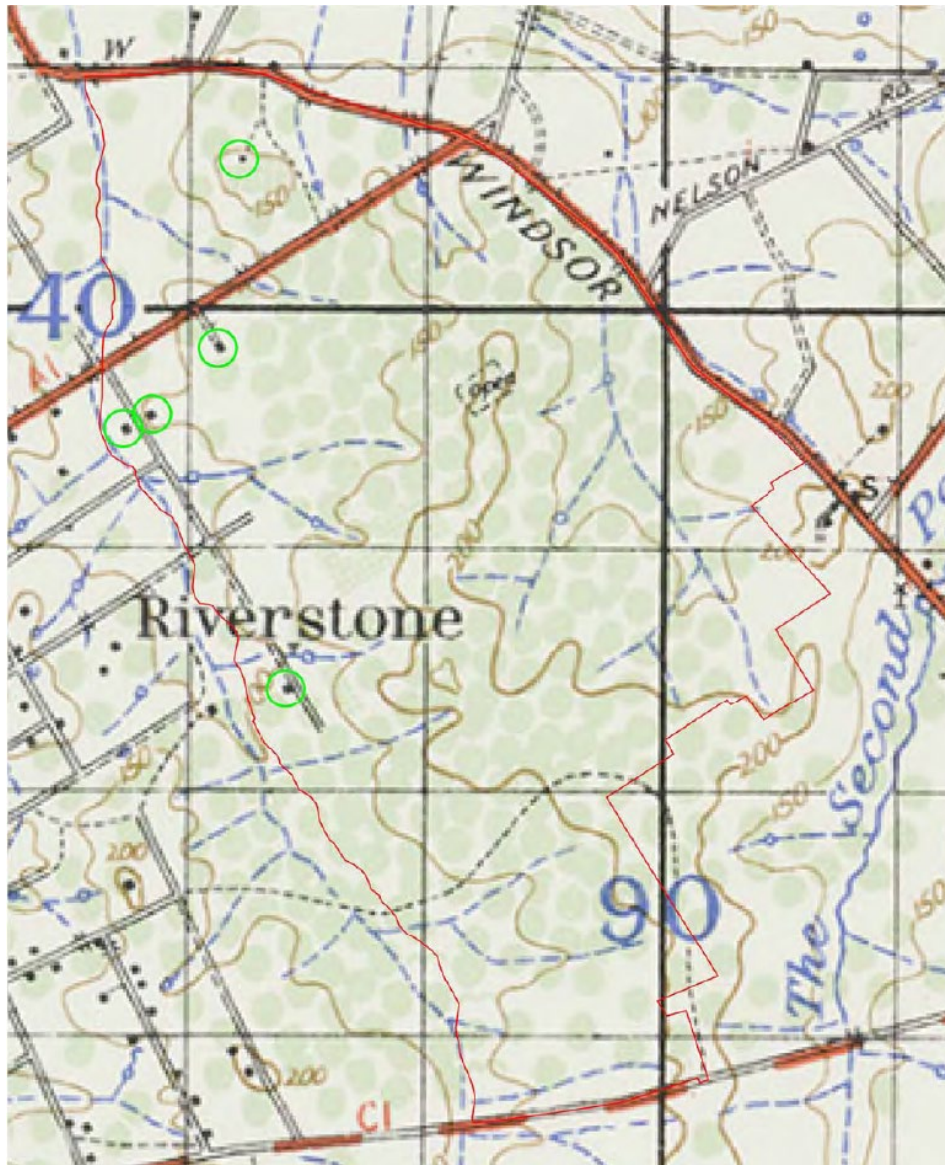
Figure 3-7 The northernmost green circle, highlighting a structure north of Garfield Road East, could be associated with the lost Rummary Family House. 1925 Australian Section Imperial General Staff plan with the approximate boundaries of the Riverstone East Precinct marked in red, and the structures within the Precinct circled in green. (AHMP 2015: p.65; Figure 24).

Whilst there is no record as to whether there was a house or building near the location marked as a potential building site (Figure 3-7), there may have been some structure there, if not a house, possibly something connected to the operation of the orchard or horses or cattle. Figure 3-8 anecdotally records a stable at this location.

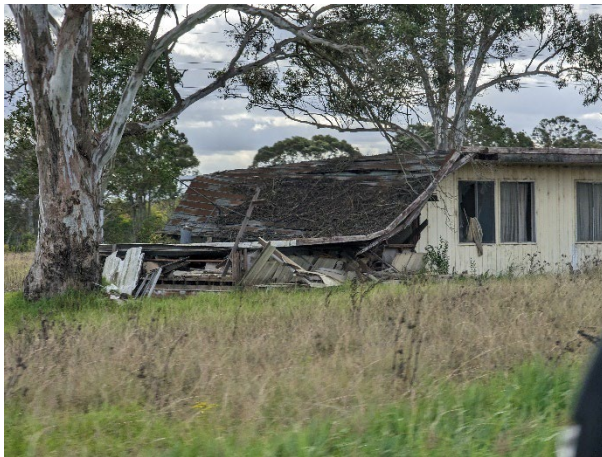
Figure 5-1 Derelict building, Junction Road

The west side of Junction Road contains abandoned and derelict dwellings (Figure 5-1) and empty paddocks at the intersection with Garfield Road East. There is a distinct boundary between the construction within Riverstone East Precinct Stage 2 and the Riverstone East Stage 3 (Figure 5-2, Figure 5-3, and Figure 5-4), yet to be developed and the concern of this heritage assessment. An aboveground power easement was noted running northwest across Junction Road. The farm fences were a mixture of wooden post and wire (Figure 5-3, Figure 5-4, Figure 5-5, Figure 5-6, and Figure 5-7).

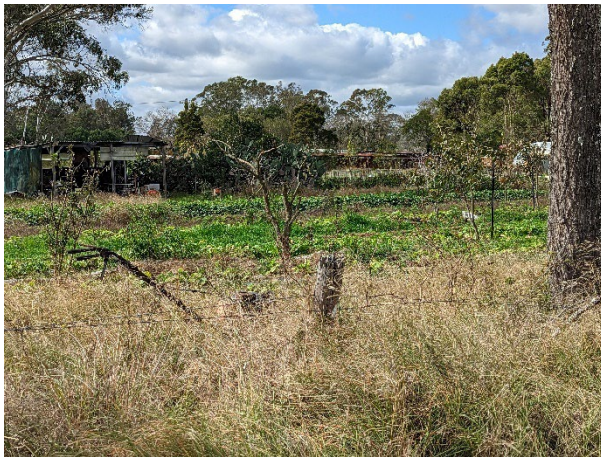
**Figure 5-7 Market Garden, east side of Junction Road**

Following a planting of eucalypts (Figure 5-6), several newer homes (c1980-1990s) were situated at the northern most extent of Junction Road. On the east side of the road, an in-use market garden was observed (273 Garfield Road East) with a dwelling and several sheds (Figure 5-7 and Figure 5-8), one of which was constructed of corrugated iron. Several shipping containers were stored in the southern extent of this property, abutting Garfield Road East.

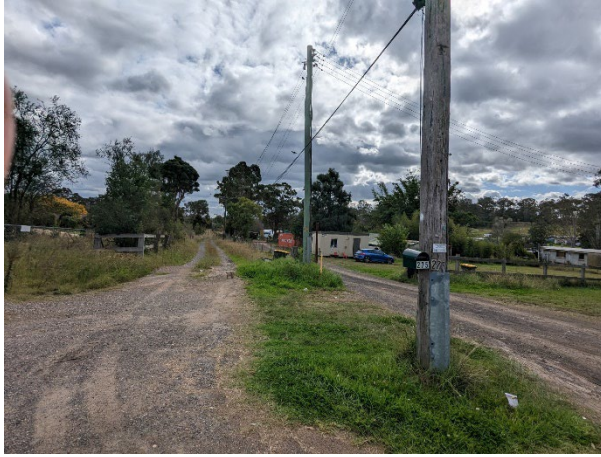
**Figure 5-9 Driveway, 275 Garfield Road East (Aurecon)**

Culverts and cuttings into the bedrock of the hill at the eastern end of Garfield Road East before it meets Windsor Road. Along the northern side of the road are residential properties set atop of the high point (Figure 5-9). At the highest point along the road is the Tyburn Priory, a brick veneer monastery constructed in 1986 (Figure 5-10).

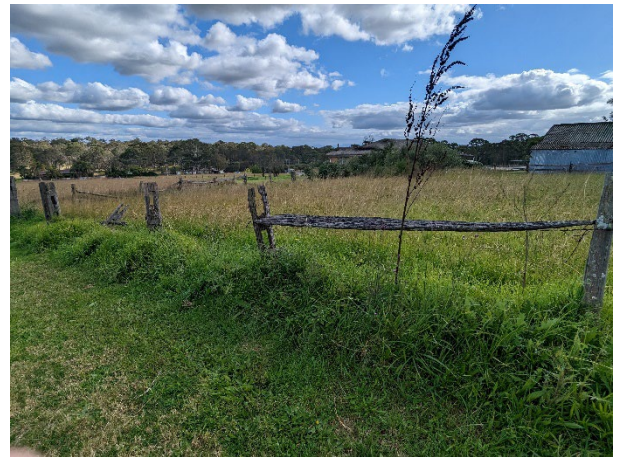
Figure 5-15 Rouse Hill Regional Park stockyard

Rouse Hill Regional Park is a mix of grasslands and remnant and planted stands of forest and community infrastructure such as playgrounds and picnic areas (Figure 5-12, Figure 5-13, Figure 5-14, Figure 5-15, Figure 5-16, and Figure 5-17). The grasslands are located on the slope of the hill upon which Rouse Hill House is located. A stockyard (Figure 5-15) associated with the Rouse Hill Estate was observed and was located outside the bounds of the existing curtilage of the SHR listing for Rouse Hill House and the Museums of History NSW property. The Rouse Hill School House, On the Windsor Road side of the Museums of History NSW property is also outside the curtilage of the SHR listing. Existing interpretative signage was noted in the regional park (Section 8).

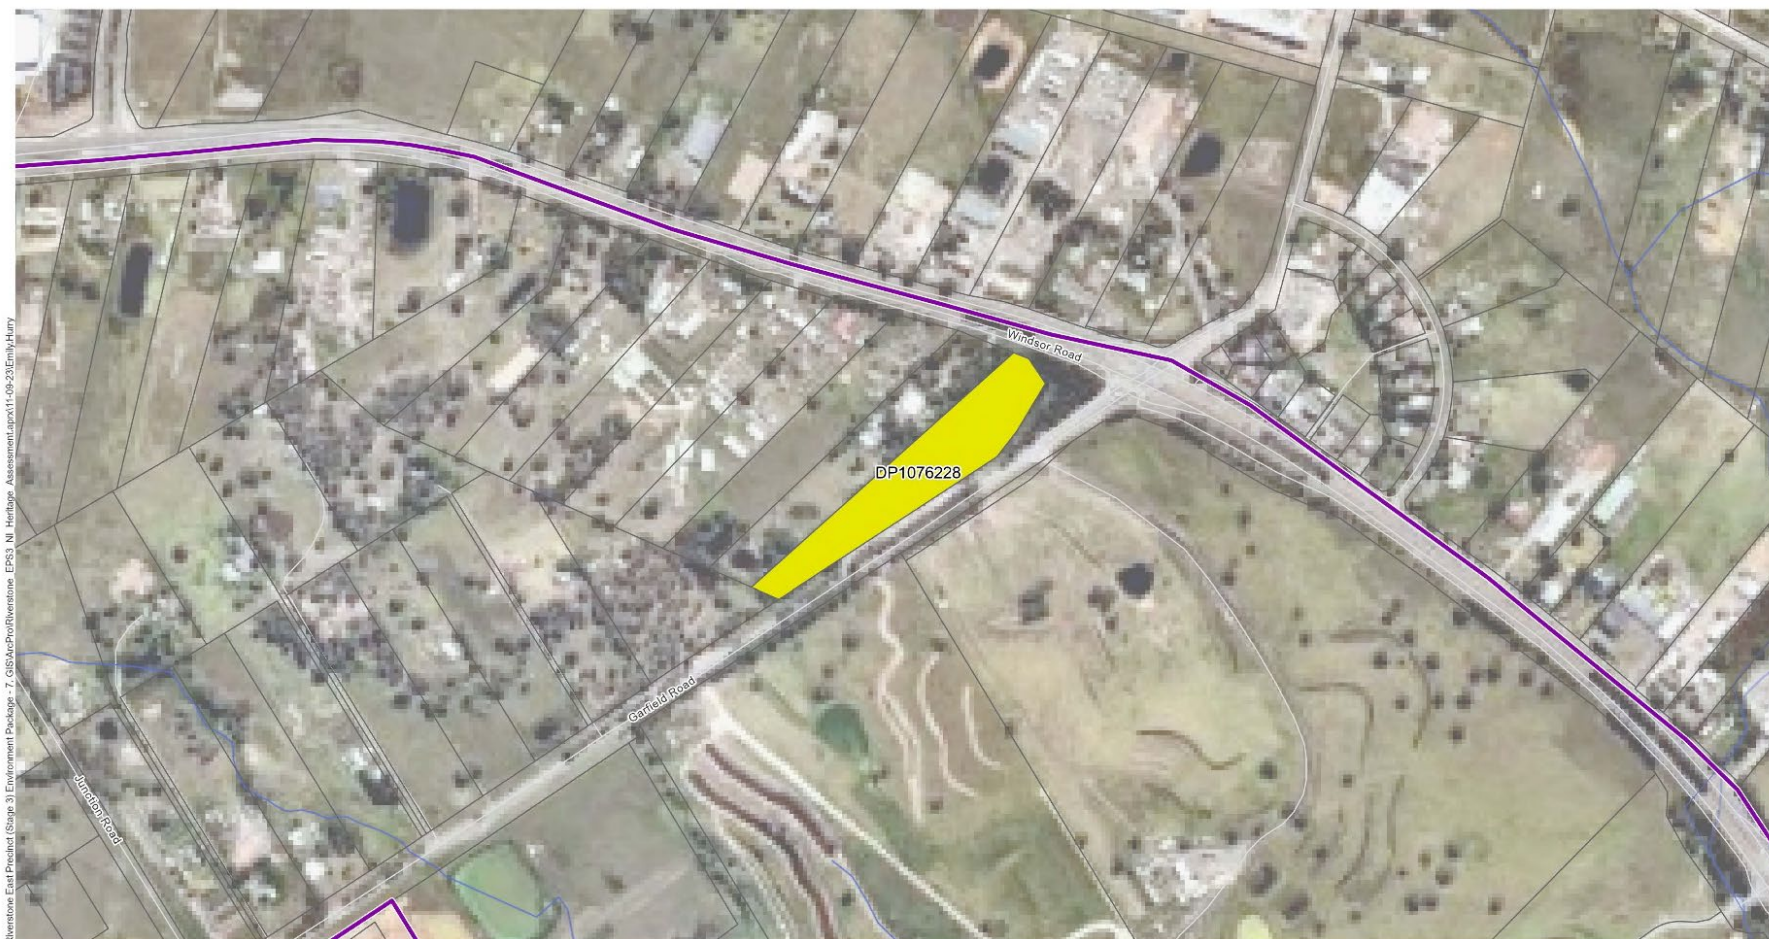
**Figure 6-1** Management Recommendations for non-Indigenous heritage and potential archaeological sites

The following mitigation and management pathways are recommended to protect the local heritage and archaeology of the Precinct (Figure 6-1).

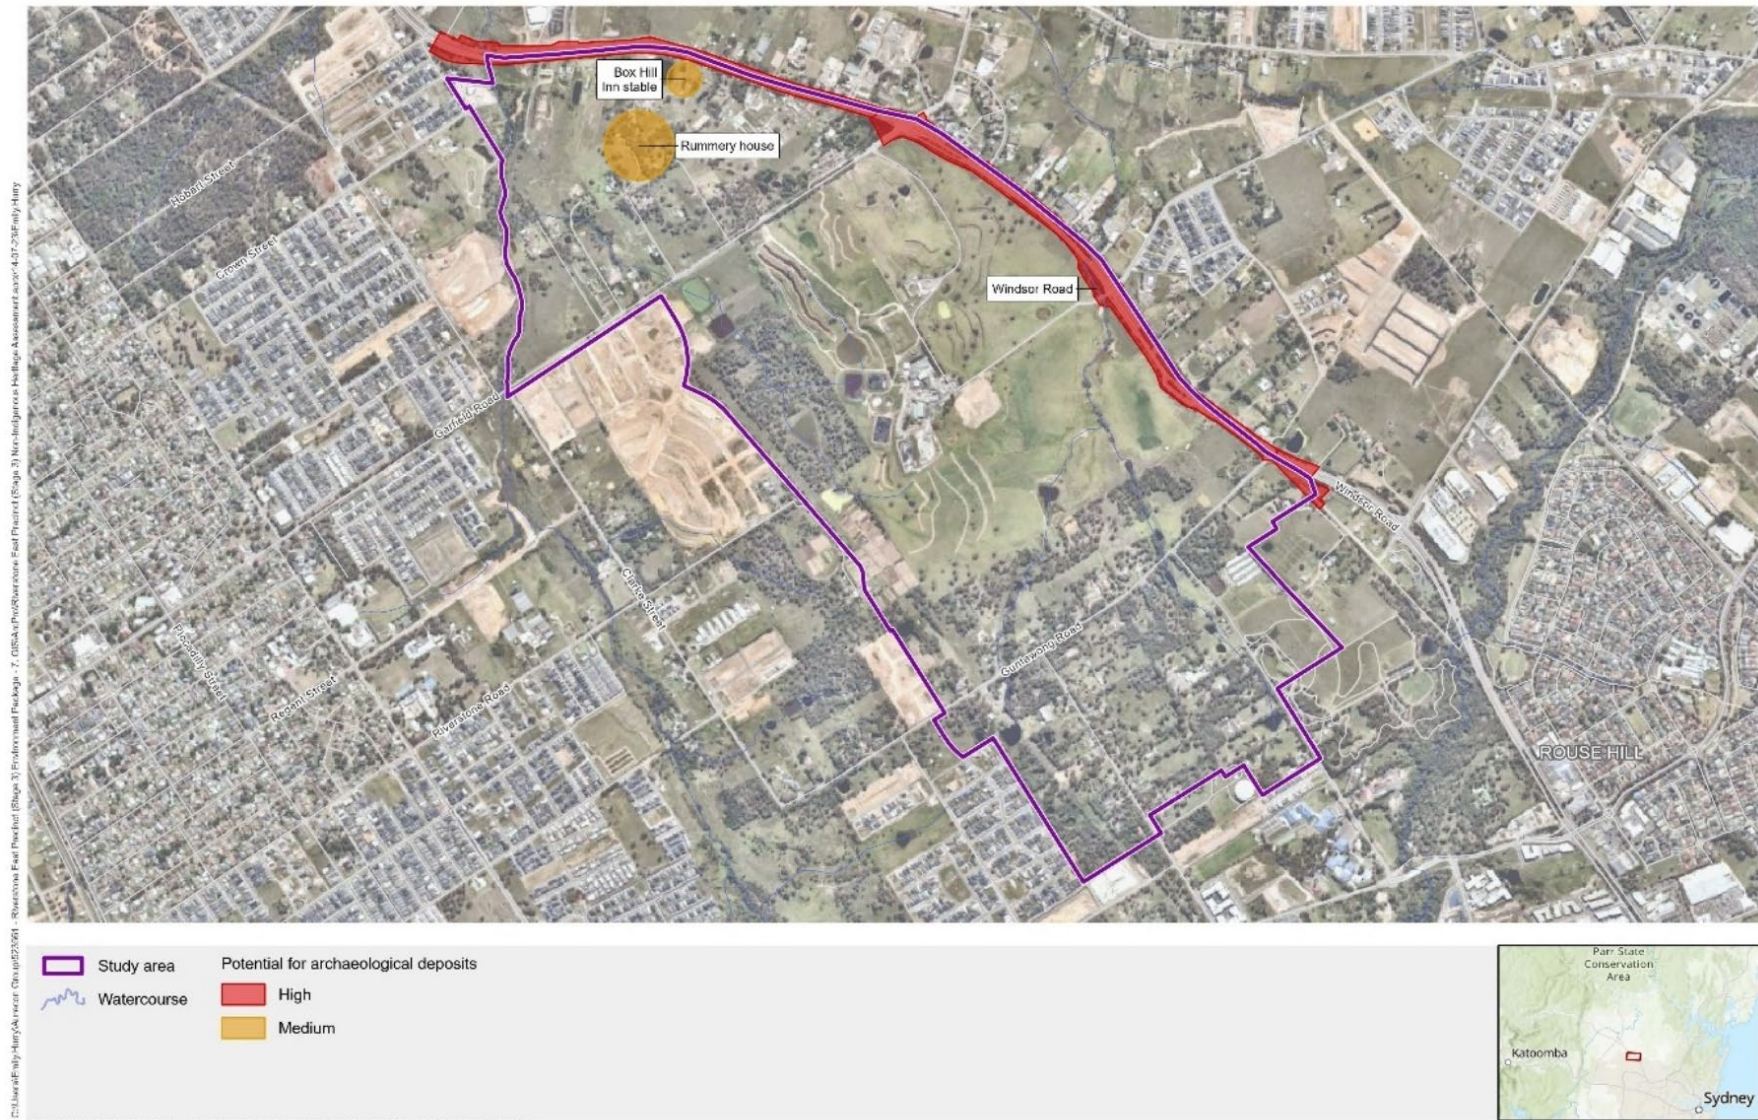
**Figure 6-4** Visual lines from Rouse Hill House in Study Area in association with the topography

- In order to preserve the distant views to the Blue Mountains (north-west) from Rouse Hill House no two-storey houses (no taller than 3.5 m) should be constructed on the highest centre point within the Precinct (Figure 6-4):

- In order to preserve the distant views to the Blue Mountains (north-west) from Rouse Hill House no two-storey houses (no taller than 5.5 m) should be constructed on the highest northern point of the Precinct (Figure 6-4):

- In order to preserve the middle-distance views from Rouse Hill House into the Rouse Hill Regional Park and into Stages 1 and 2 areas (Figure 6-4) no buildings taller than 3.5m should be constructed in the following locations:

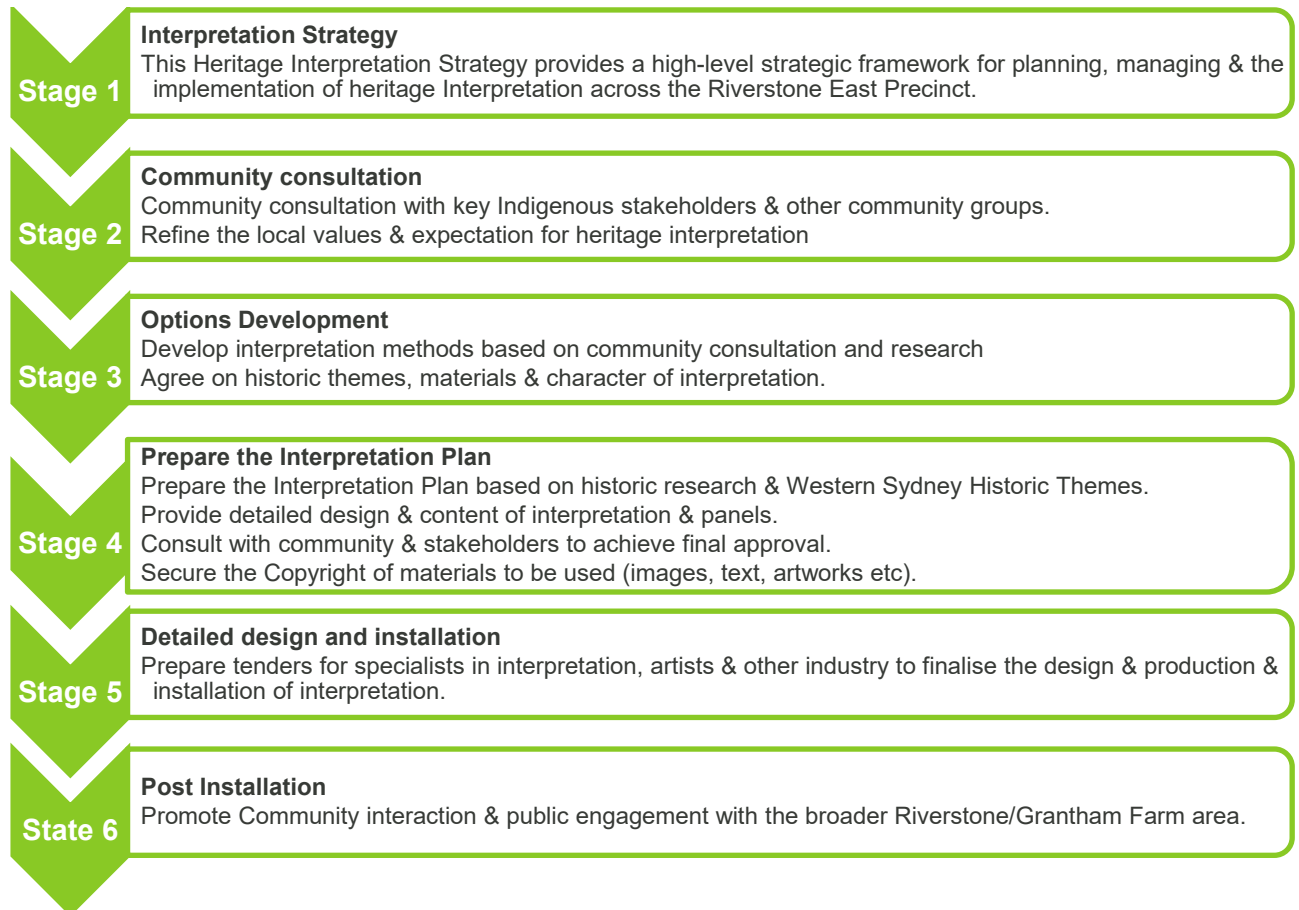
Figure 8-2 Implementation Processes for the Interpretation options

The following procedure (Figure 8-2) is recommended to be applied for the development and subsequent implementation of heritage interpretation throughout the Precinct and the broader Riverstone East Precinct. Implementation may be shared across numerous people and organisations but chiefly should be overseen by a single body (either the Department or BCC) so that interpretation is developed in a coordinated and holistic manner.
