Arboricultural Impact Assessment (AIA) report for Mono Constructions regarding 56 Beane St, Gosford, NSW

By David Shrimpton
Koala Arbor Consulting Arborists
e:david@koalaarbor.com

26/02/2020

PRELIMINARY ARBORICULTURAL REPORT

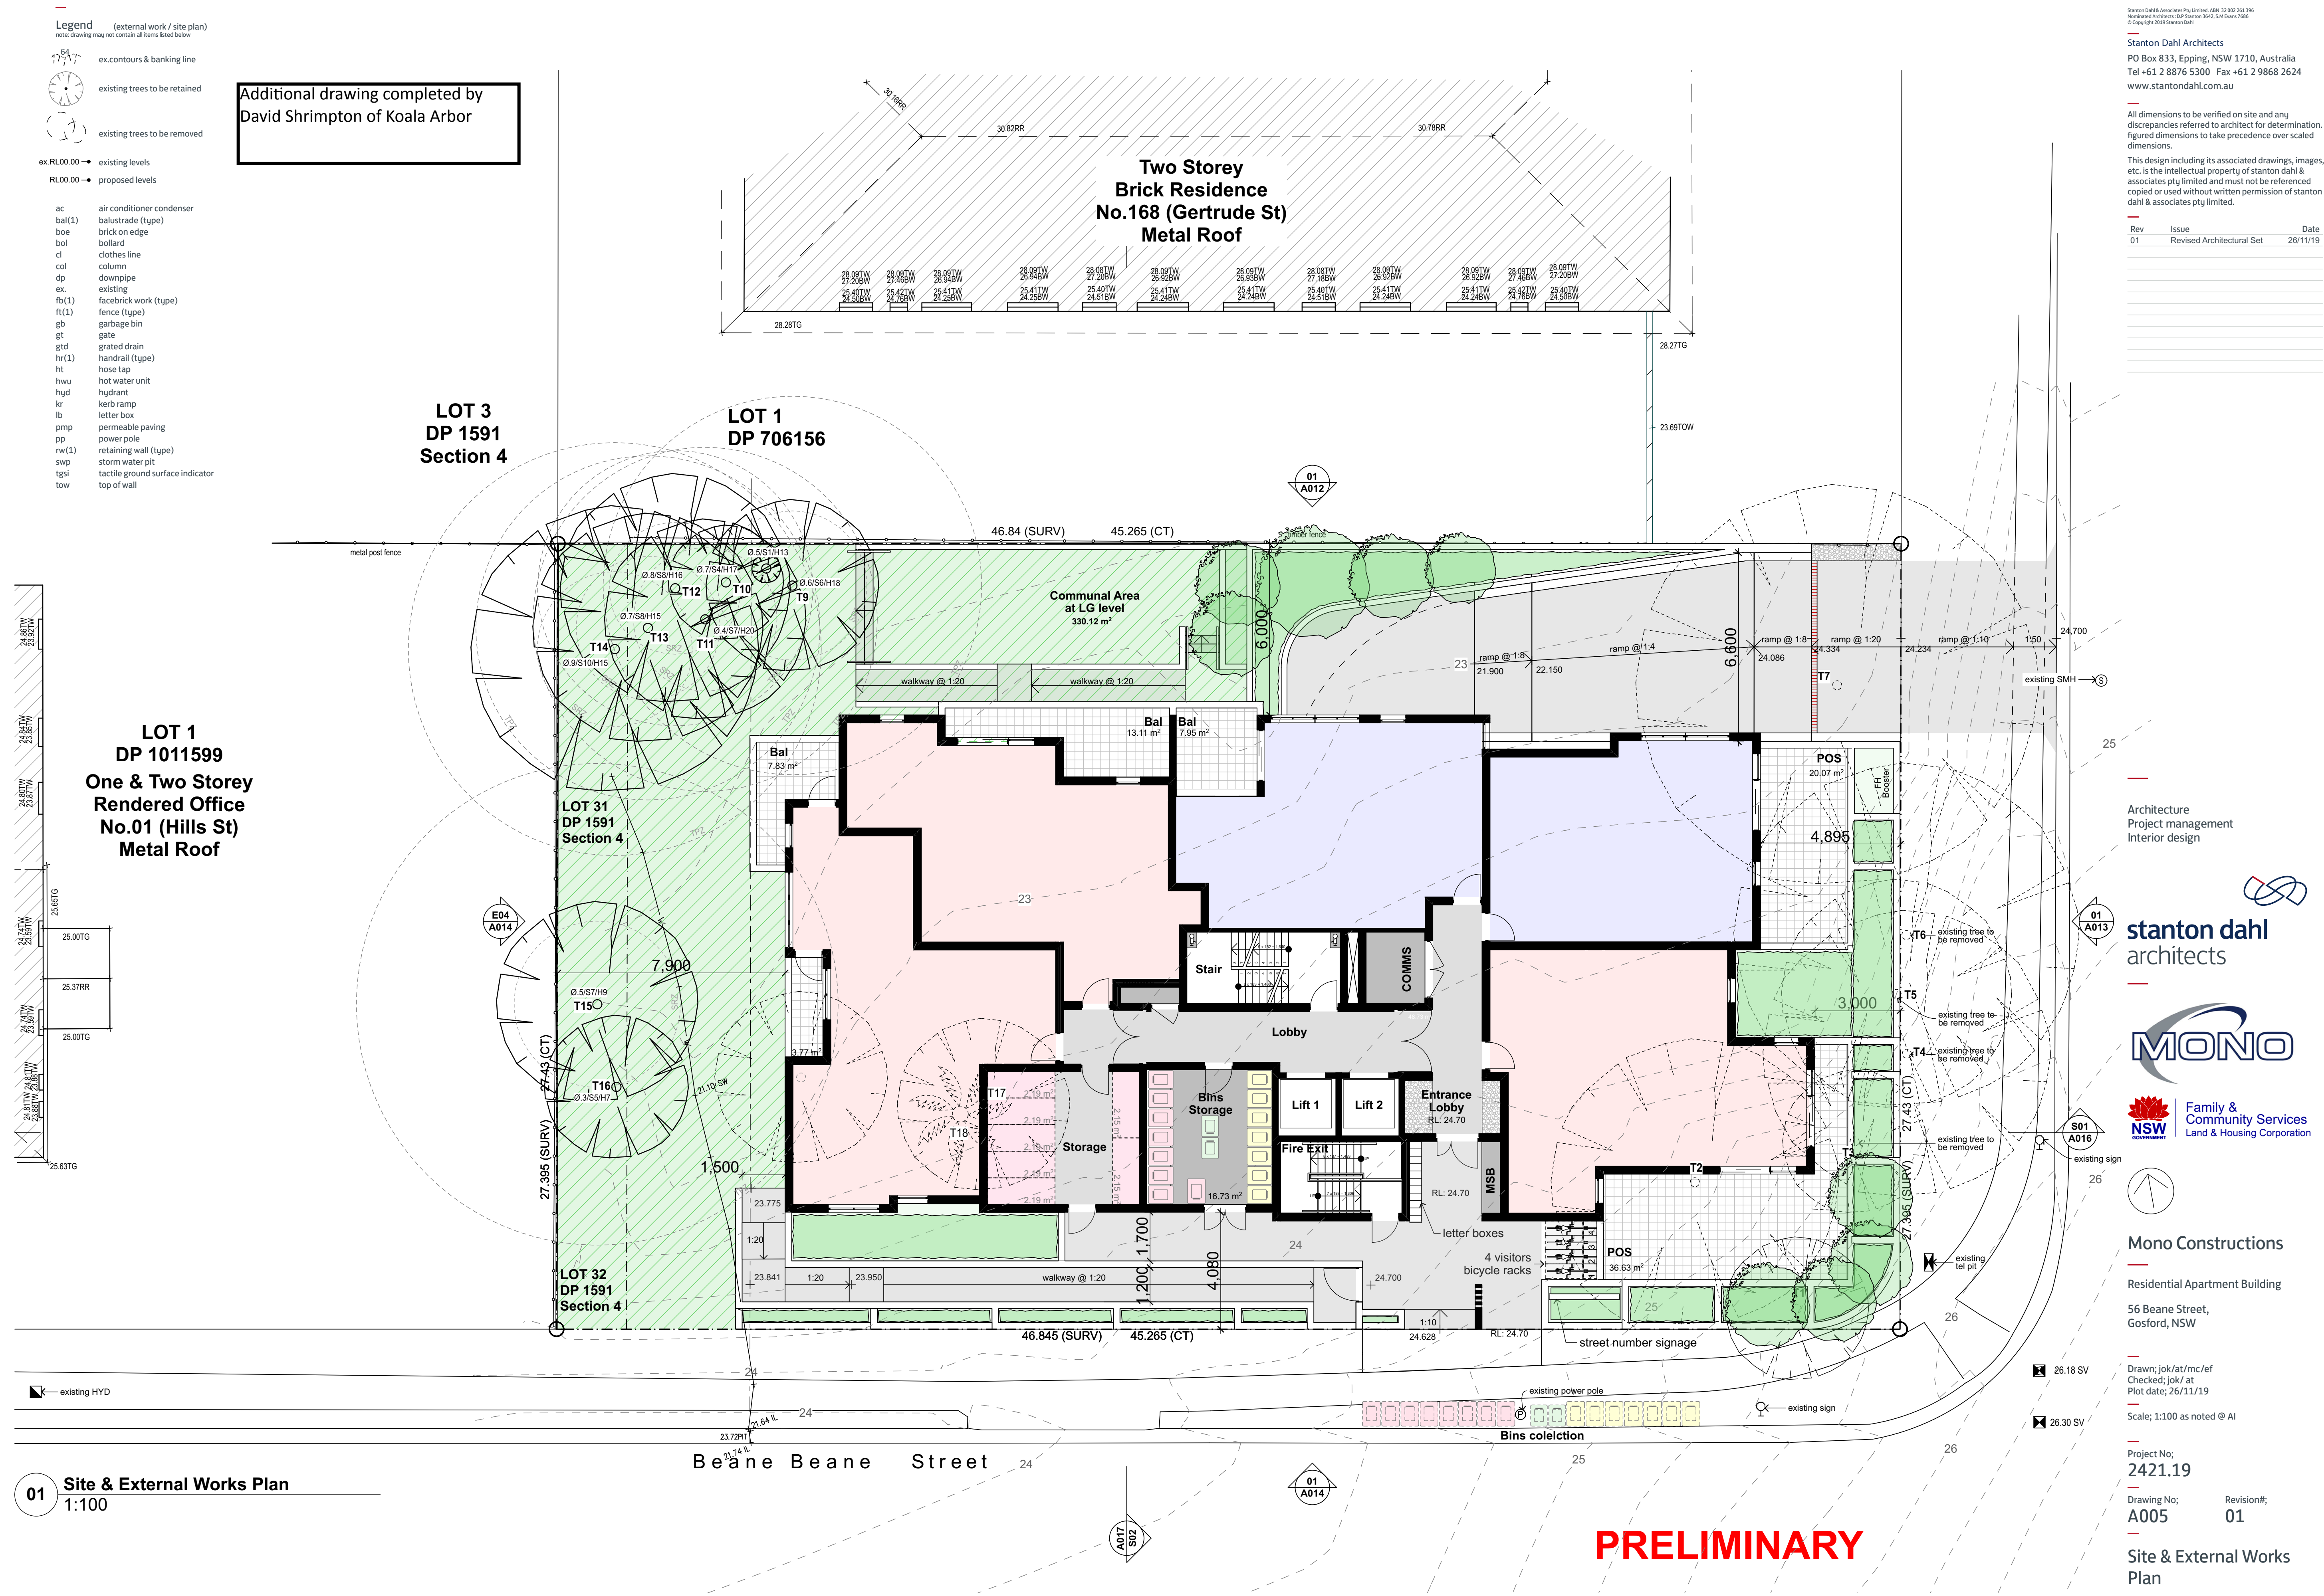
6. Tree Location Map

Nineteen trees were located and inspected by TreeIQ on the 28th January 2019 which could be potentially affected by the development at the above address.

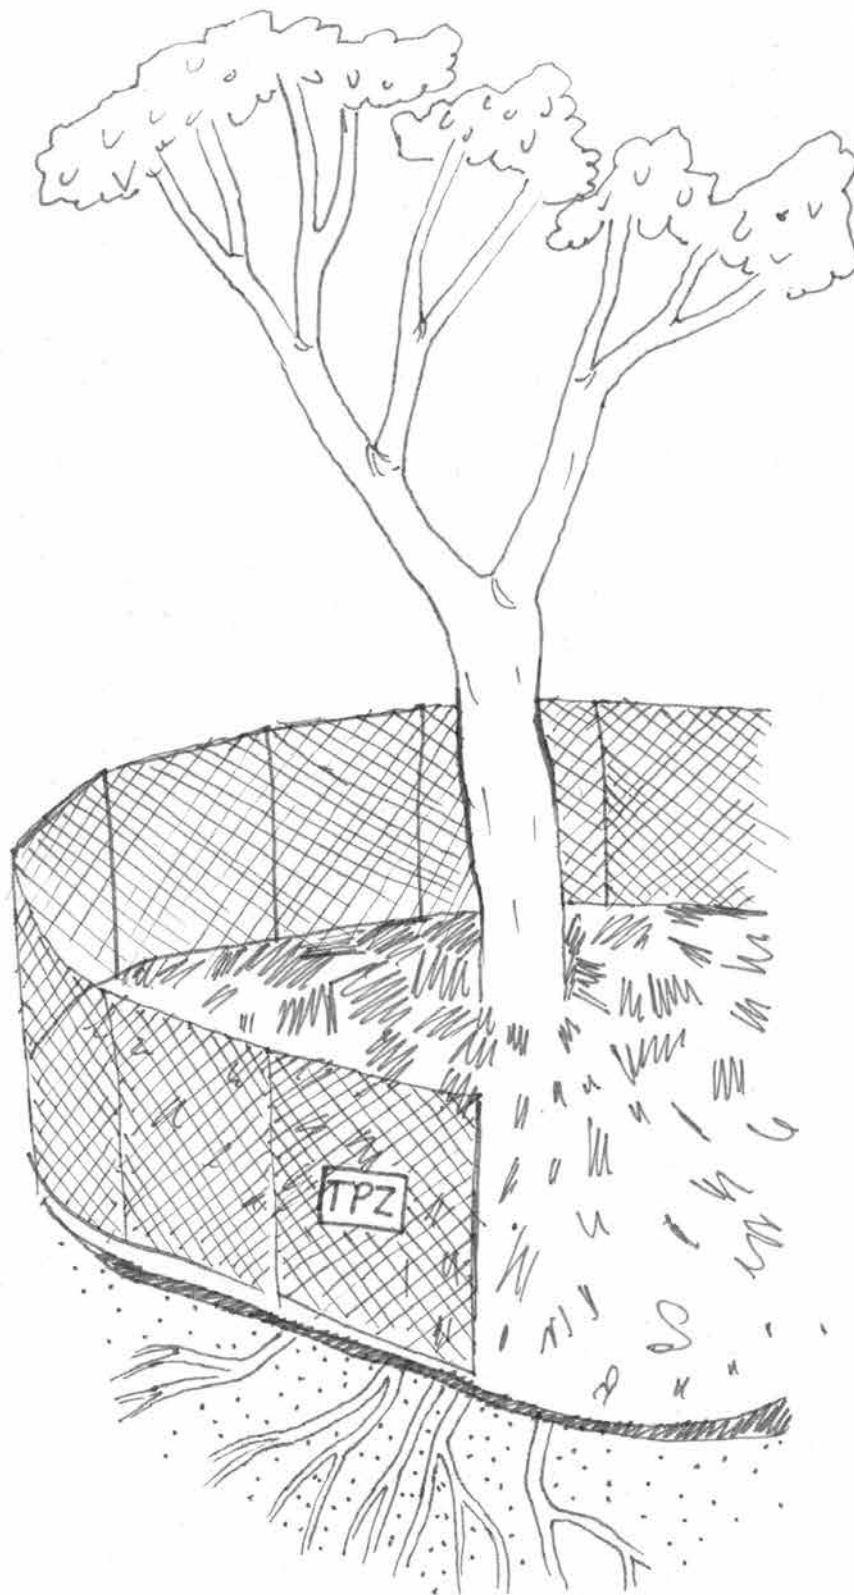
Fig 1.1 Examples of sufficient TPZ fencing.

2. A protective fence should be installed as indicated on the Tree Removal, Retention and Protection Map found on Page 14. The fence should be a 1.8m high chain-link fence with concrete feet (see Fig 1.1). The fence must be locked at all times and access is only to be granted with approval from the Project Arborist. The fence must be maintained for the entirety of the project. Appropriate signs must be displayed on the fence with the words TPZ clearly shown (see Fig 1.2).

TPZ fence to
be 1.8 meters
high chain
link fence
with concrete
feet
