GEOTECHNICAL ASSESSMENT

FOR **PROPOSED SCREEN FENCING**

BULLOCKS FLAT SEWERAGE TREATMENT PLANT, PERISHER VALLEY, NSW

10 November 2014 Ref: 27811RH7rpt

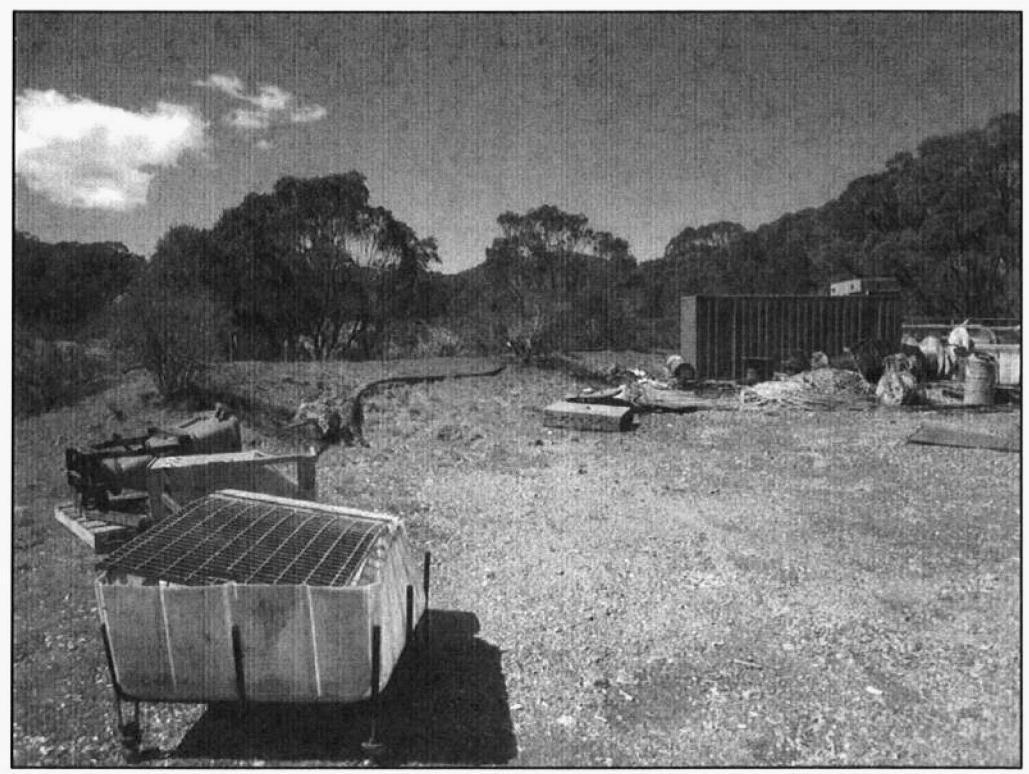
A grass covered fill mound was located on the northern and eastern sides of the depot and had a maximum height of about 1.5m above surrounding ground surface levels, as shown in Plate 1 below. The sides of the fill mound sloped down between about 17° and 30°. No obvious signs of fill batter slope instability were observed, such as tension cracks along the crest, slumping, groundwater seepage through the fill mound etc. The proposed screen fencing is to be located along the crest, or partway down the sides, of the fill mound.

Plate 1: Looking east showing existing maintenance depot and fill mound in background.

- The proposed footings must be designed for a maximum allowable bearing pressure of 50kPa.
- The stability and lateral toe restraint for the fence post footings may be achieved by embedding the footings to sufficient depth below the ground. To check the current embedment depth design is sufficient, a triangular lateral earth pressure coefficient should be adopted with a "passive" earth pressure coefficient, K_p, of 1.5, assuming the ground surface adjacent to the footing slopes down at about 30°. If the footing is deepened to the base of the fill mound, such that the ground surface slopes along the toe of the mound no steeper than about 15°, the "passive" earth pressure coefficient, K_p, may be increased to 2.5. We note that significant deflection is required in order to mobilise the full passive resistance of a soil and therefore a factor of safety of at least 2 should be adopted.
