Our Ref: 20406

RE: DIGITAL SIGNAGE – WOODVILLE ROAD, GRANVILLE RESPONSE TO SUBMISSIONS

RE: DIGITAL SIGNAGE SAFETY ASSESSMENT EXISTING DIGITAL SIGNAGE CRASH DATA ANALYSIS

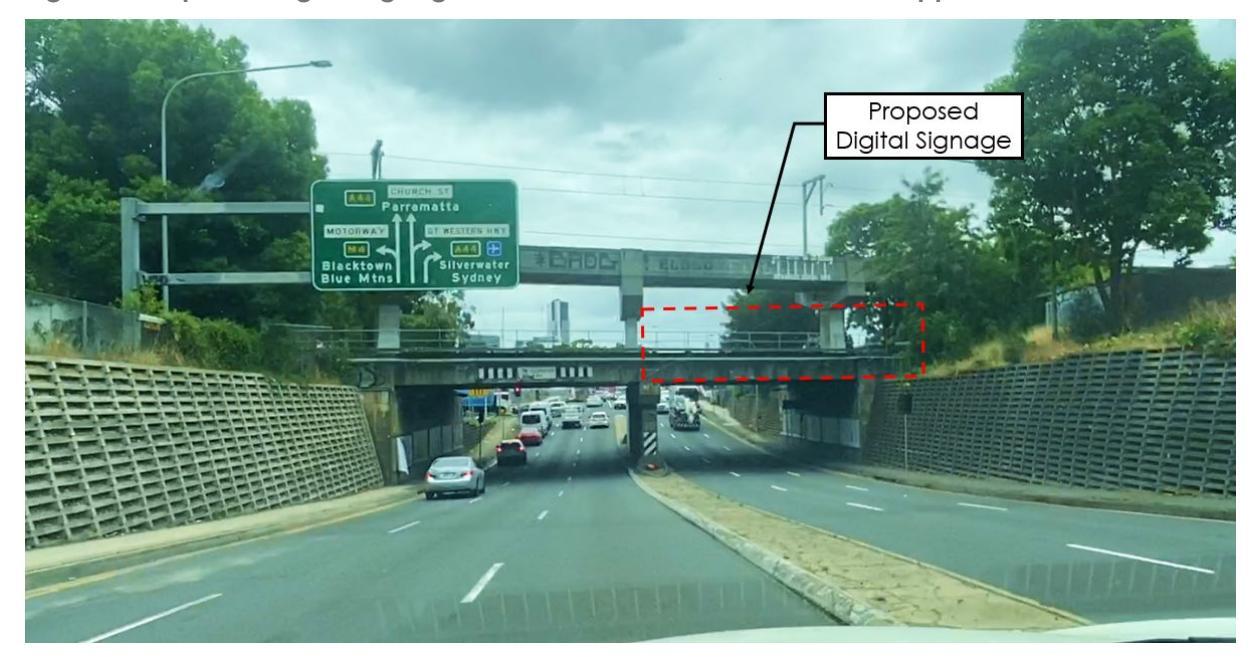
A digital signage is proposed to be installed on the existing railway bridge above the southbound carriageway of Woodville Road. The existing interchange sequence sign is located above the northbound carriageway which is in the direct view of oncoming motorists on Woodville Road. As such, the existing interchange sequence sign will not be obstructed by the proposed digital signage as shown in Figure 1.

Figure 1: Proposed Digital Signage Location - Woodville Road South Approach

In accordance with the Transport Corridor Outdoor Advertising and Signage Guidelines, the amount of text and information displayed on the proposed digital signage will be kept to a minimum i.e. no more than a driver can read at short glance. This is to ensure that all motorists would still be able to process the information shown on the surrounding road signs, such as the interchange sequence sign. In addition, the contents and images displayed on the proposed digital signage would not predominantly utilise colours and shapes that are similar to the interchange sequence sign to ensure motorists travelling on Woodville Road can distinguish the road sign.

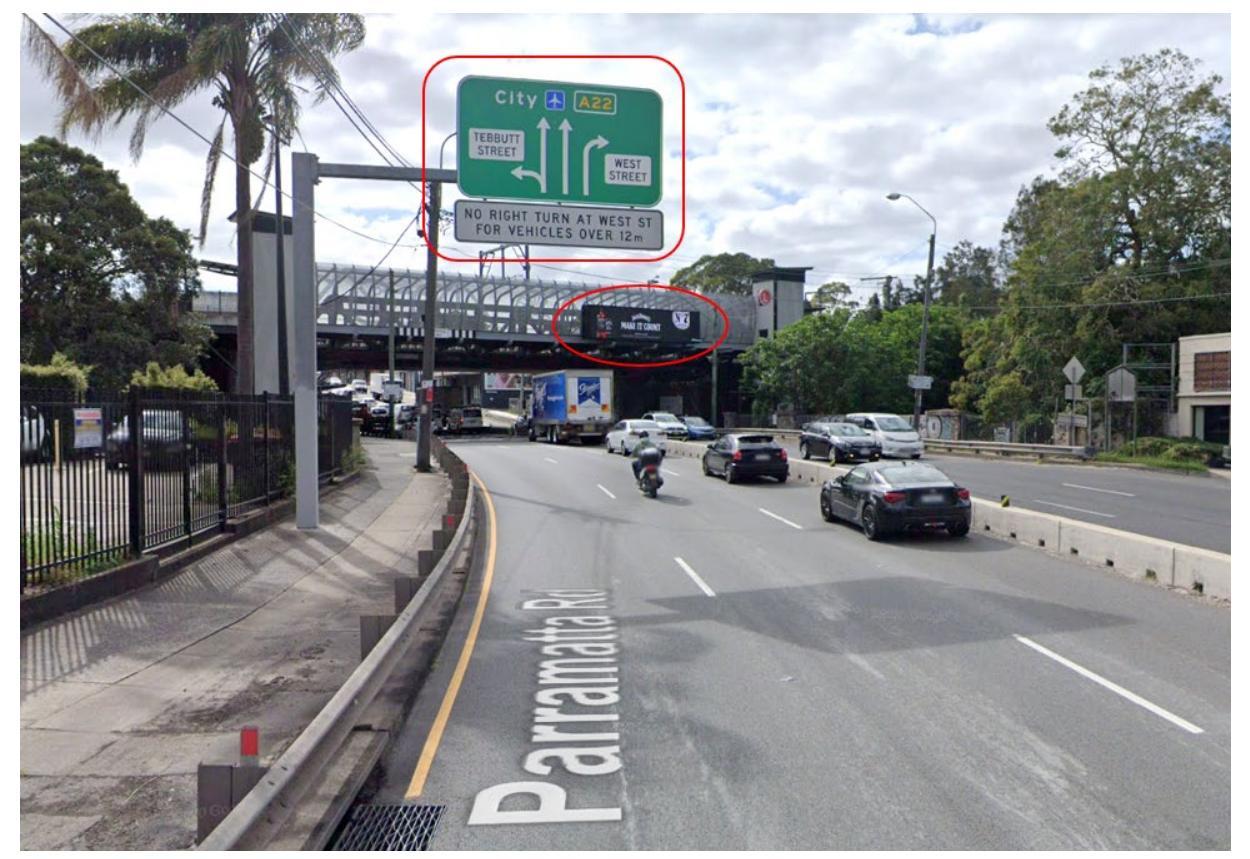
The digital signage in Lewisham, which was installed in May 2017, is located on the western side of an overhead railway bridge above Parramatta Road (parallel to the Brown Street cross-street) as shown in Figure 2. Like Parramatta Road, the Woodville Road digital signage would be located along a major arterial road having a signposted speed limit of 60 km/h. There would be three travel lanes on approach to the digital signage on both roads, and the signage infrastructure would be located above the opposite travel lane i.e. not directly above the travel lanes from which the signage would be visible. Also, there would be an interchange sequence sign located immediately prior to the digital signage as shown in Figure 3.

Figure 2: Digital Signage at Parramatta Road, Lewisham

Figure 3: Existing Digital Signage and Interchange Sequence Sign - Parramatta Road

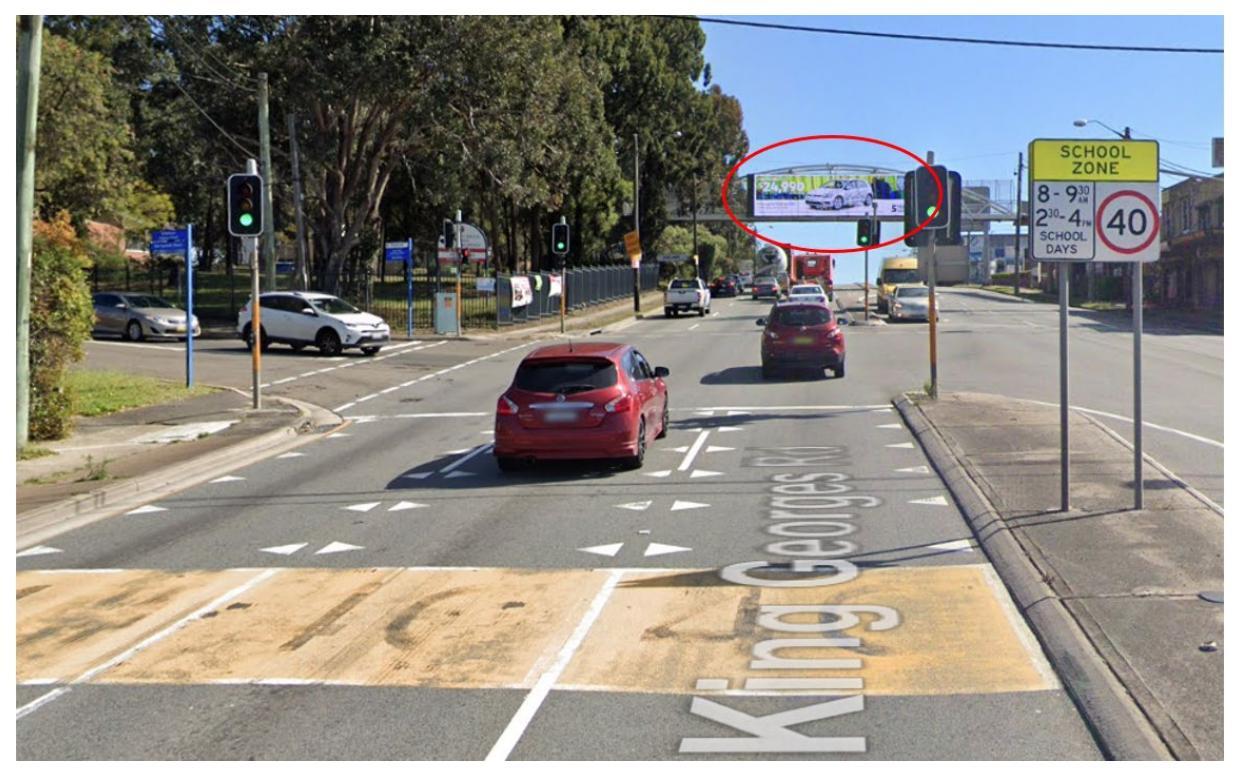
Figure 4: King Georges Road, Roselands

Provided in accordance with the Guidelines, there are several locations across Sydney Metropolitan where a digital signage is located beyond traffic signals yet the signage does not detract from the traffic signals. Relevant examples are shown in Figure 4 to Figure 7. Similar to these examples, the Woodville Road digital signage facing the north approach would not be expected to distract motorists' attention away from the traffic signals.

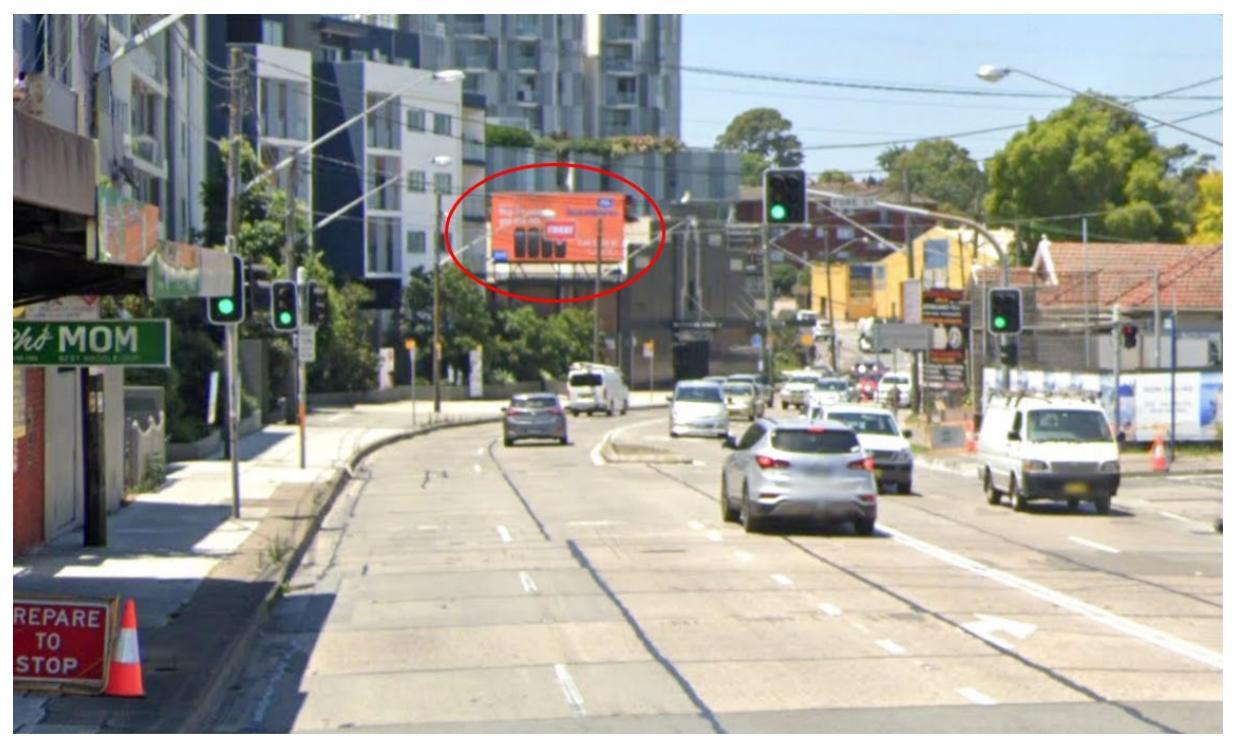
Figure 5: Canterbury Road, Canterbury

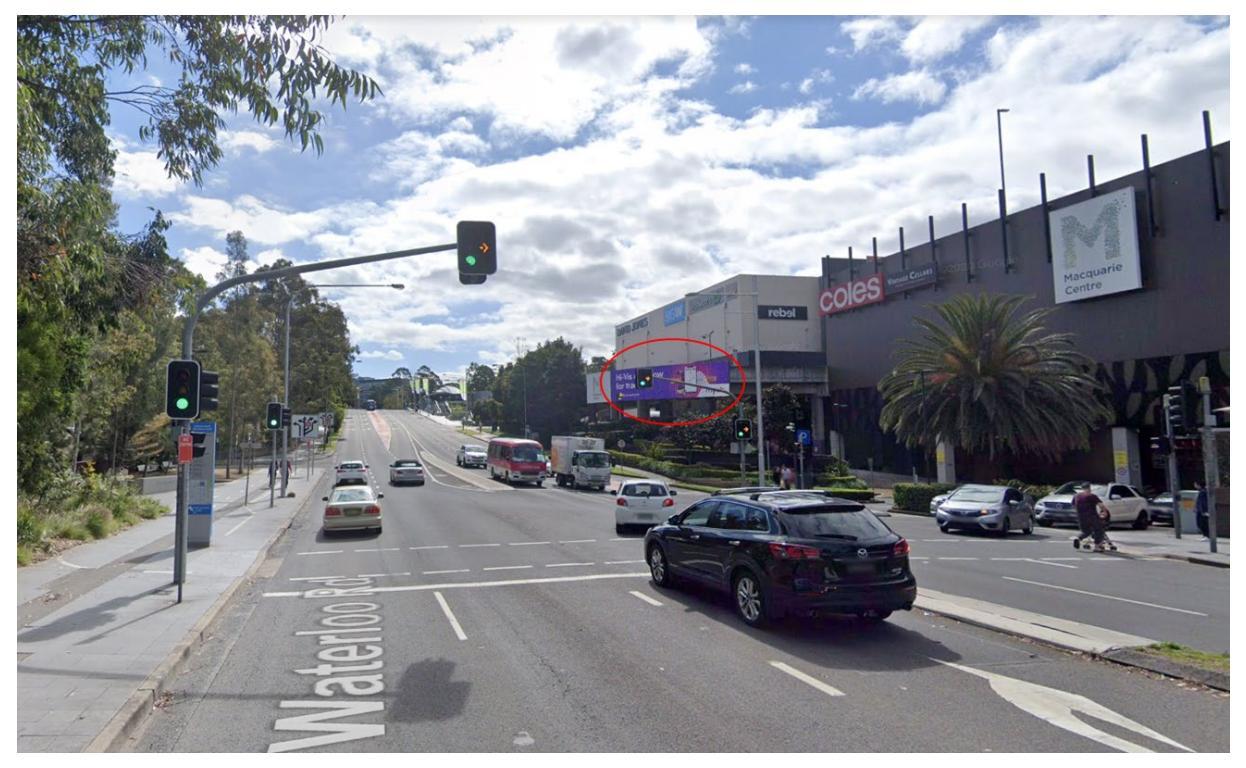
Figure 6: Waterloo Road, Macquarie Park

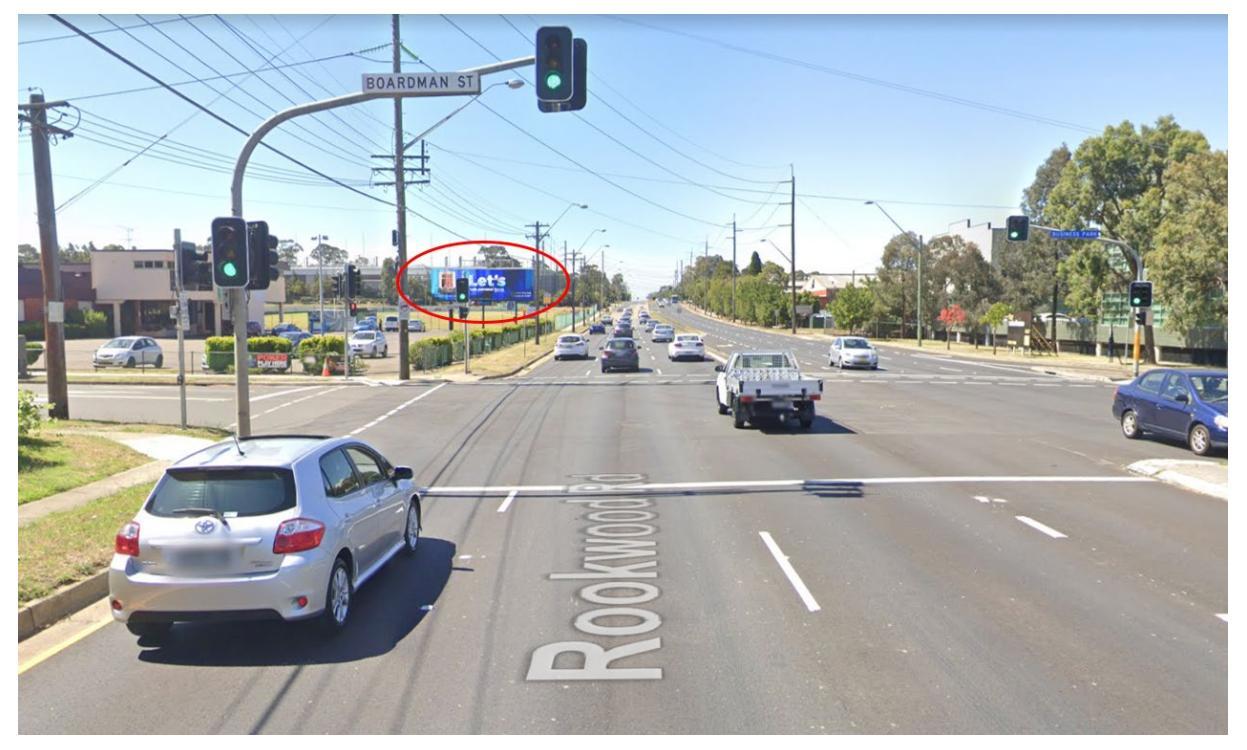
Figure 7: Rookwood Road, Yagoona

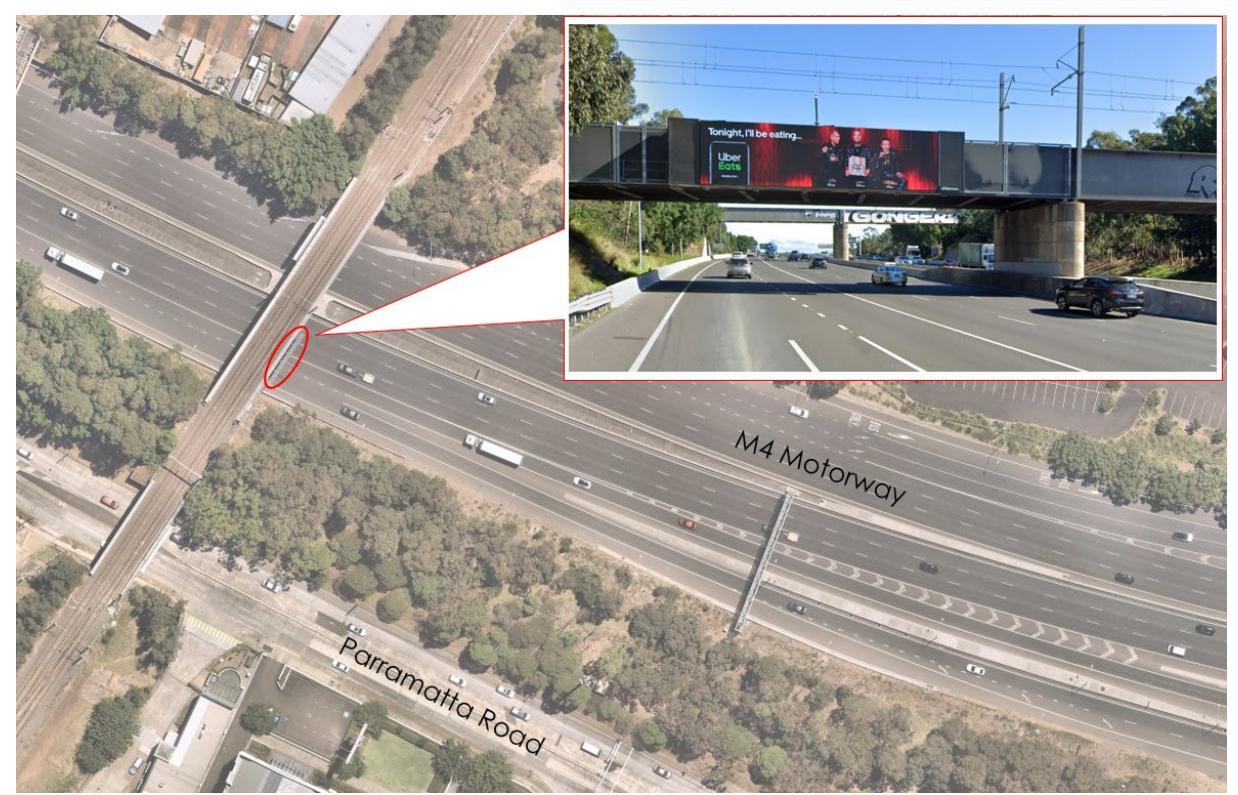
Figure 1: M4 Motorway, Homebush

A digital signage is located on the eastern side of an overhead railway bridge across the M4 Motorway as shown in Figure 1. This digital signage, which was installed on 25 July 2016, is visible to motorists travelling on the M4 Motorway east approach within approximately 350m.

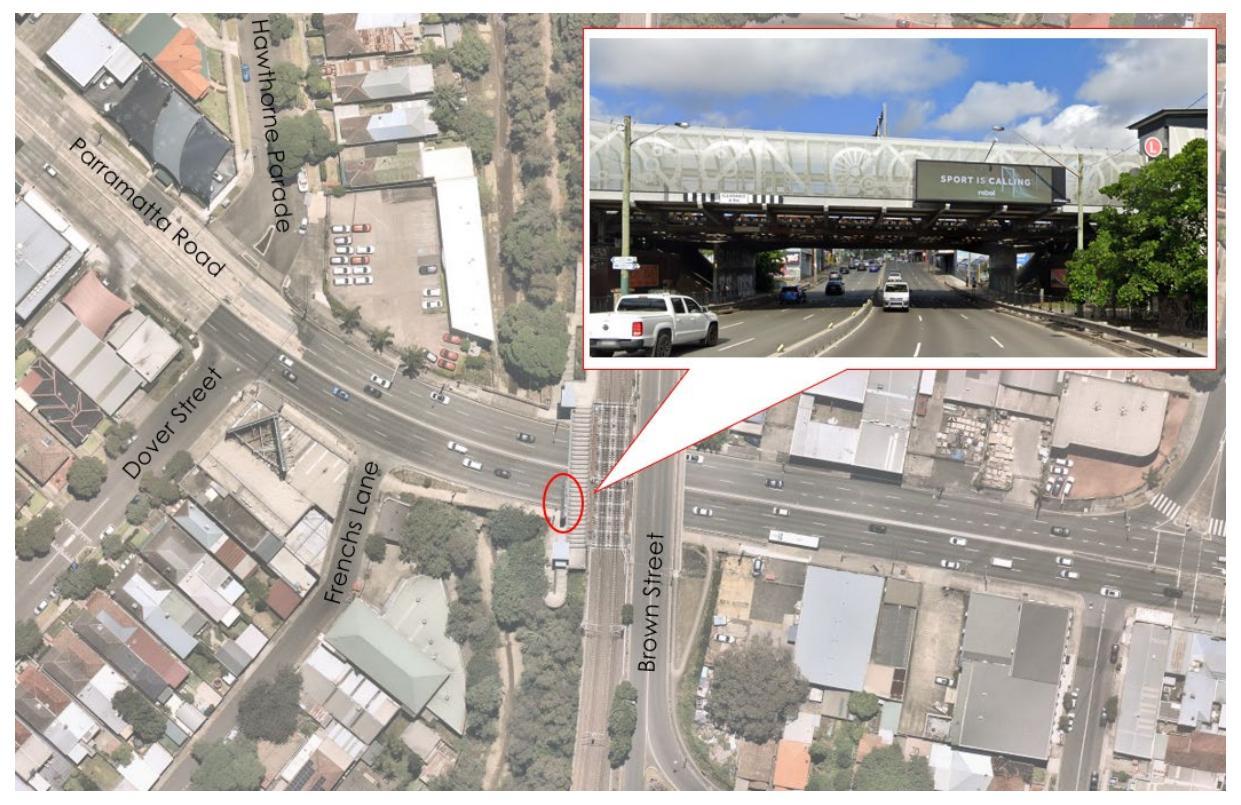
Figure 2: Parramatta Road, Lewisham

A digital signage is located on the western side of an overhead railway bridge across Parramatta Road in Lewisham as shown in Figure 2. This digital signage, which was installed on 29 May 2017, is visible to motorists travelling on the west approach on Parramatta Road within approximately 230m.

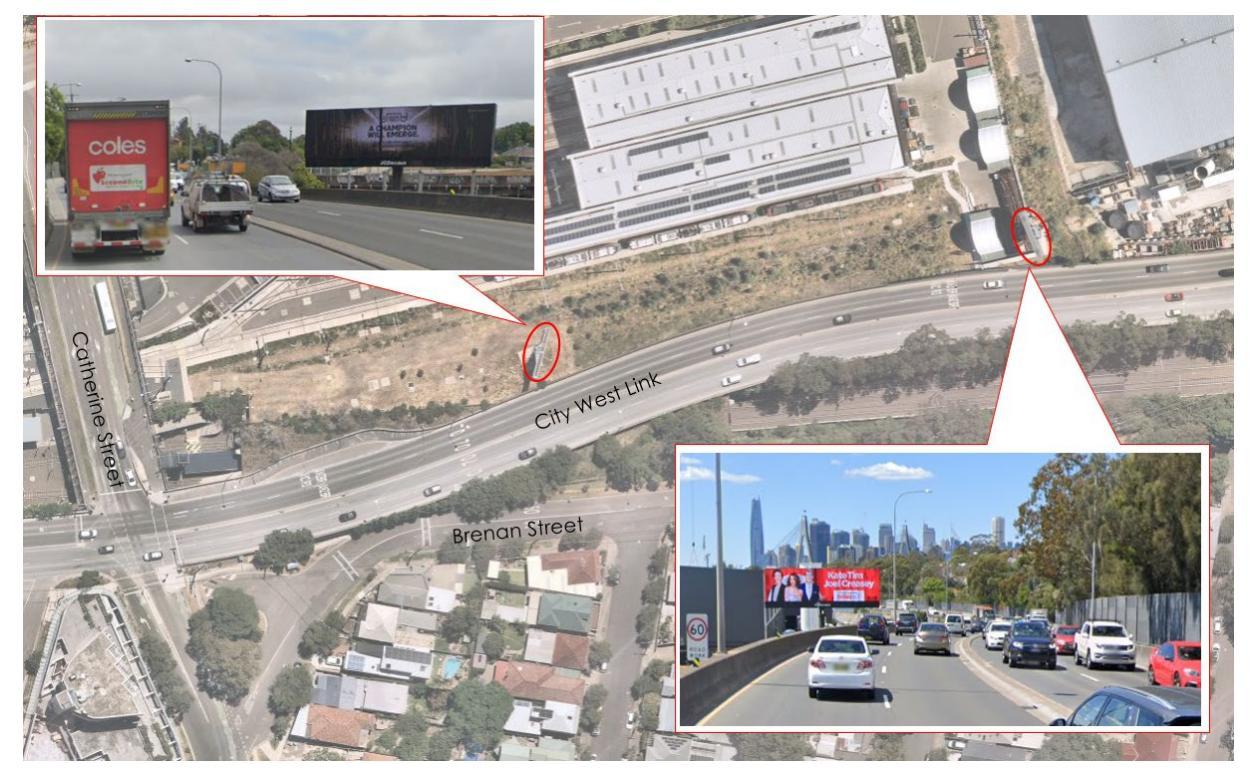
Figure 3: City West Link, Lilyfield

A digital signage is located on the northern side of the City West Link carriageway at Lilyfield, facing eastbound traffic as shown in Figure 3. This digital signage, which was installed on 20 April 2015, is visible to motorists travelling on the western approach on Parramatta Road within approximately 350m.

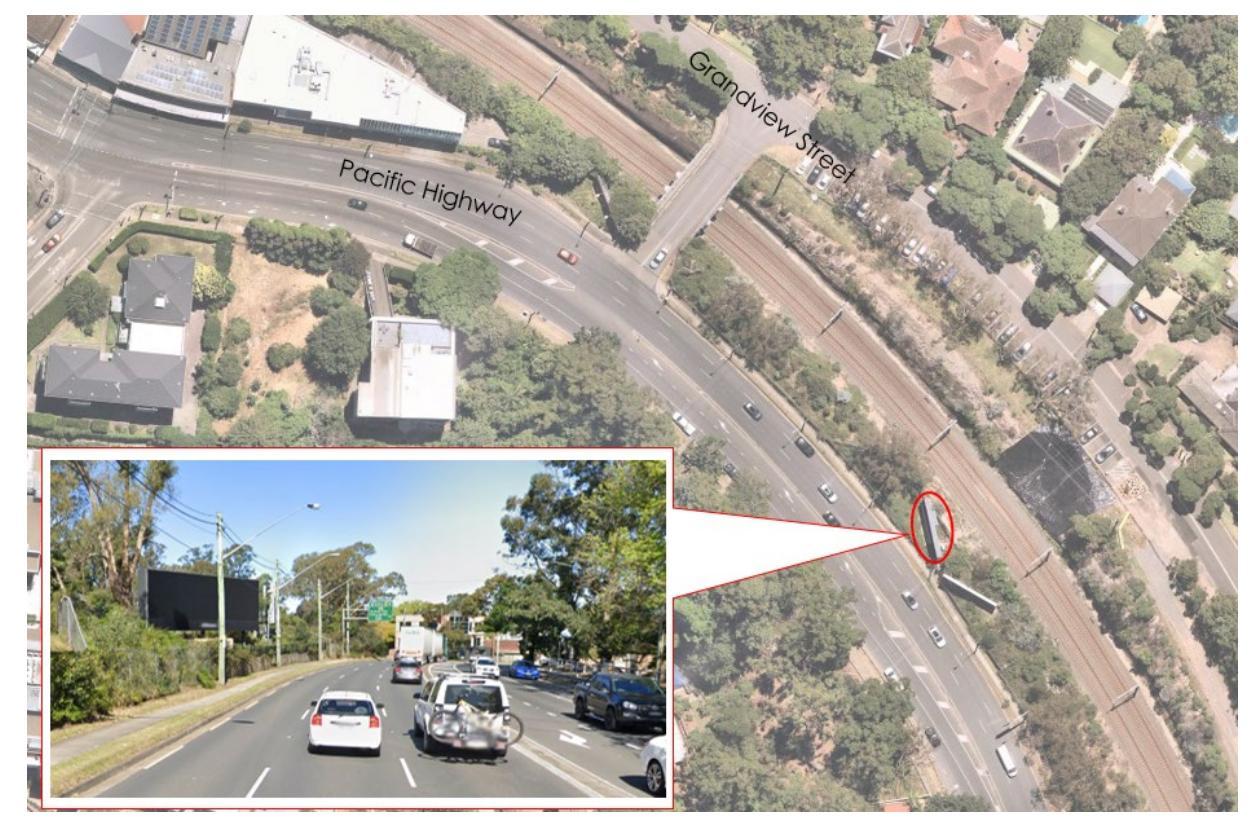
Figure 4: Pacific Highway, Pymble

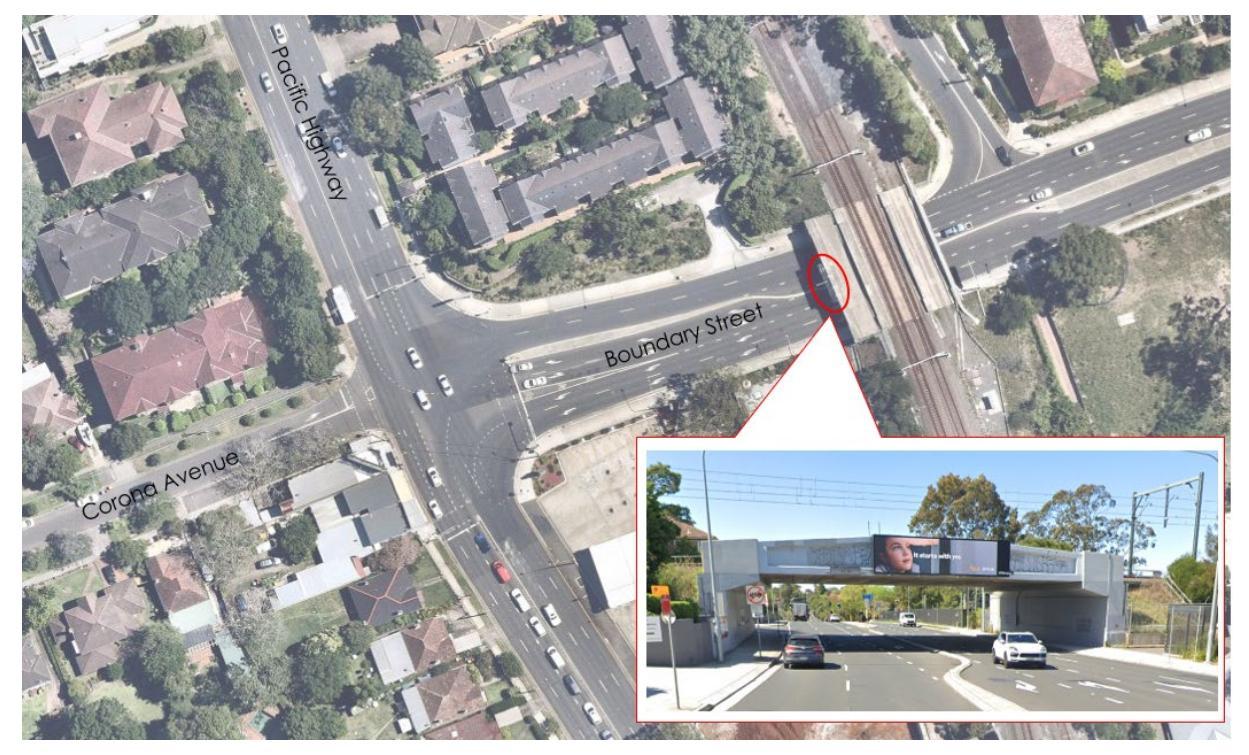
Figure 5: Boundary Street, Roseville

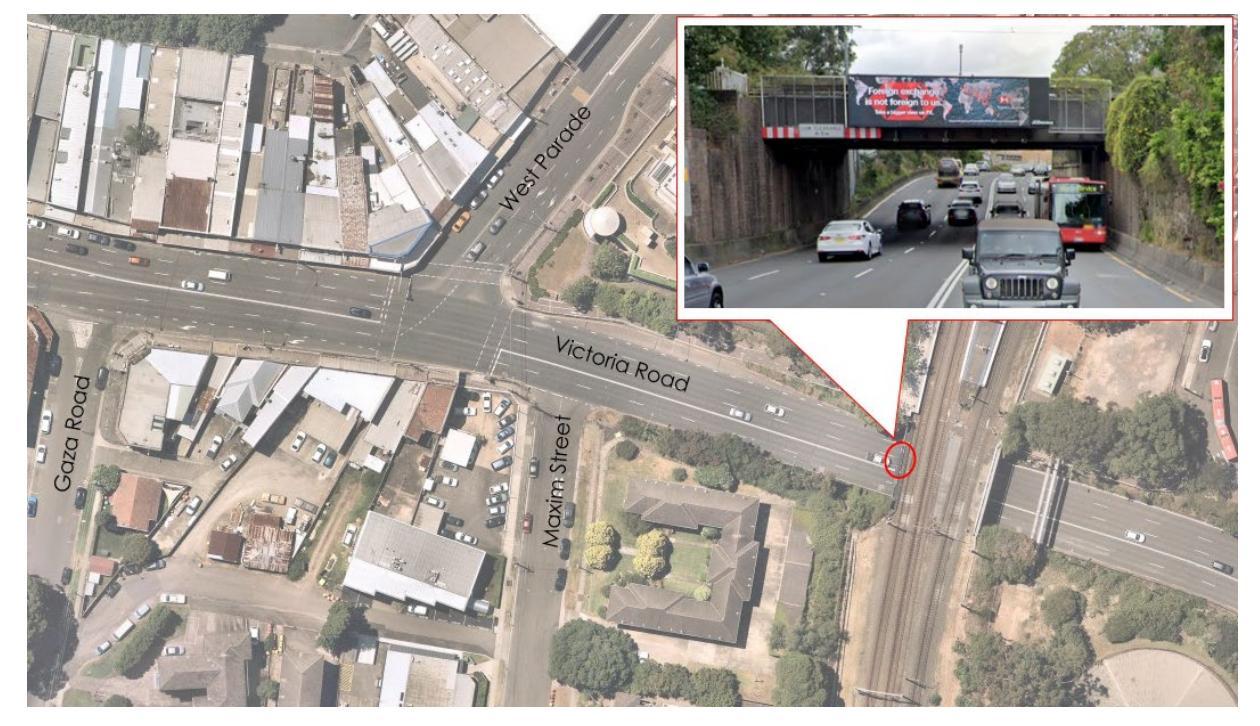
Figure 6: Victoria Road, West Ryde

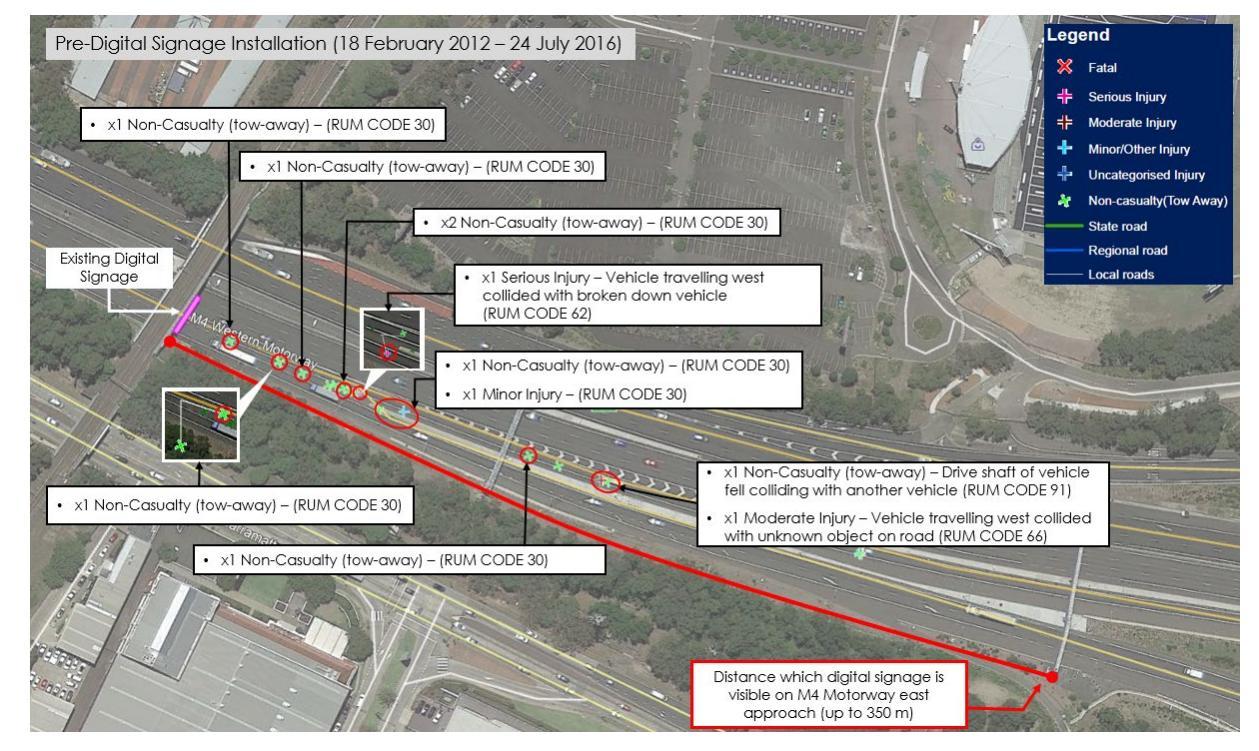
Figure 7: Crash Locations at M4 Motorway, Homebush – Pre-Installation

From Table 1, a total of 11 incidents occurred in the time period prior to the digital signage. The majority of the crashes resulted in no injuries or casualties, only vehicles being towedaway; that is, 8 out of 11 crashes. As a result of the crashes, there was one serious injury, one moderate injury, and one minor injury.

The serious injury crash was a result of a vehicle colliding into a broken-down vehicle (RUM CODE 62) on the M4 Motorway. The moderate injury crash occurred when a vehicle collided with an object on the road (RUM CODE 66). The minor injury crash was a result of a rear end collision (RUM CODE 30).

Prior to installation of the digital signage, the most common type of crash was a rear end crash which made up 8 out of 11 crashes.

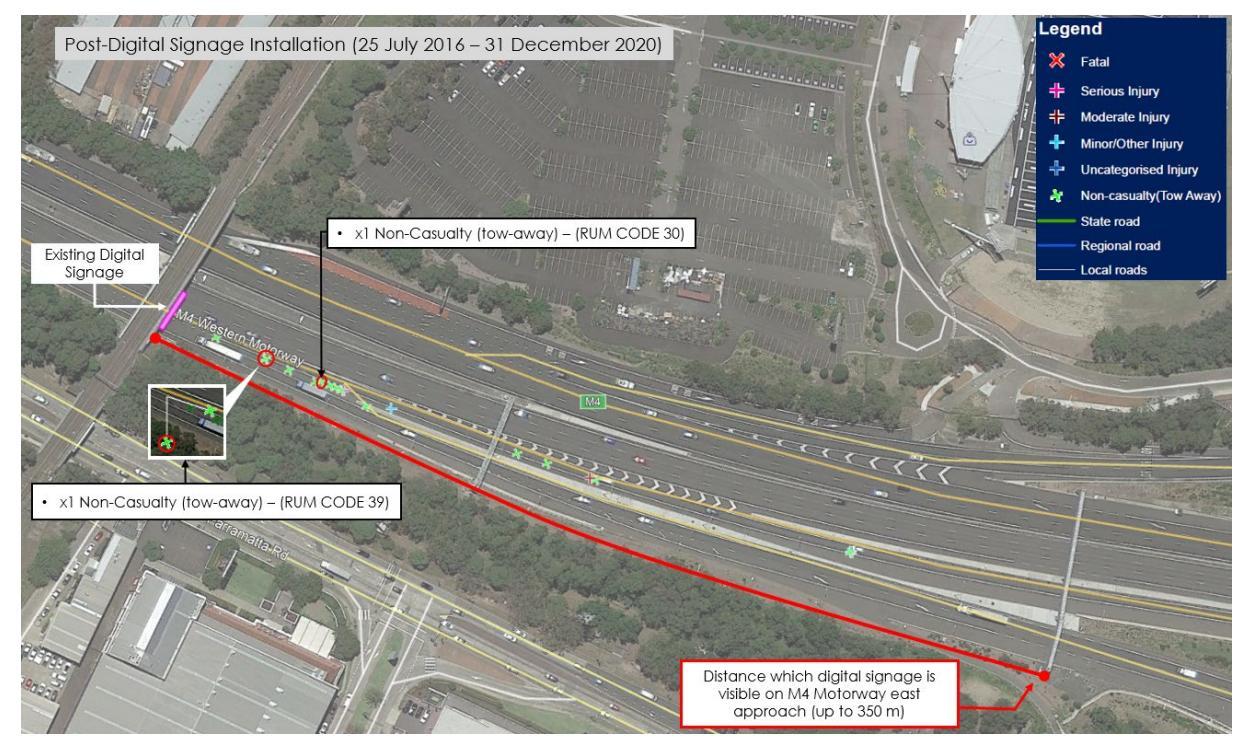
Figure 8: Crash Locations at M4 Motorway, Homebush – Operational

Once the digital signage was in operation, there was a total of two crashes recorded. Both incidents resulted in a no injuries (tow-away). One incident was a rear end crash and the other was the result of two vehicles travelling in the same direction colliding with one another (RUM CODE 39).

Overall, the number of crashes on the M4 Motorway east approach has not increased following the installation of the digital signage.

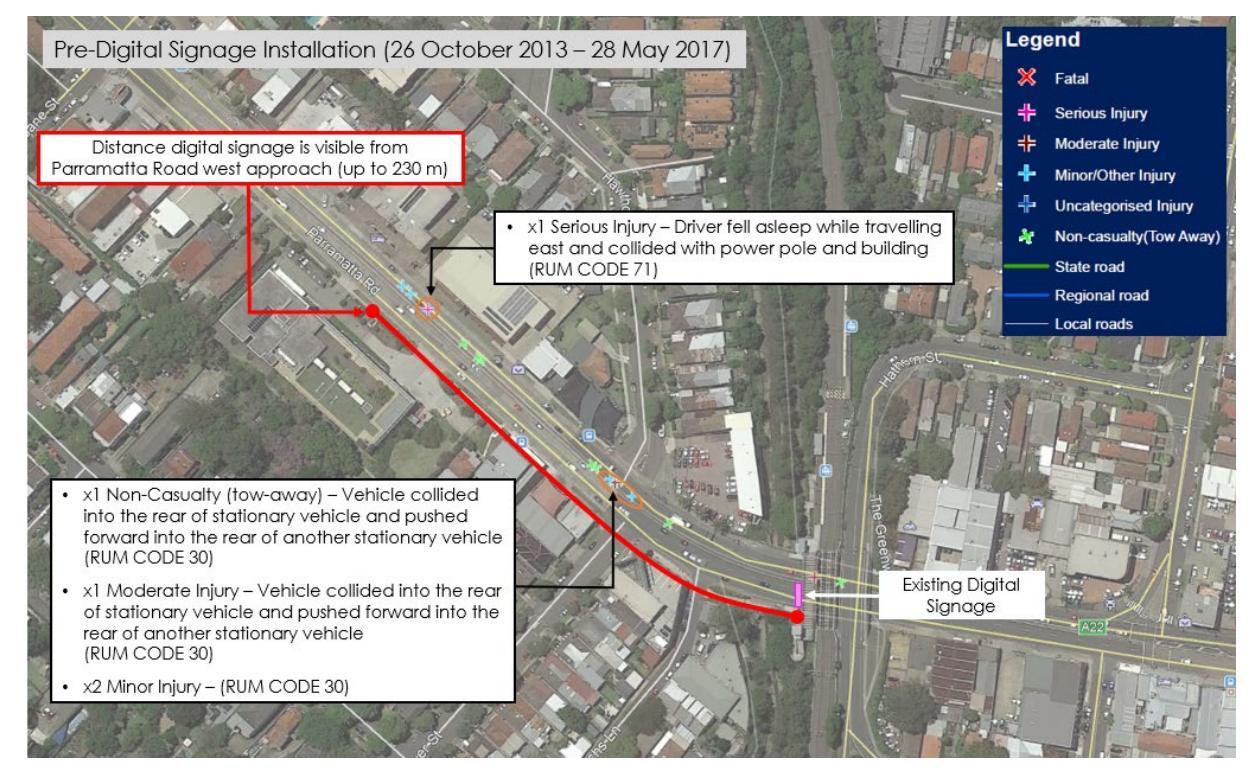
Figure 9: Crash Locations at Parramatta Road, Lewisham – Pre-Installation

In the time period prior to the digital signage, there were a total of five crashes recorded within the visible distance of the digital signage. The serious injury crash was the result of driver fatigue which caused the driver to veer from the carriageway and collide into a power pole (RUM CODE 71). The moderate injury crash was related to a rear end incident. There two minor injuries resulting from rear end collisions (RUM CODE 30), and one crash that resulted in no injuries (tow-away).

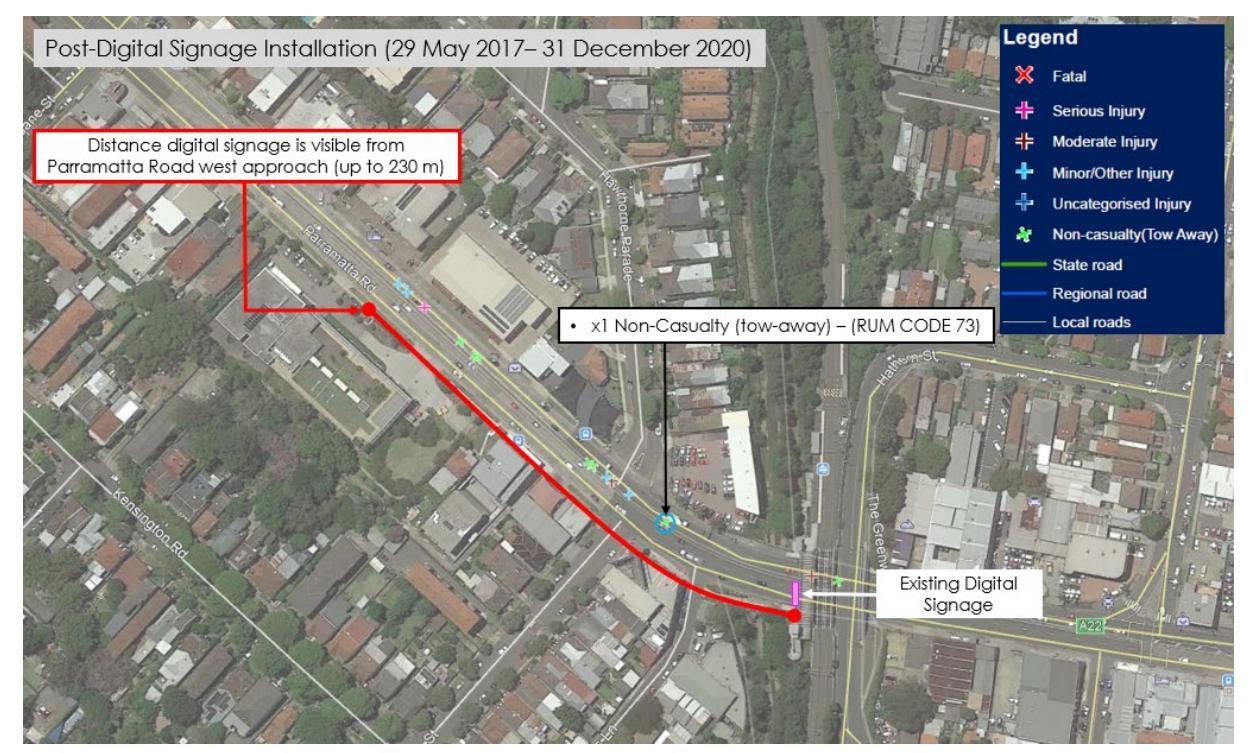
Figure 10: Crash Locations at Parramatta Road, Lewisham – Operational

Since the digital signage has been in operation, a vehicle has veered from the carriageway colliding into a parked vehicle (RUM CODE 73). This crash resulted in the vehicle being towed away, however, no injuries.

Whilst the digital signage has been operational, there has been no increase in the number of crashes within the signage visible distance on Parramatta Road.

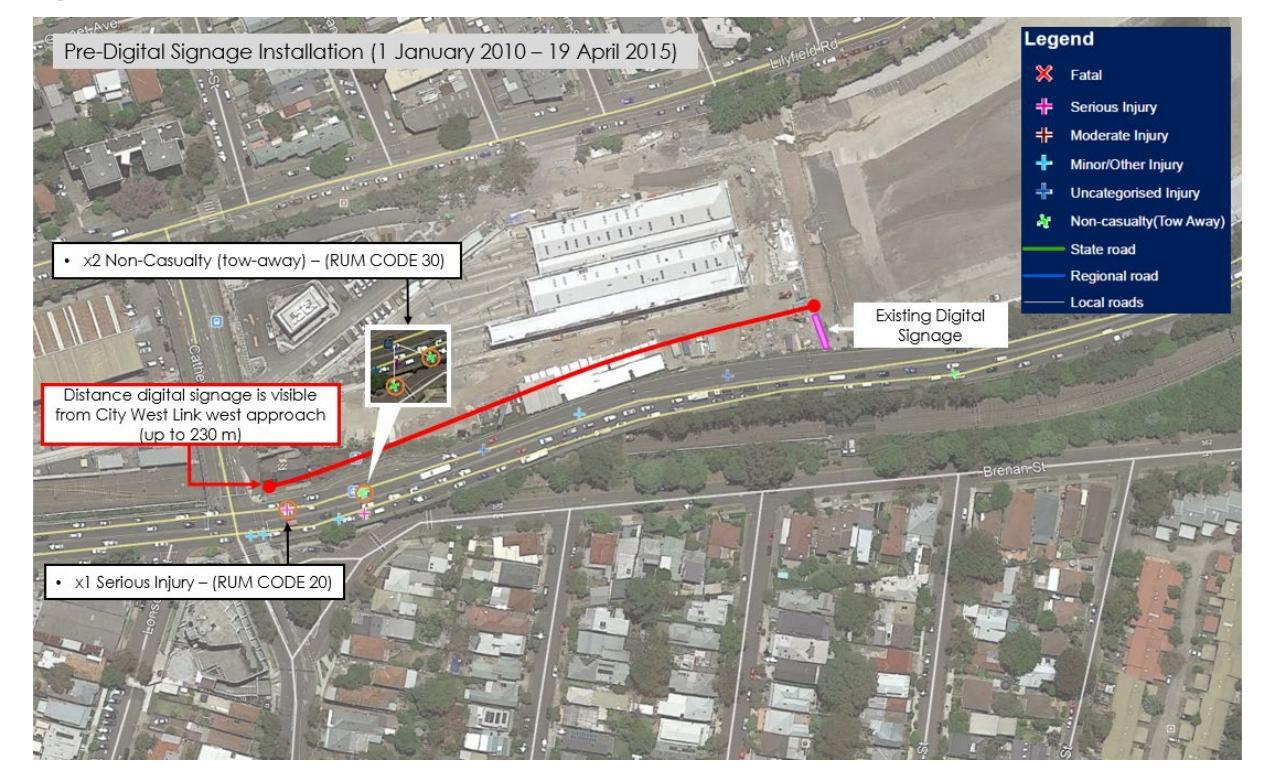
Figure 11: Crash Locations at City West Link (Eastbound), Lilyfield – Operational

A total of three crashes have been recorded during the five-year period prior to the digital signage. One incident occurred east of the City West Link – Catherine Street intersection which was a head on crash (RUM CODE 20) that resulted in a serious injury. The other two incidents were rear end crashes which resulted in vehicles being towed away.

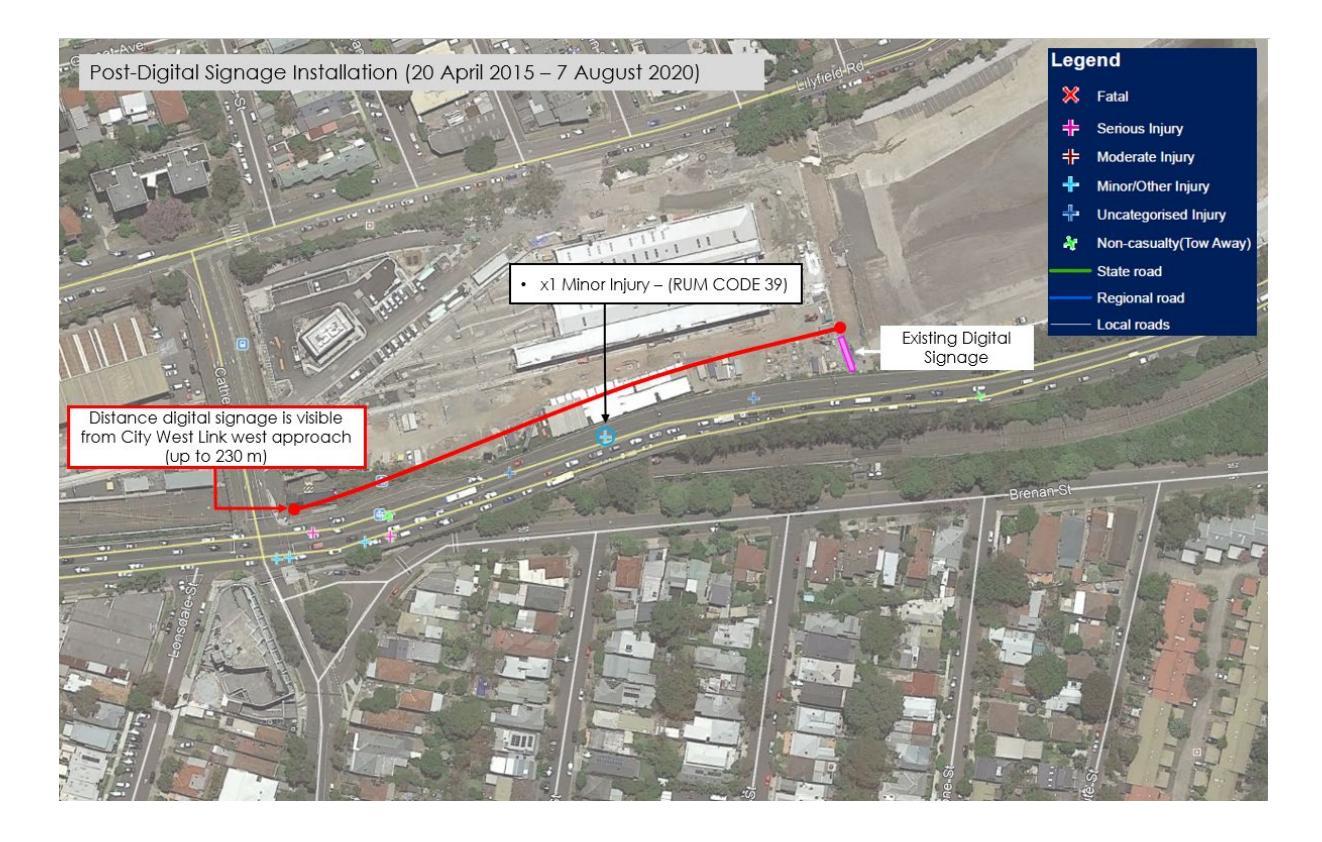
Figure 12: Crash Locations at City West Link (Eastbound), Lilyfield – Operational

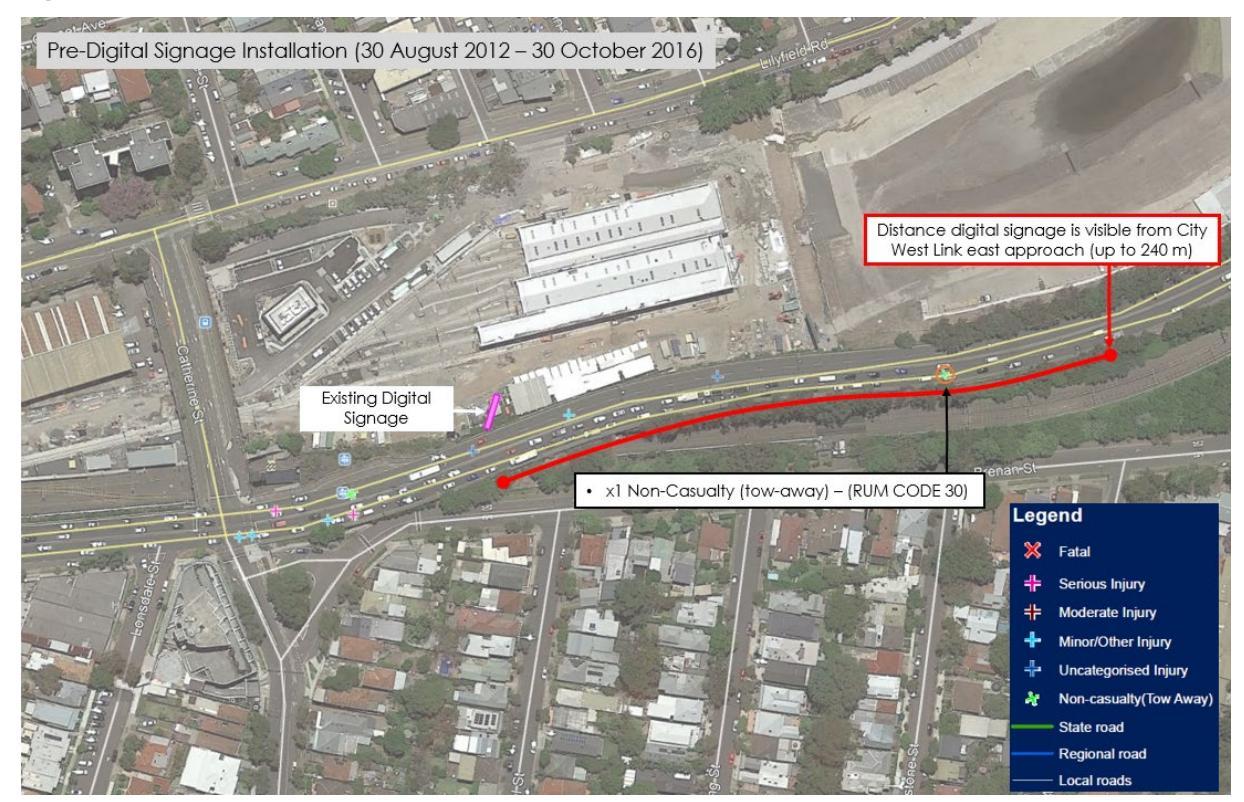
Figure 13: Crash Locations at City West Link (Westbound), Lilyfield – Pre-Installation

During the time period prior to the digital signage, there was one rear end crash which resulted in no injuries and only the vehicle/s being towed away. Since the signage was installed, there have been no crashes recorded within the visible distance on City West Link in the westbound direction.

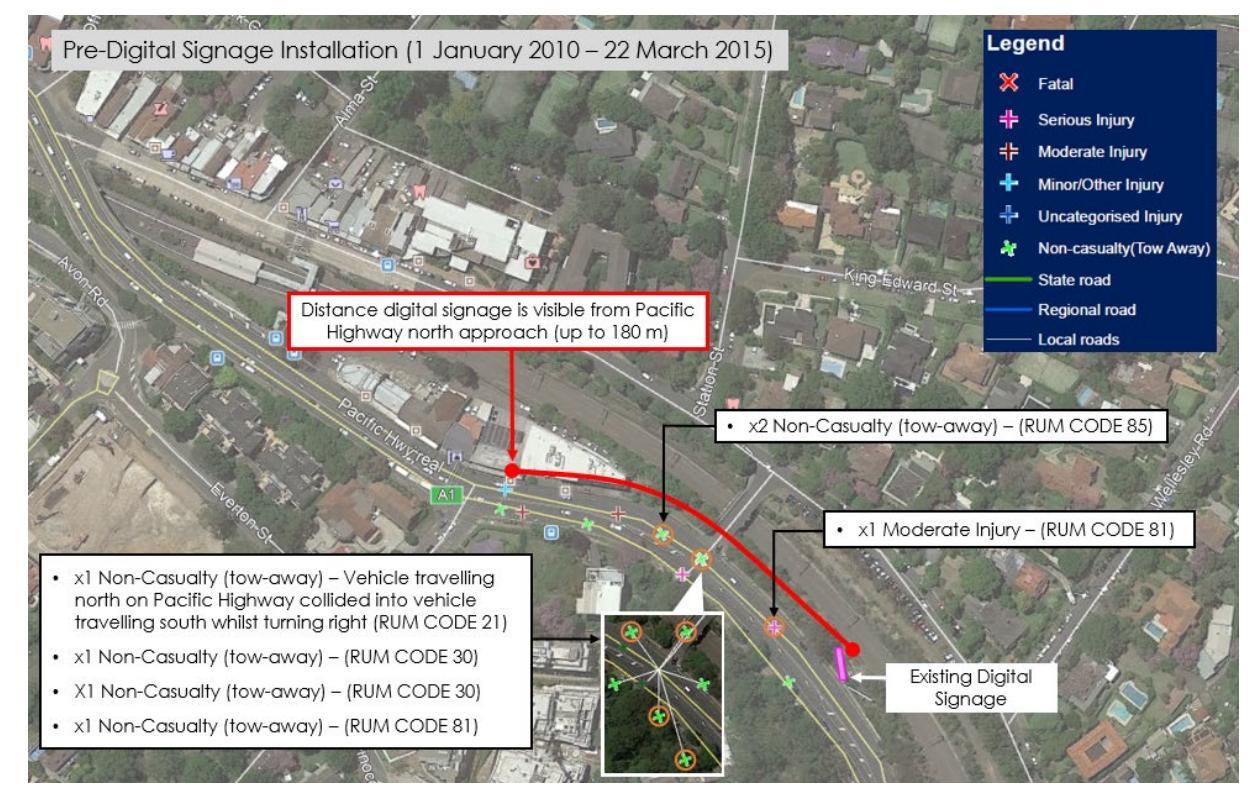
Figure 14: Crash Locations at Pacific Highway, Pymble – Pre-Installation

There were seven crashes recorded within the time period prior to the digital signage. Most of these crashes occurred at the intersection of Pacific Highway with the side road bridge crossing towards Grandview Street, and resulted in no injuries. The crashes include two rear end collisions, a vehicle travelling south colliding into vehicle turning right onto the bridge (RUM CODE 21), and three vehicles veering from carriageway at the bend into an object (RUM CODE 81 and RUM CODE 85). A similar incident occurred approximately 40m south of the bridge where a vehicle veered from the carriageway at the bend into an object resulting in a moderate injury.

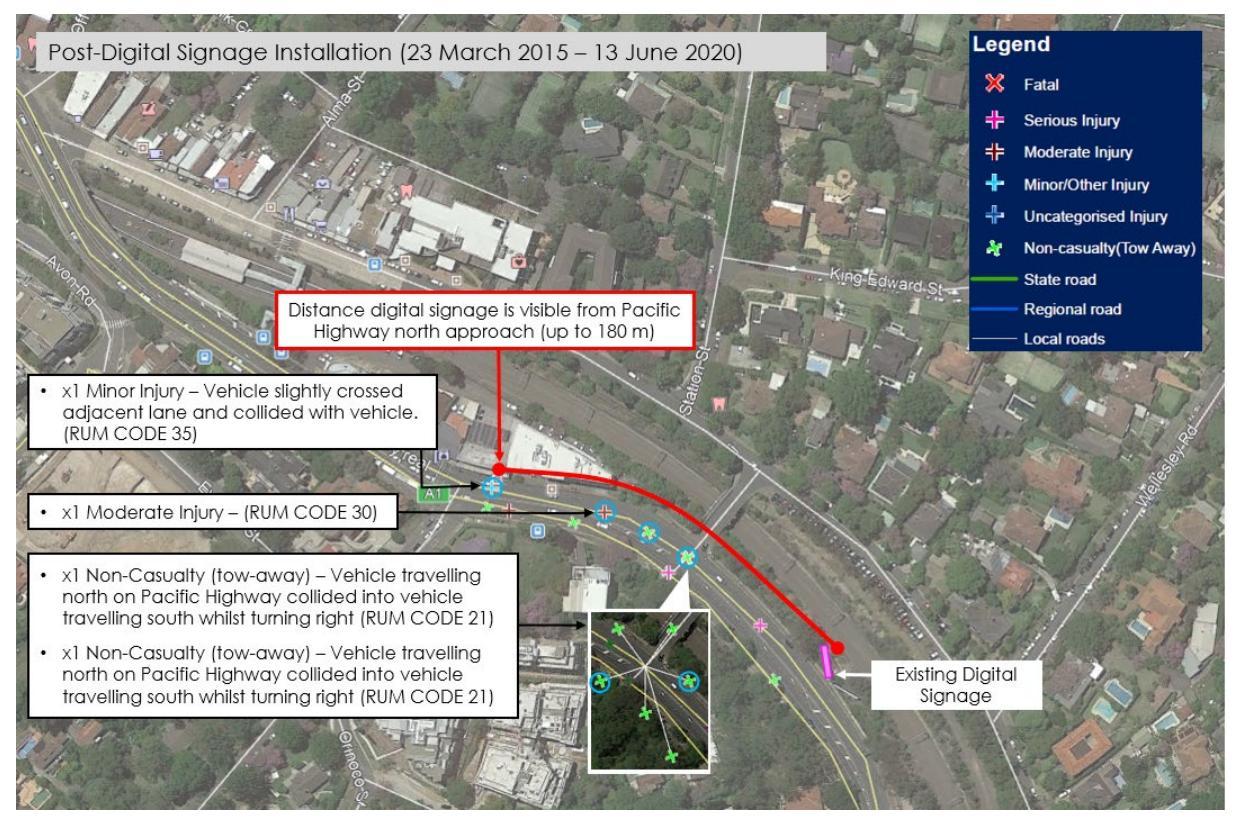
Figure 15: Crash Locations at Pacific Highway, Pymble – Operational

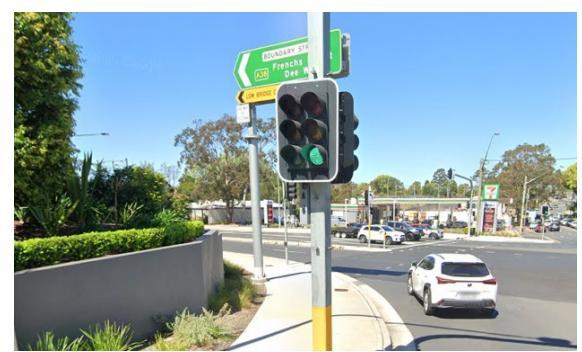
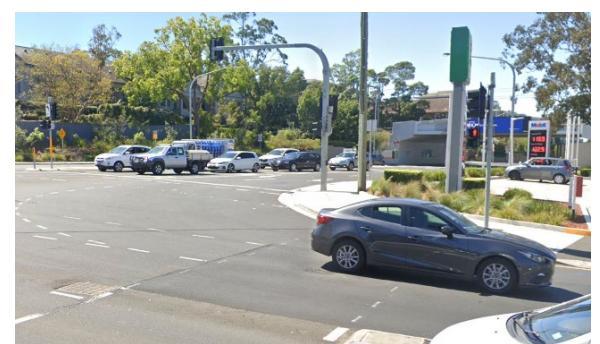
Figure 16: Pacific Highway North Approach and South Approach

Motorist's view from north approach

Motorist's view from south approach

On Boundary Road west approach, the signage becomes visible after a motorist has turned left or right from Pacific Highway. The digital signage is not visible on Pacific Highway north approach, and visibility is partially obstructed on the south approach as shown in Figure 16.
