Our Ref: 20406

RE: DIGITAL SIGNAGE – WOODVILLE ROAD, GRANVILLE RESPONSE TO SUBMISSIONS

RE: DIGITAL SIGNAGE SAFETY ASSESSMENT EXISTING DIGITAL SIGNAGE CRASH DATA ANALYSIS

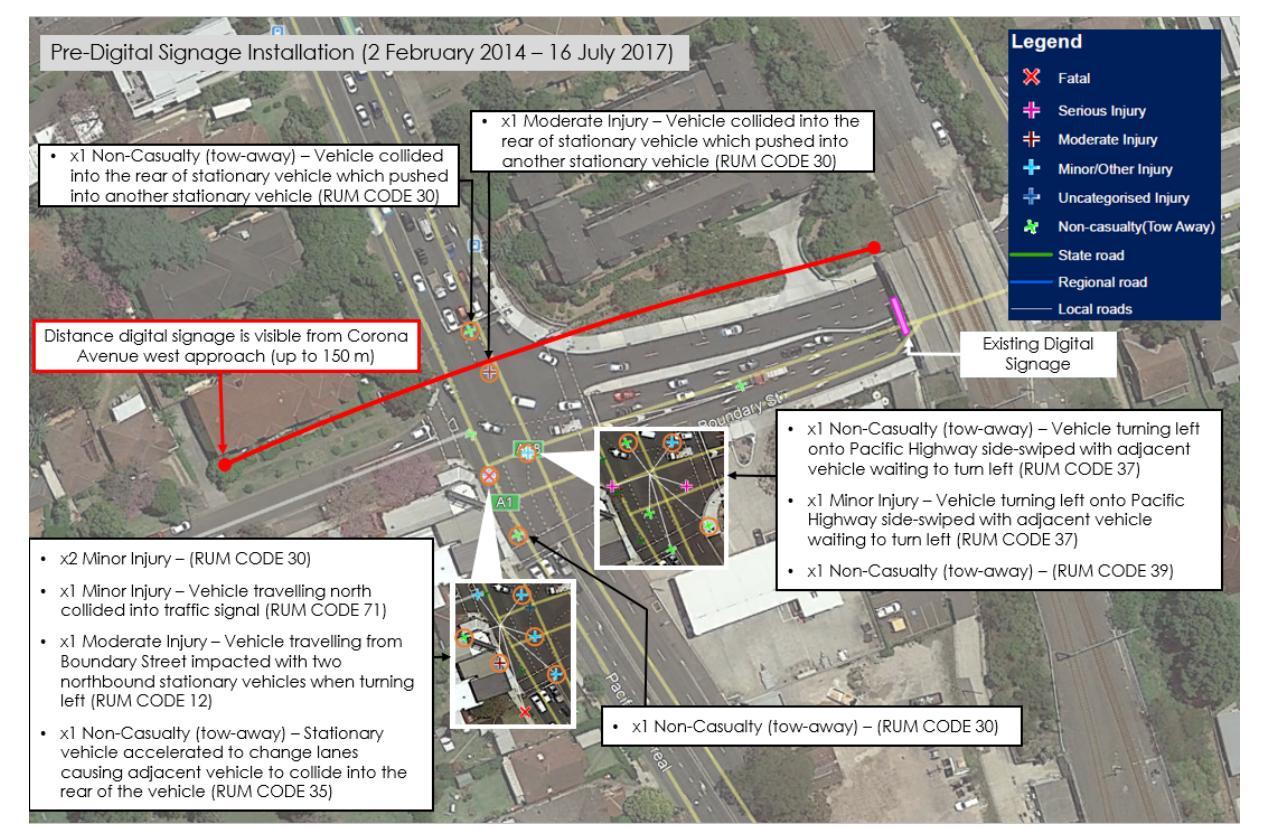
Figure 17: Crash Locations at Boundary Street, Roseville – Pre-Installation

From Table 6, the recorded crashes have all occurred at the intersection of Pacific Highway-Boundary Street. There was a total of 11 crash incidents within the time period prior to the digital signage. Of those 11 crashes, there were two moderate injuries, four minor injuries, and five non-casualties (tow-away). It is noted that these crashes occurred at the signalised intersection of Pacific Highway - Boundary Street where vehicles were recorded as travelling north and south through the intersection. Given that the digital signage is partially obstructed or not visible from the north approach and south approach, such crashes would be unrelated to the presence of a digital signage on Boundary Street.

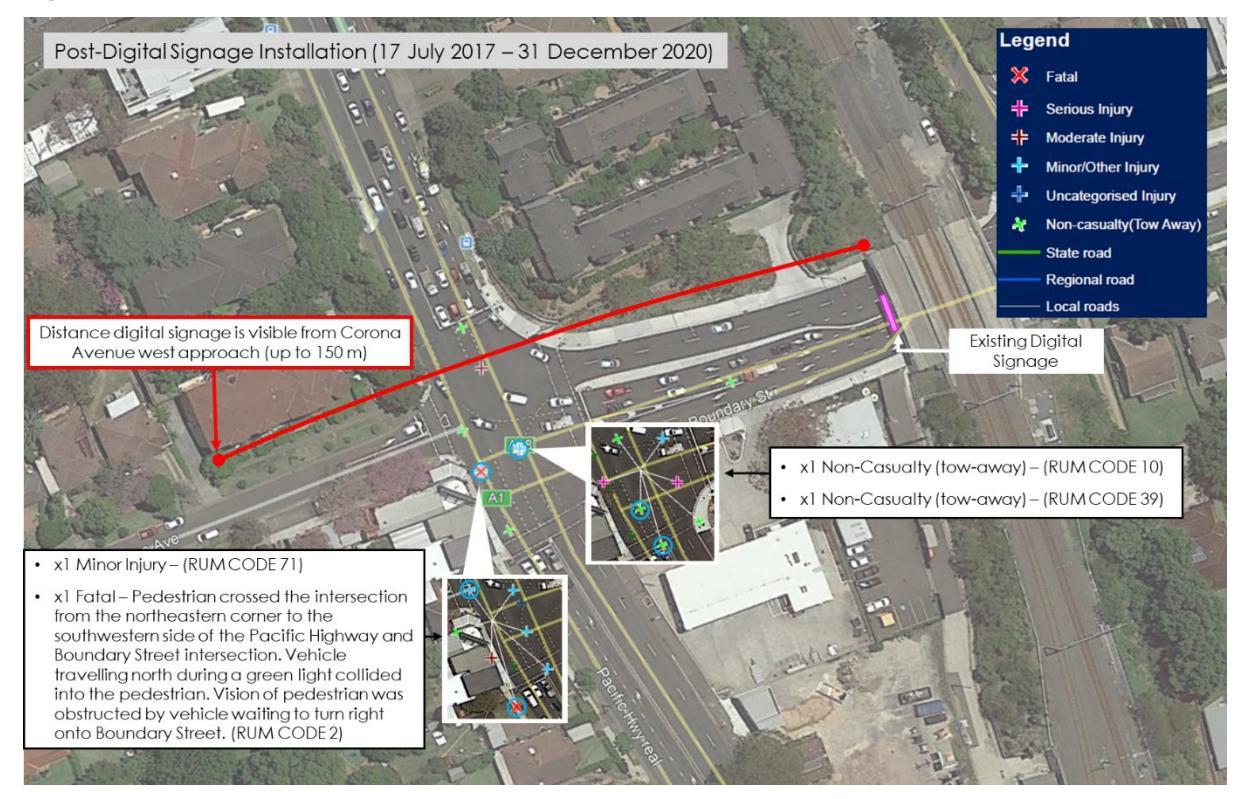
Figure 18: Crash Locations at Boundary Street, Roseville – Operational

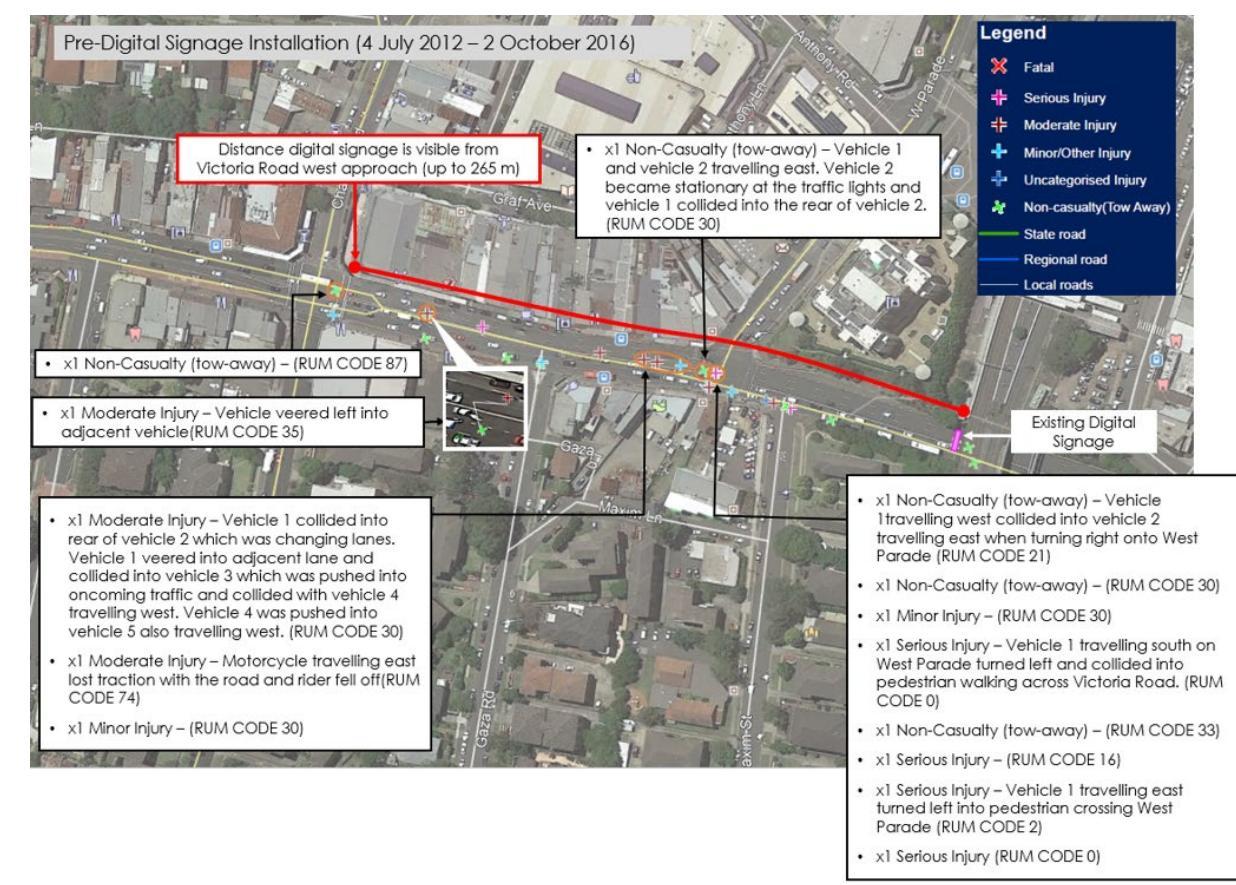
Figure 19: Crash Locations at Victoria Road, West Ryde – Pre-Installation

From Table 7, there are a total of 14 crashes recorded in the period prior to the digital signage. Of these incidents, four crashes resulted in serious injuries, three crashes with moderate injuries, and two crashes with minor injuries. Five crashes resulted in no injuries and a vehicle tow-away.

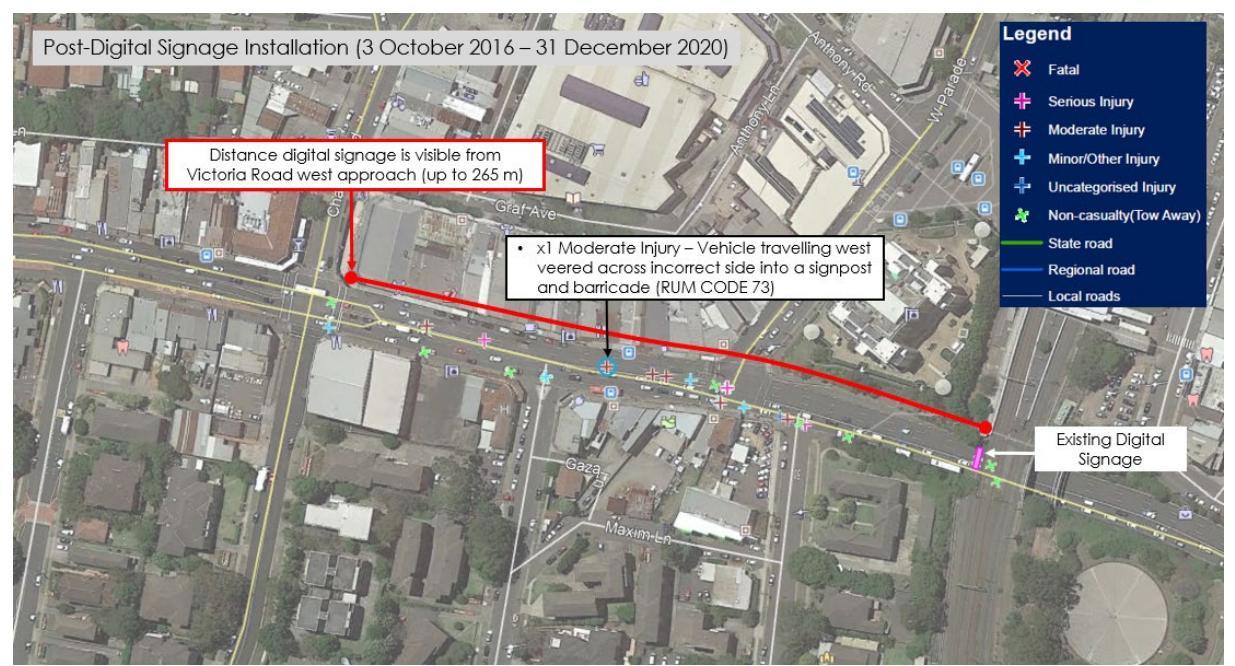
Figure 20: Crash Locations at Victoria Road, West Ryde – Operational
