Report on Preliminary Site Investigation (Contamination)

Precinct Rezoning Orchard Hills Precinct, Orchard Hills

Prepared for Department of Planning, Housing and Infrastructure

> Project 216919.00 June 2024

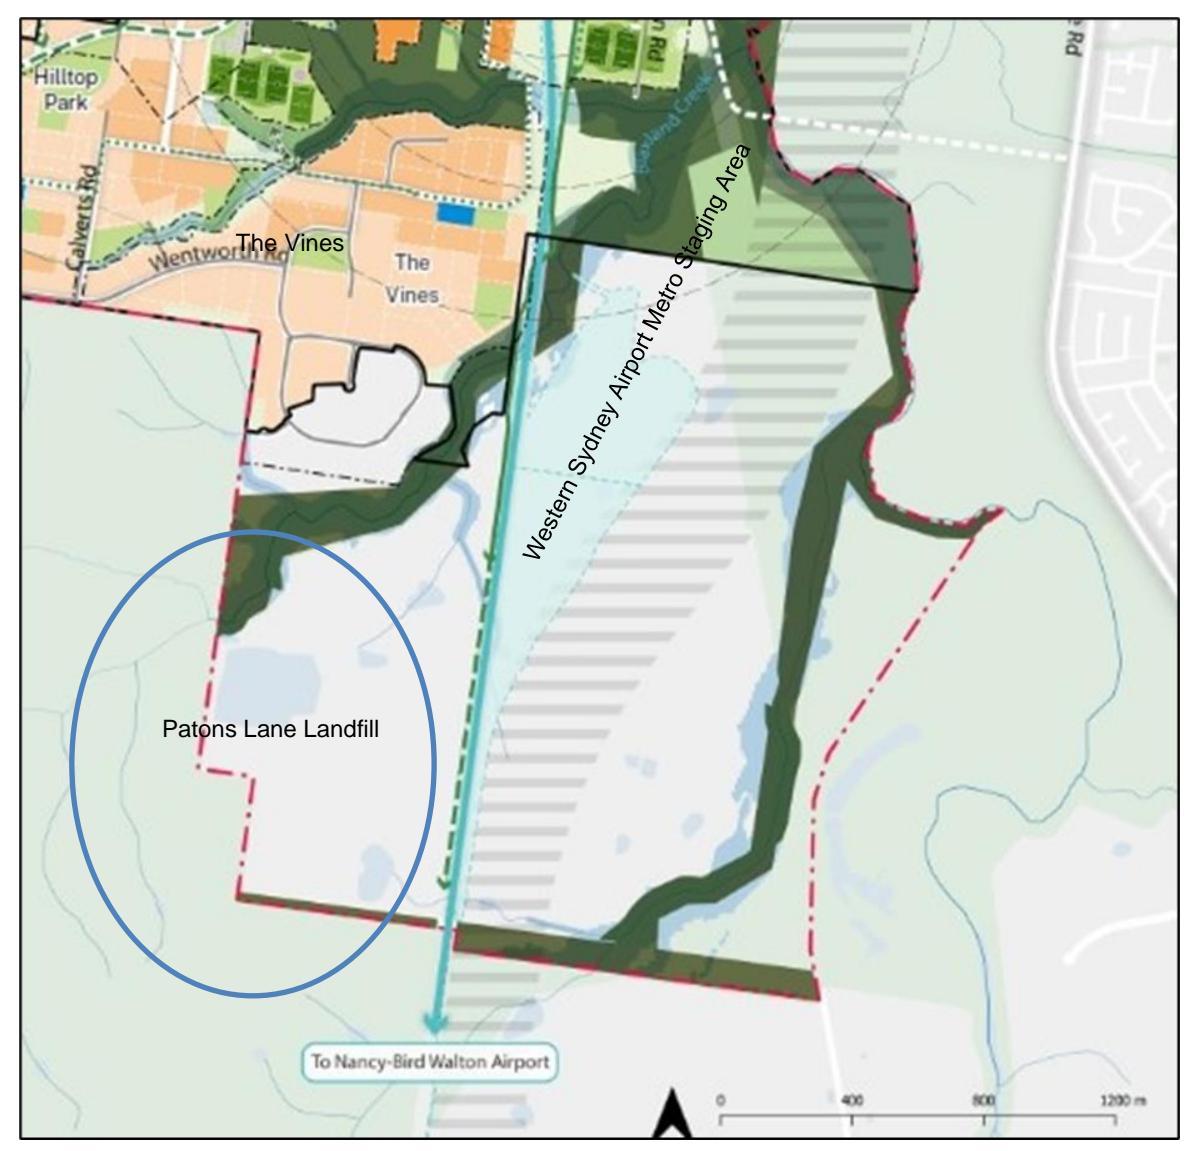
Figure 3: Excerpt of the ILP showing south-eastern part of the site

(see Figure 3). The area that is not proposed to be rezoned includes part of The Vines (existing residential area), Samuel Marsden (existing rural residential area), constrained land associated with riparian corridors, a staging area associated with the construction of the Western Sydney Airport Metro (teal shading) and the future Outer Sydney Orbital Stage 1 corridor (grey hatching). This area of the site is specifically relevant to the PSI given potential contamination constraints associated with the Patons Lane Landfill as discussed further in the report. It is understood that the PSI and site-specific constraints that apply to this area have informed the proposed ILP and these areas are not being considered for potential urban land uses.

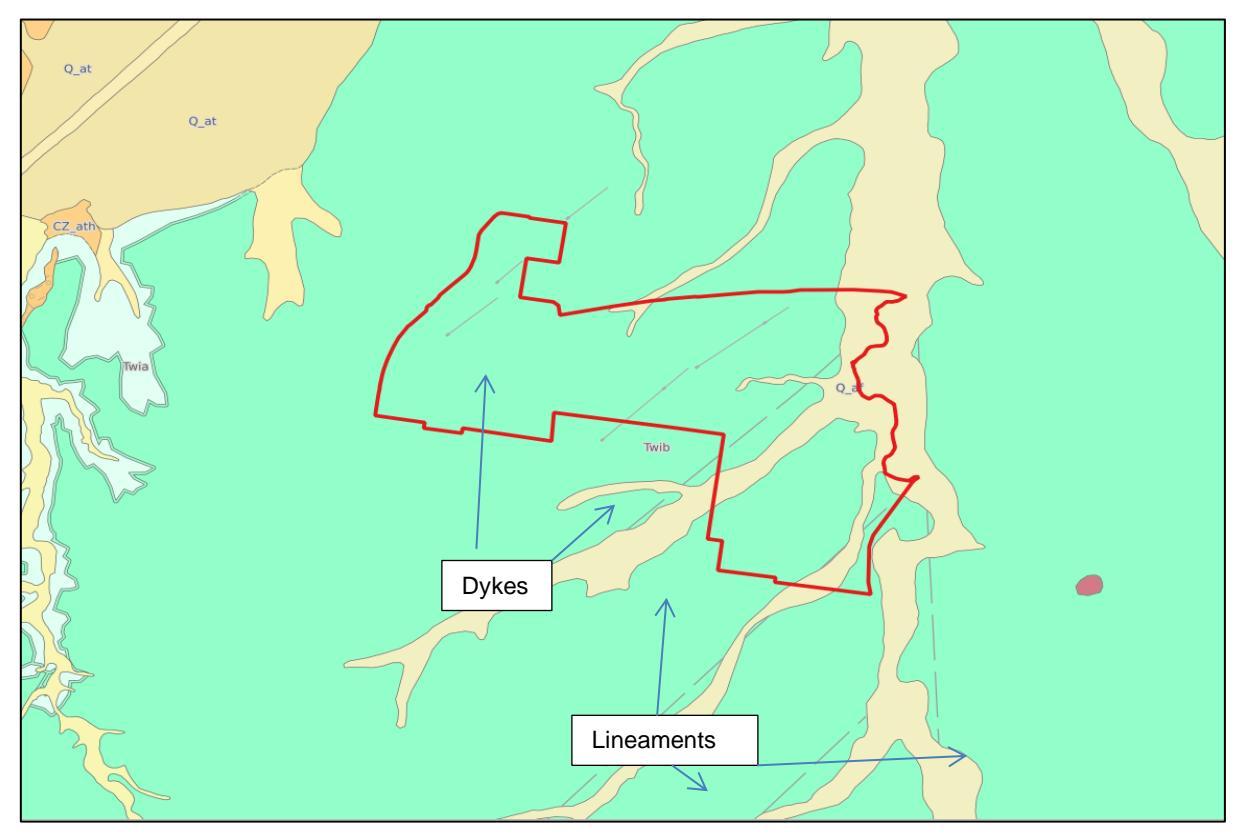
Figure 4: Regional Geology

Bringelly Shale typically comprises shale, carbonaceous claystone, claystone, laminite and fine to medium-grained lithic sandstone with occasional coal and tuff. Bringelly Shale typically weathers to form clays of medium to high plasticity. The alluvial floodplain deposits typically comprise silt, very fine to medium grained, lithic to quartz rich sand and clay. The regional geology mapping is presented in Figure 4.

Where: Dark green = Bringelly Shale (Twib), Yellow = Alluvial Floodplain Deposits (Q_af), site boundary shown in red.

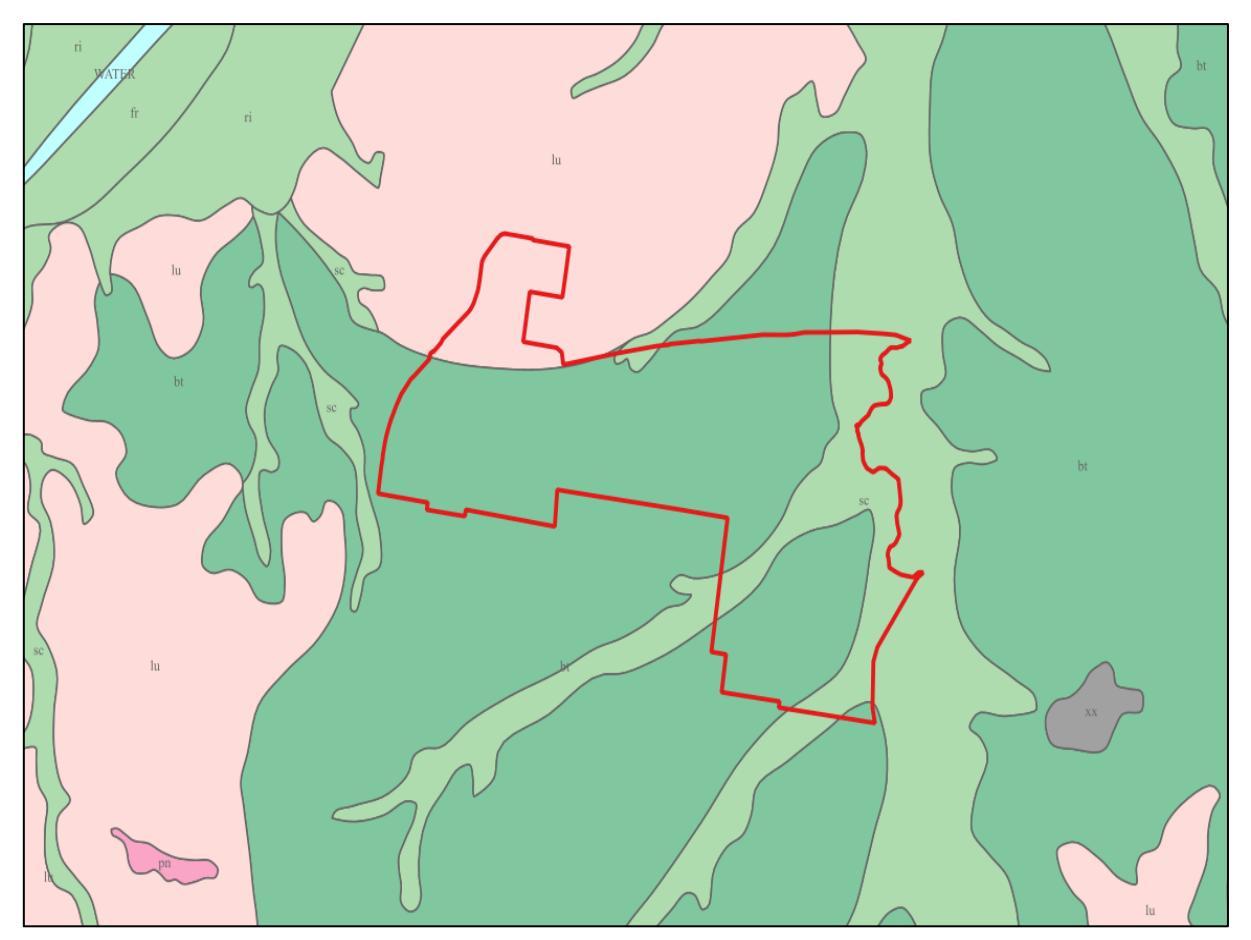
Figure 5: Soil Landscape

Reference to the Penrith 1:100,000 Soils Landscape Sheet (NSW Government, 1991) indicates that the site is underlain by the Blacktown, Luddenham and South Creek soil landscapes. The distribution of soil landscapes is presented in Figure 5.

Where:
 Dark green = Blacktown (bt), Pink = Luddenham, South Creek = Light Green, site boundary shown in red

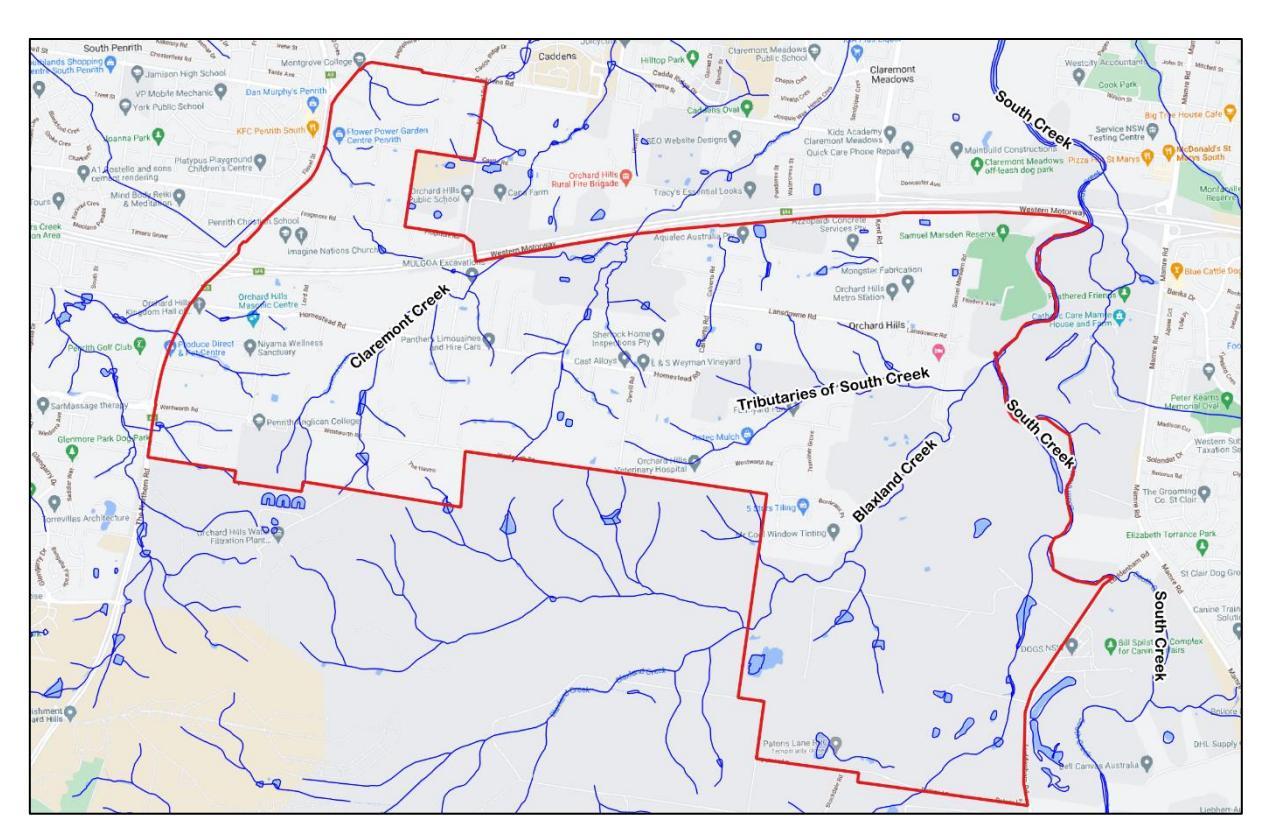
Figure 6: Surface Water Bodies

South Creek is present along the eastern boundary of the site and flows in a south to north direction, eventually draining into the Hawkesbury River.

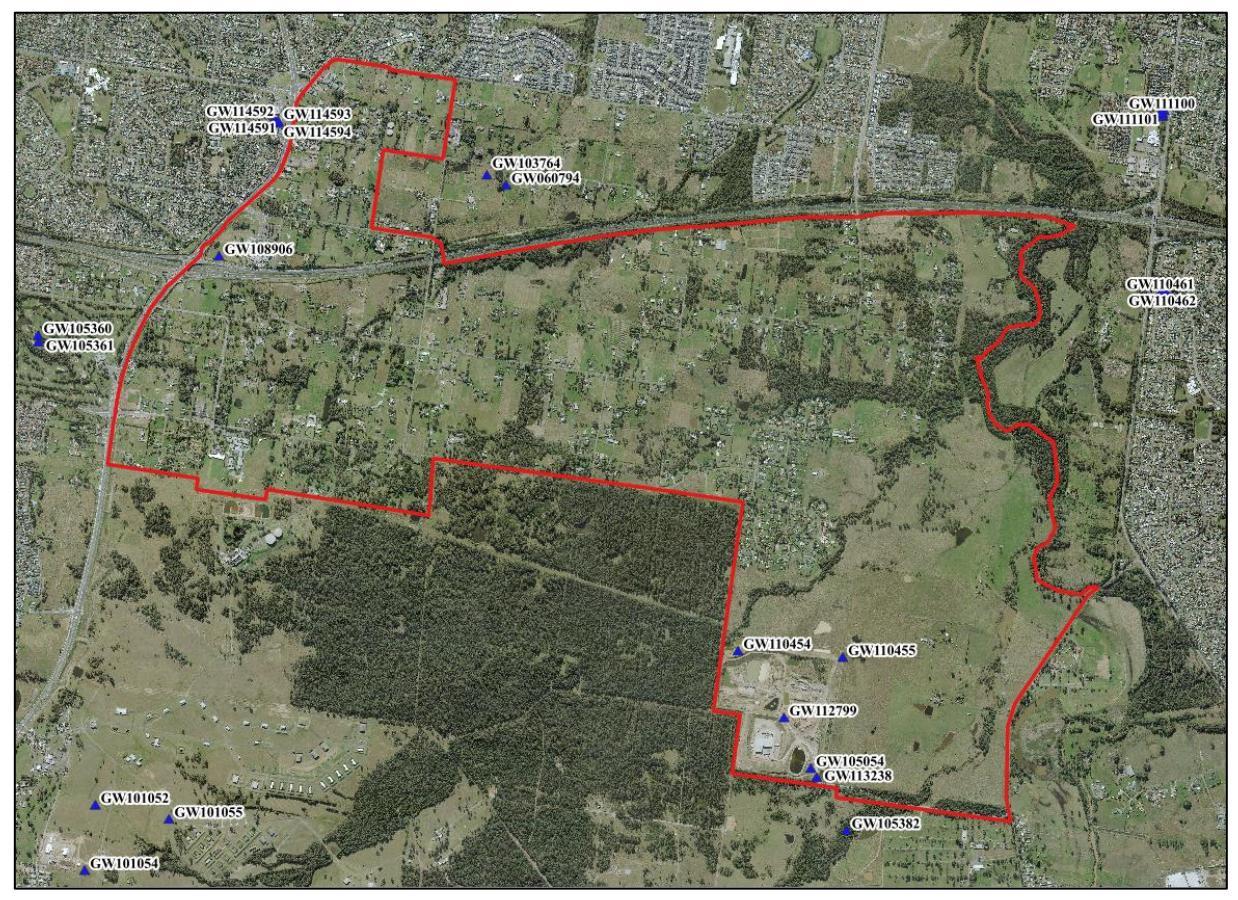
Figure 7: Registered Groundwater Bores

A search of the publicly available registered groundwater bore database indicated that there are 14 registered groundwater bores on site or within 500 m of the site. The locations of the on site and nearby groundwater bores are presented in Figure 7 and are summarised in Table 1.

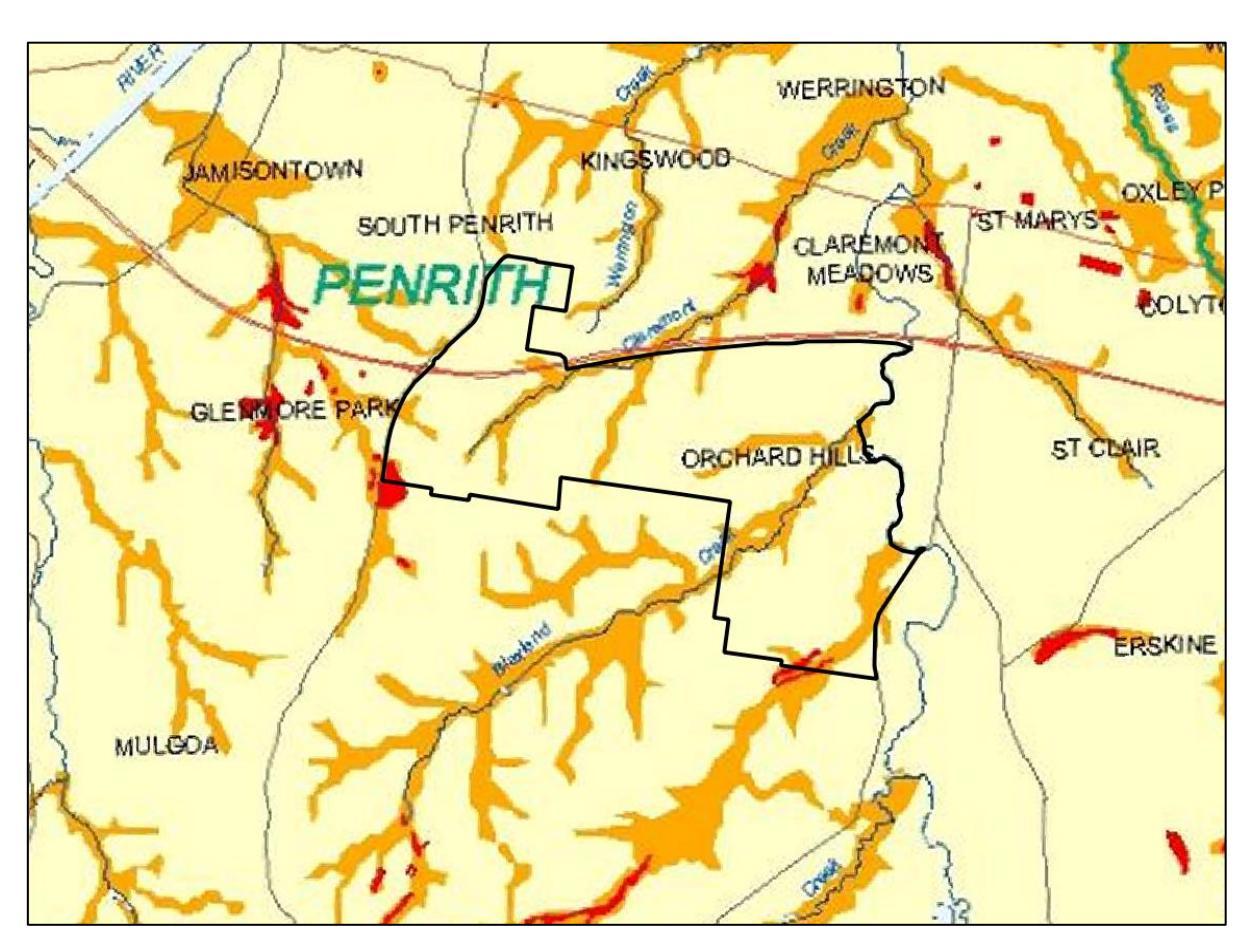
Reference to the Salinity Potential in Western Sydney Plan prepared by the Department of Infrastructure, Planning and Natural Resources in 2002, shows the site is located in an area of moderate salinity potential, with high salinity potential along the lower slopes and creek lines where water accumulation is high (orange) along with areas of known saline soils. It is noted that the mapping is based on soil type, surface level and general groundwater considerations but is not generally ground-truthed, hence actual soil salinity needs to be assessed to confirm the potential salinity. An extract of the salinity potential from available mapping is presented in Figure 8.

Figure 8: Salinity Potential Where: Yellow = Moderate Salinity Potential, Orange = High Salinity Potential, Red = Known Salinity, site boundary in black

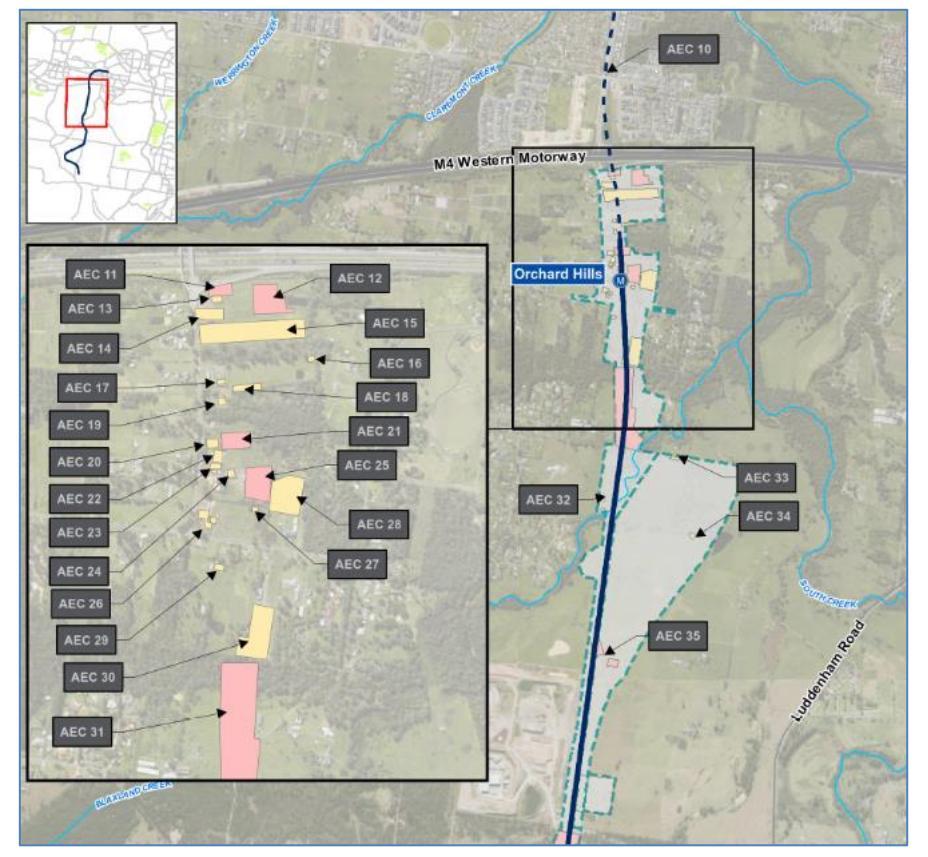
Figure 9: Extract of Figure 16-2b of the EIS

Potential contamination sources associated with the AEC identified in the EIS within the site are summarised below:

- Potential workshops and above ground storage tanks;
- Unlicenced waste disposal to land (refuse and fill);
- Storage and use of fuel, chemical and hazardous building materials;
- Historical use of herbicides and pesticides; and
- Potential cattle tick dip sites.

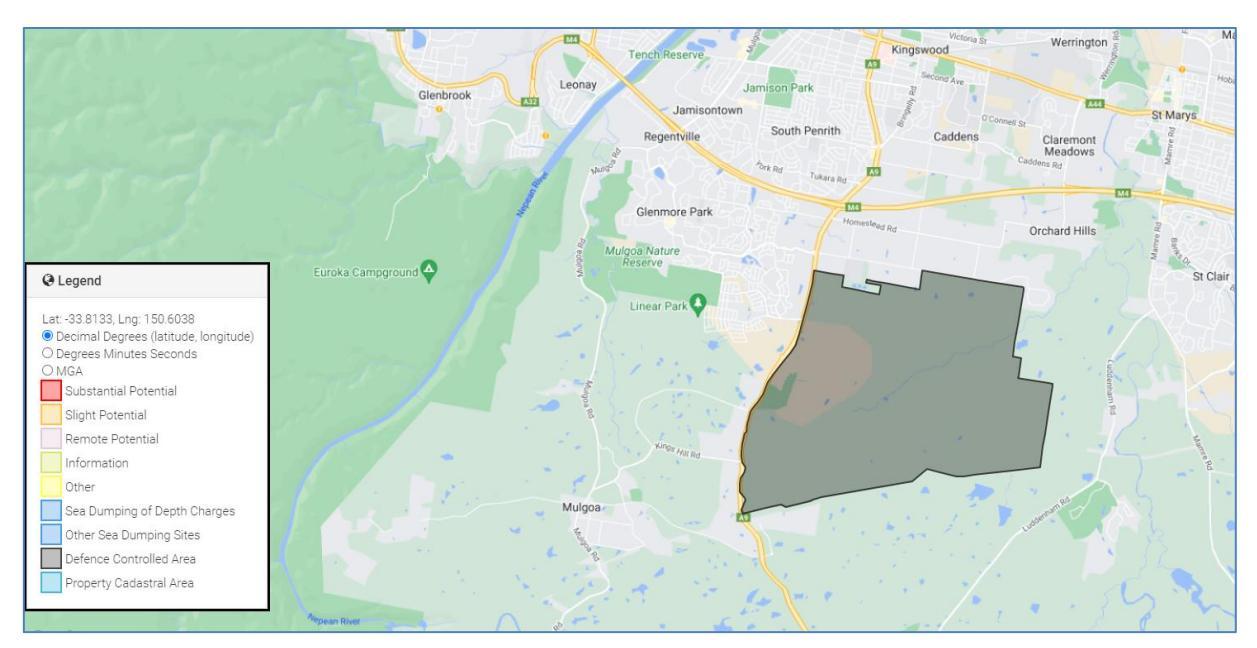
Figure 10: Unexplained ordnance search results

Based on the proximity of DEOH to the site, the previous PSI (Douglas Ref. 216919.00.02.R.002,Rev0)previously considered there was a potential UXO and EO risk at the site.

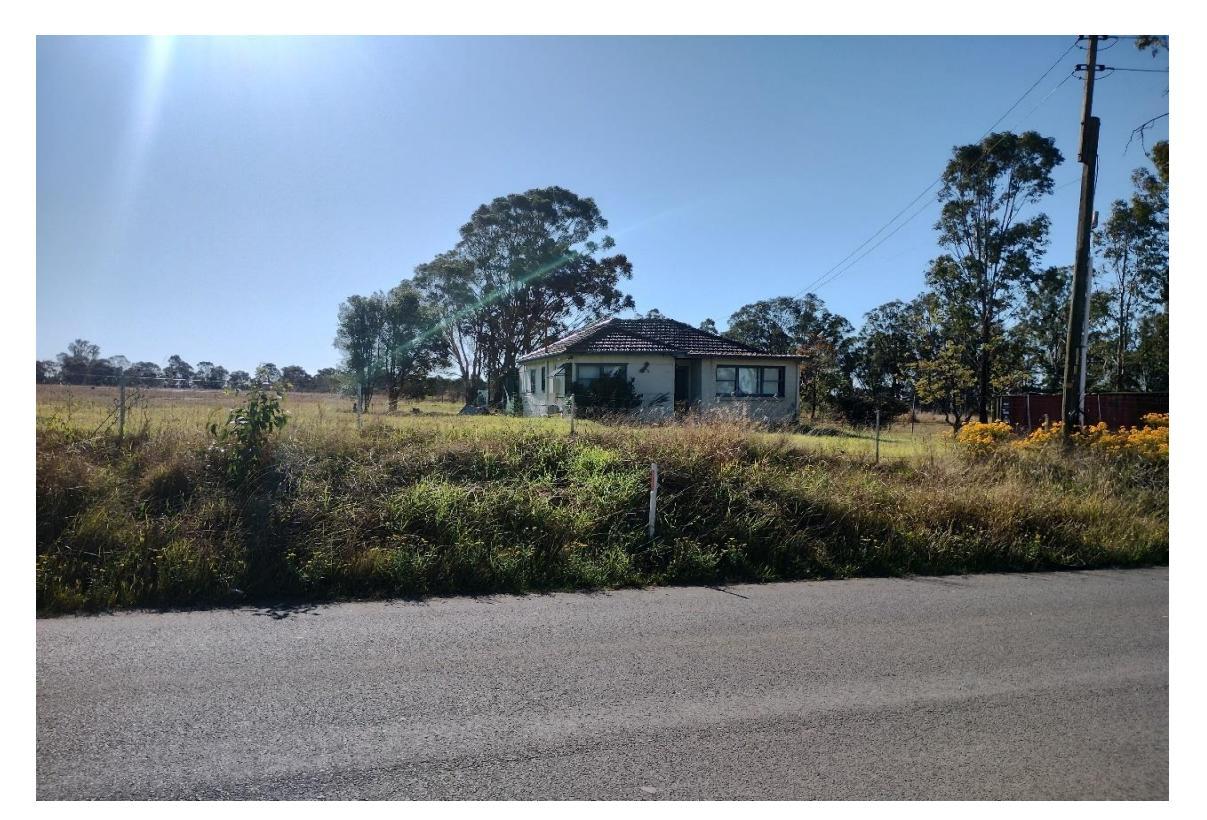
Photo 4 - Fibro house

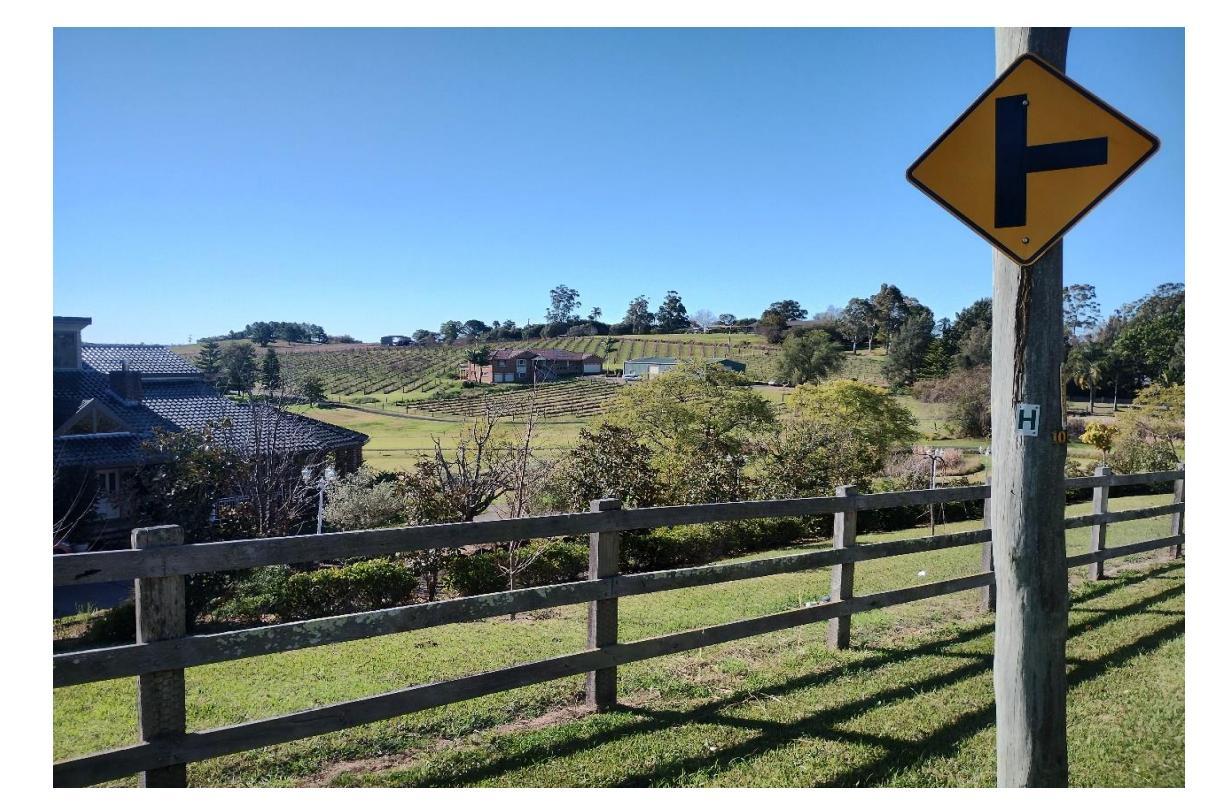
- Market gardening activities and vineyards were observed in several lots (Photographs 8 and 9);
- A number of lots were also being used to store trucks and associated equipment (Photograph 10);

Photo 9 - Vineyards on rural residential properties

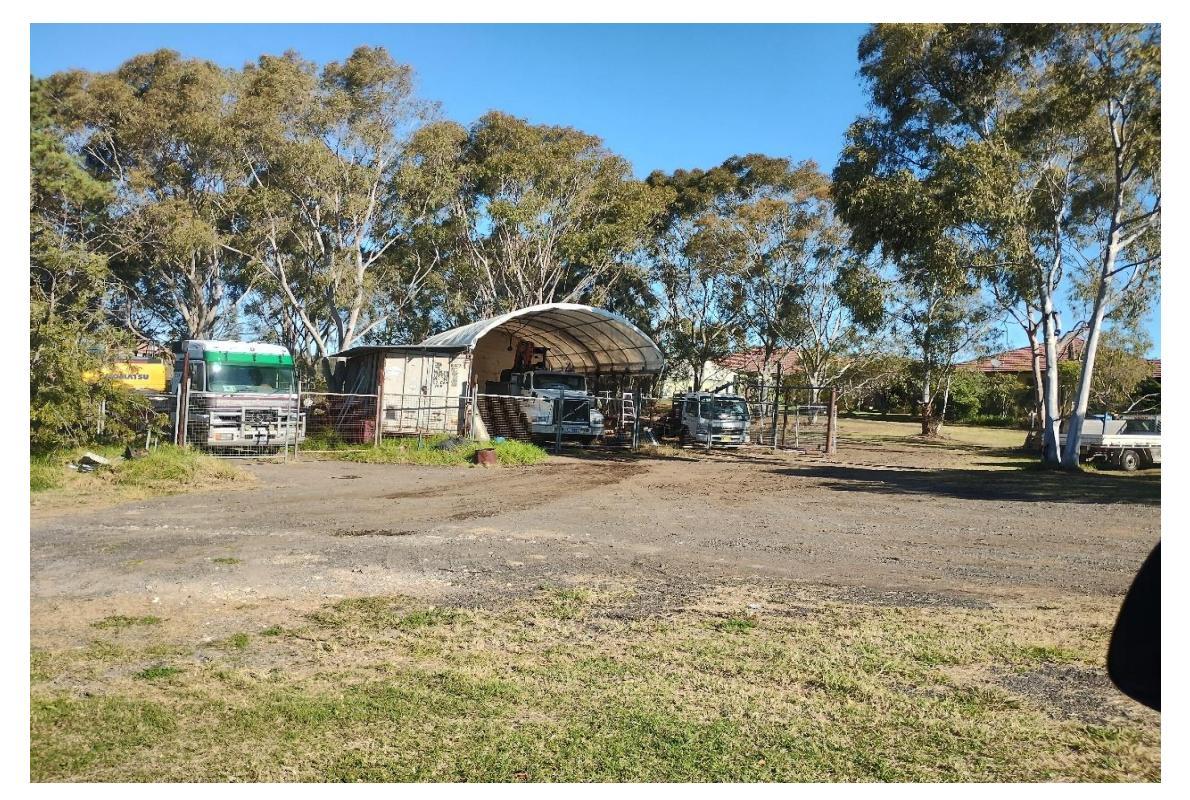
Photo 10 - Truck storage

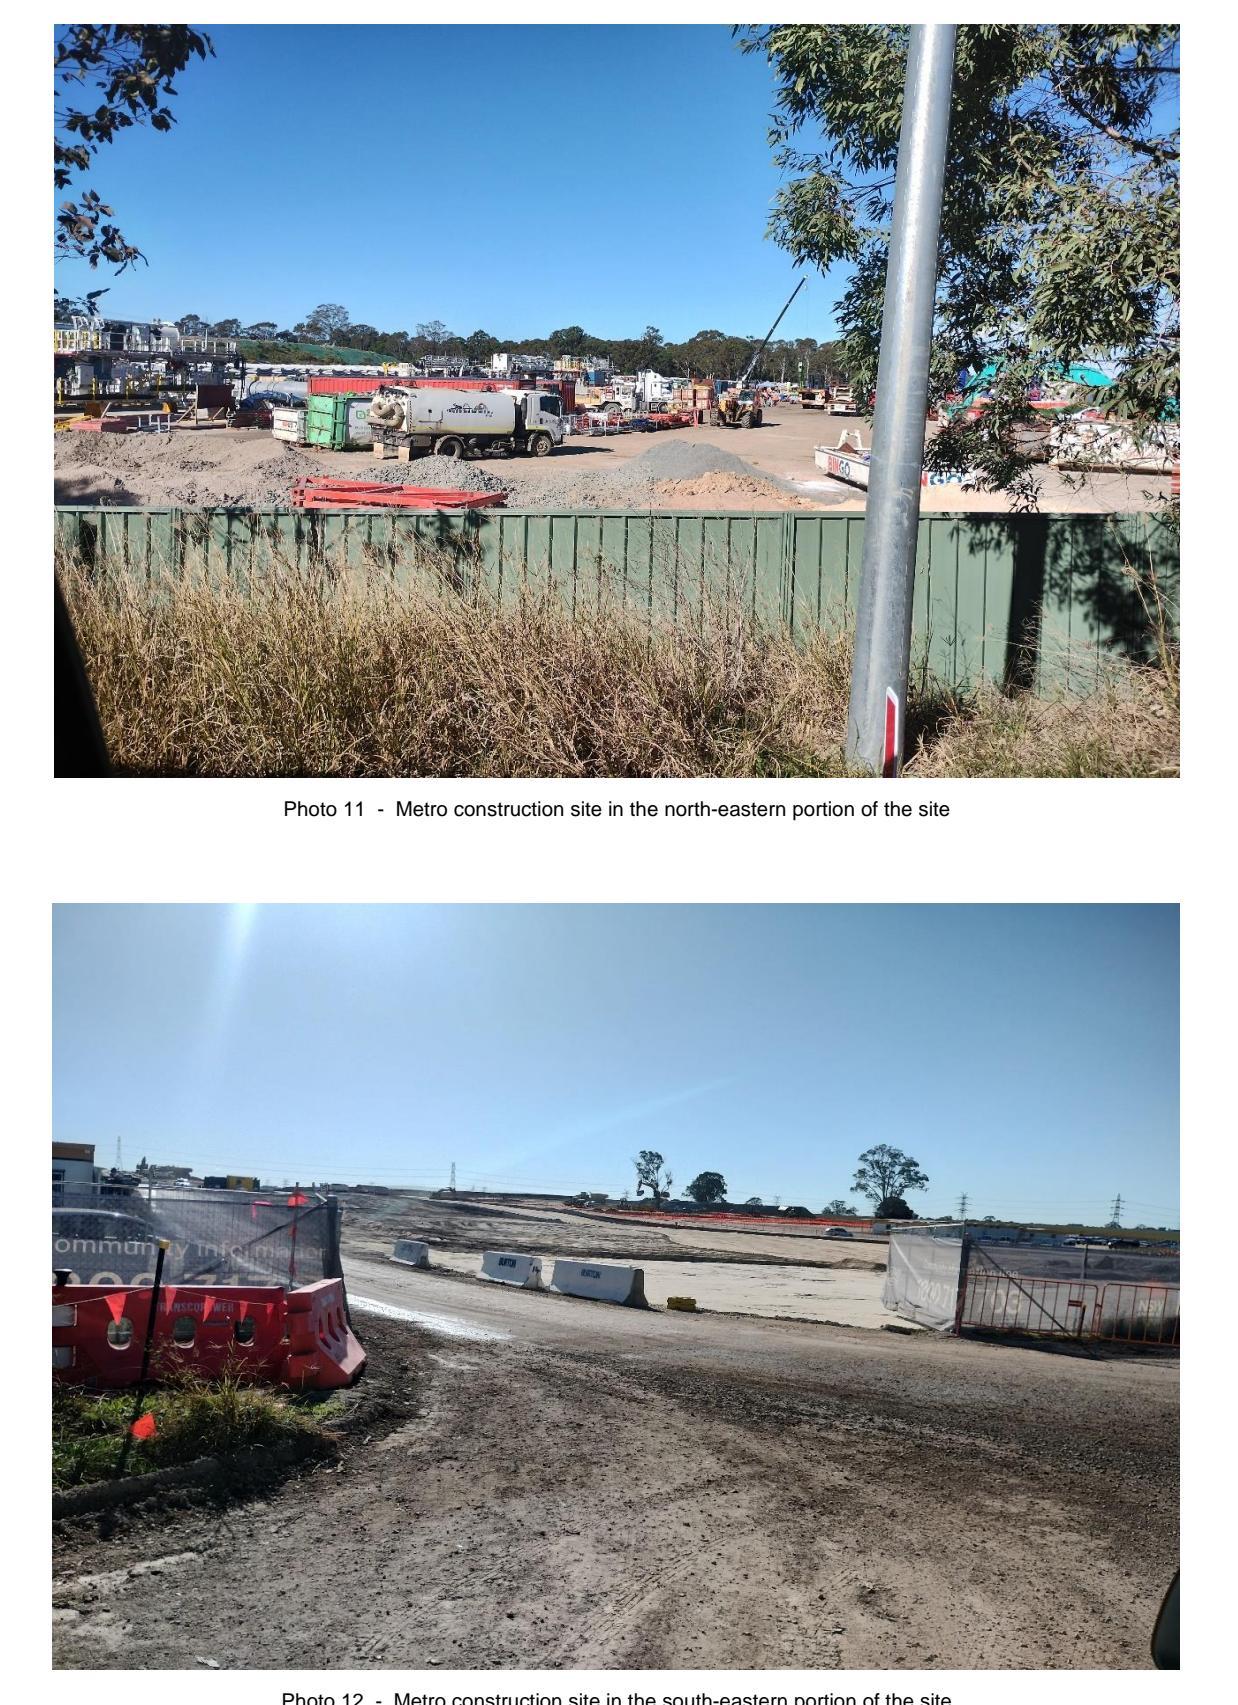
Photo 12 - Metro construction site in the south-eastern portion of the site

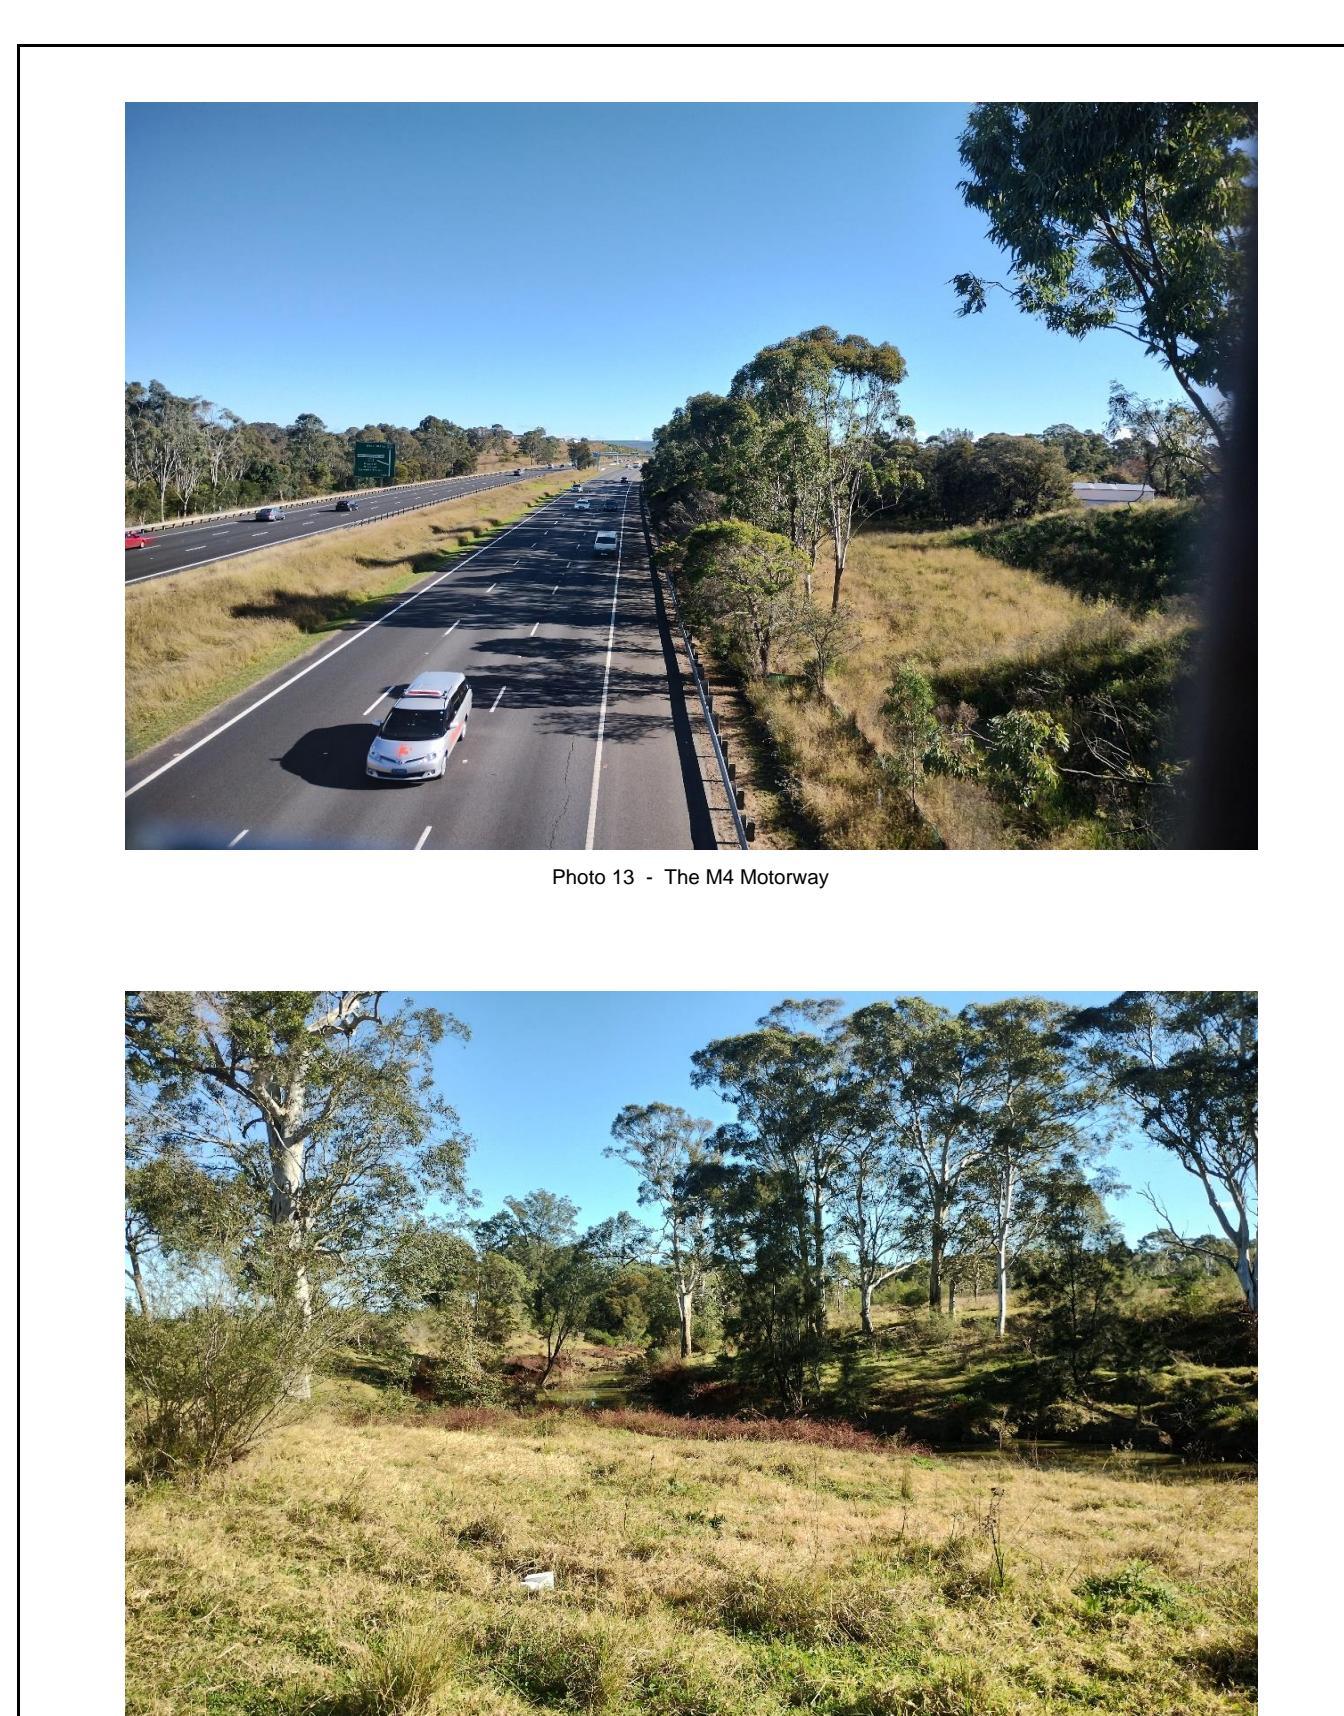
- South Creek was present in the eastern portion of the site (Photograph 14);
- A service station was observed approximately 100 m west (off-site and down gradient) of the north-western site boundary (Photograph 15);

Photo 14 - South creek in the eastern portion of the site

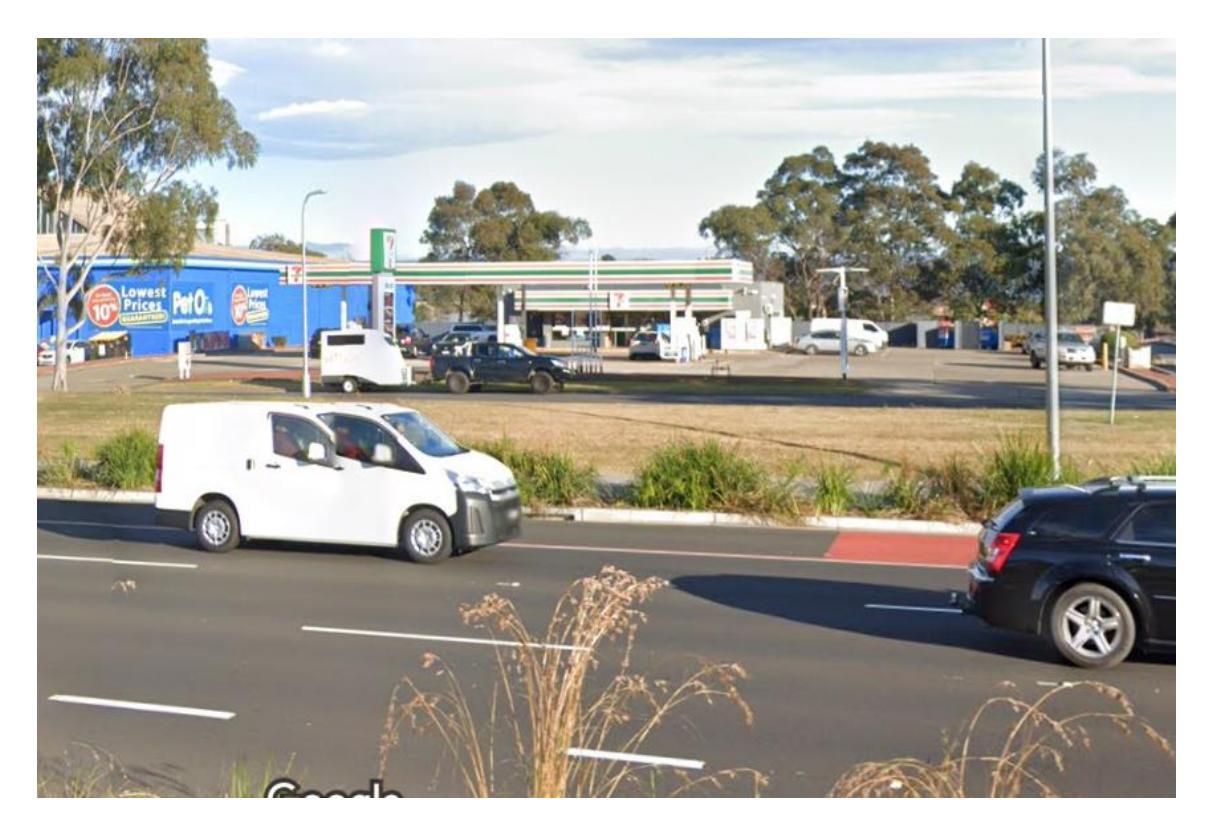
Photo 15 - View of off-site service station

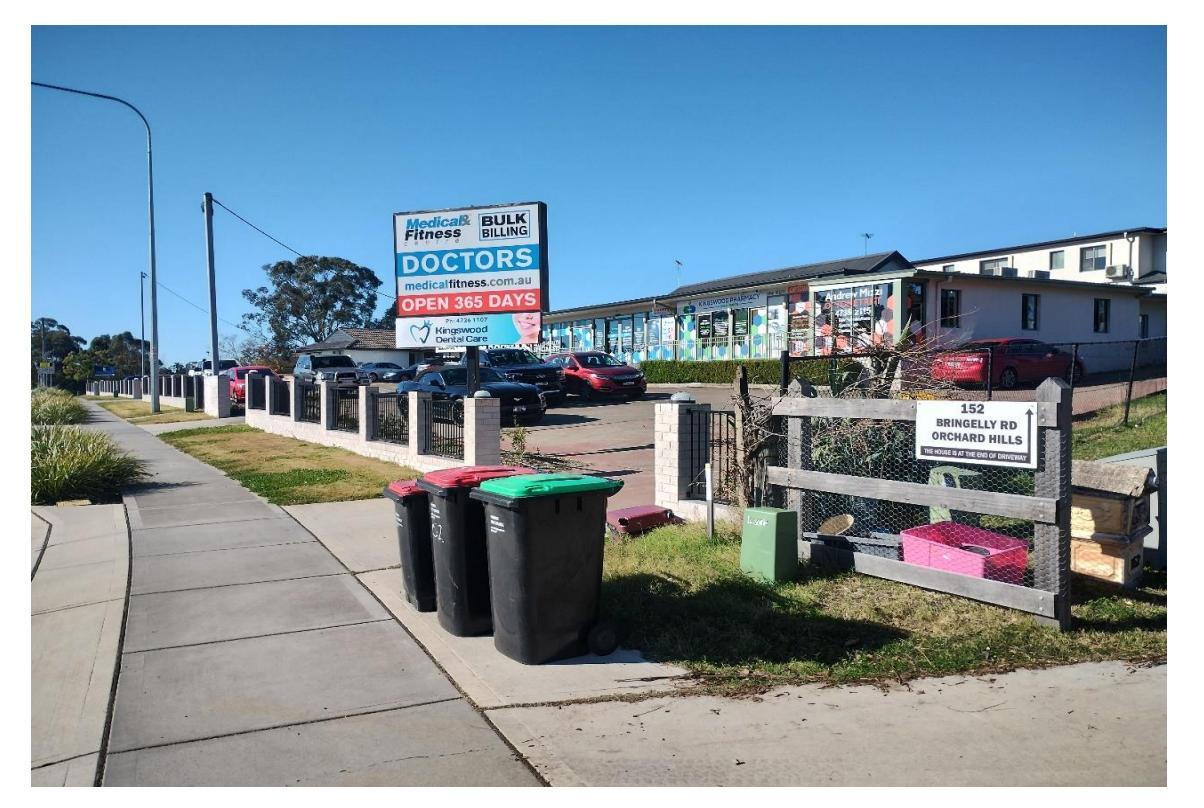
- Several commercial premises were present in the north-western part of the site (Photograph 16); and
- The Patons Lane Landfill was observed in the south-eastern part of the site (Photograph 17). A detailed inspection of the premises was not completed as part of the PSI.

Photo 16 - Commercial premises in the north western portion of the site

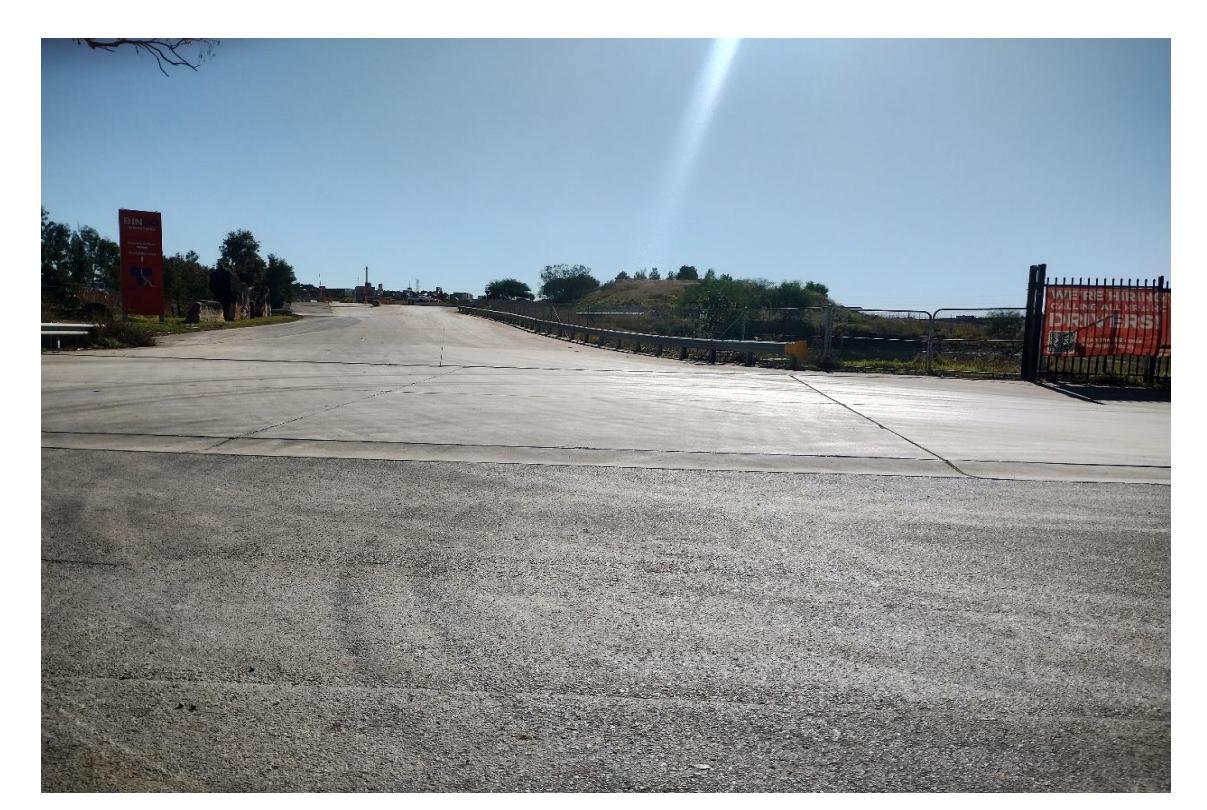
Photo 17 - View of the entrance to the Patons Land Landfill

Patons Lane Landfill is located within the south-eastern part of the site however is greater than 500 m from the closest additional residential development potential, in the Vines. Potential leachate impacted groundwater and subsurface gas migration associated with decomposing waste material at the Patons Lane Landfill has the potential to constrain development in the vicinity of the landfill. Douglas recommends that an appropriate buffer zone, which excludes residential development within approximately 440 m of Patons Lane Landfill be implemented.
